# SANTA BARBARA CITY COLLEGE

## ADA PATH OF TRAVEL ASSESSMENT

# Facility Condition Assessment Report ADMINISTRATION BUILDING

**Facility Condition Assessment Report**  
**Santa Barbara City College – Main Campus**  
**Administration Building**  
**721 Cliff Drive**  
**Santa Barbara, CA 93109**

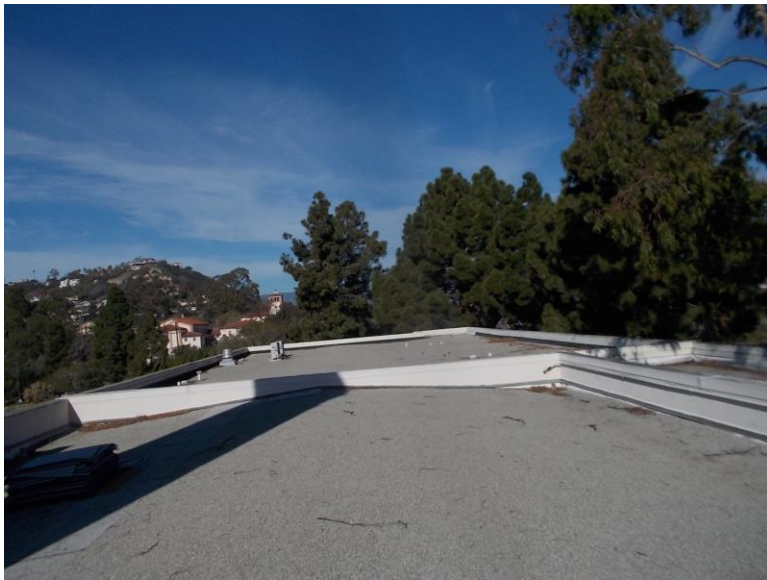
R2. Northeast wing built-up roof.

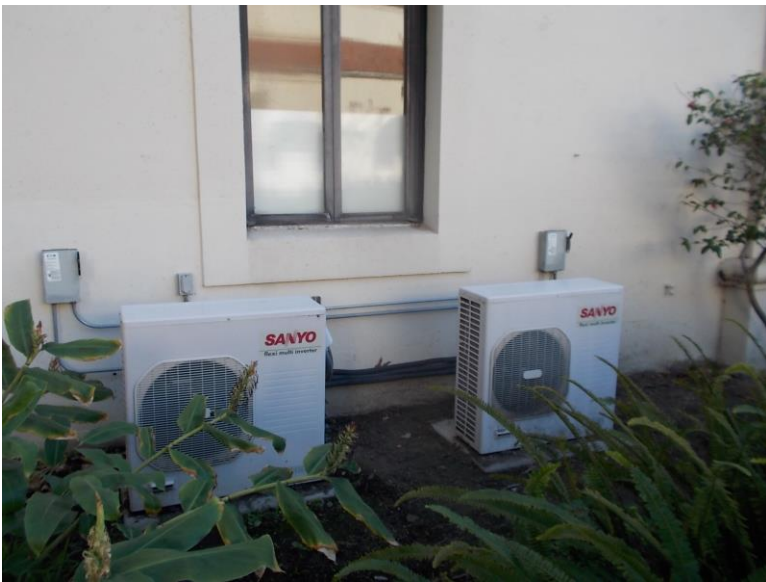
M4. Split heat pump systems for air conditioning offices.

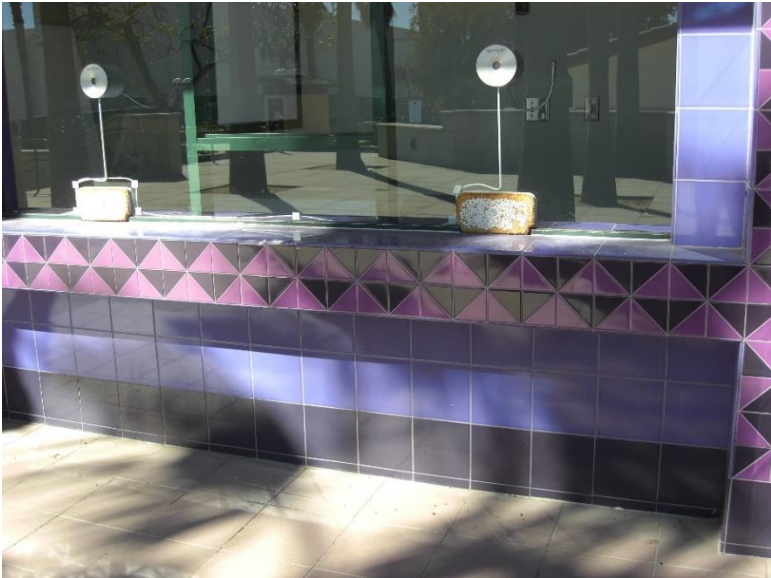
AE6. Forum ticket booth exterior ceramic tile finish.

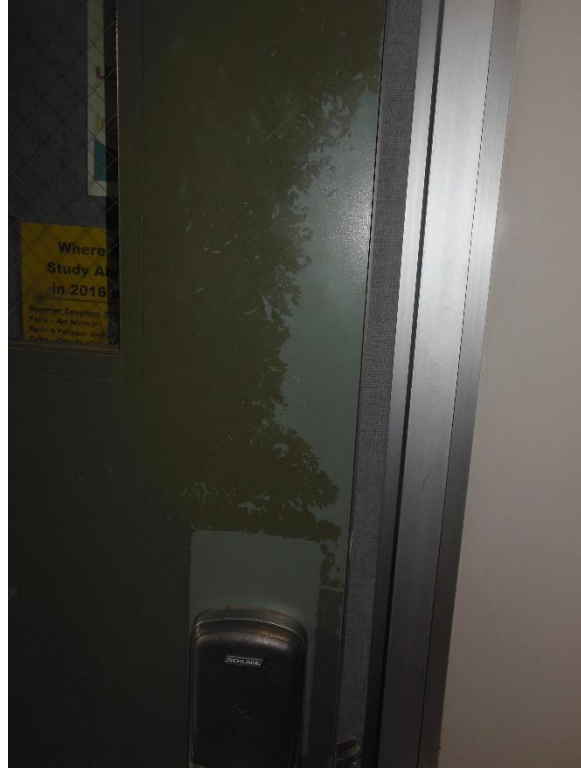
D6. Exterior classroom door; paint finish damaged.

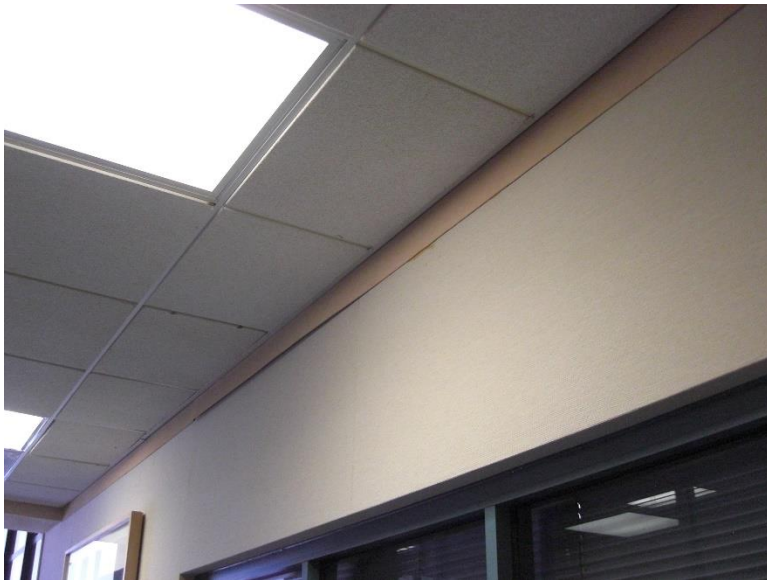
A4. Second floor Corridor 205; head trim piece delaminating from wall.

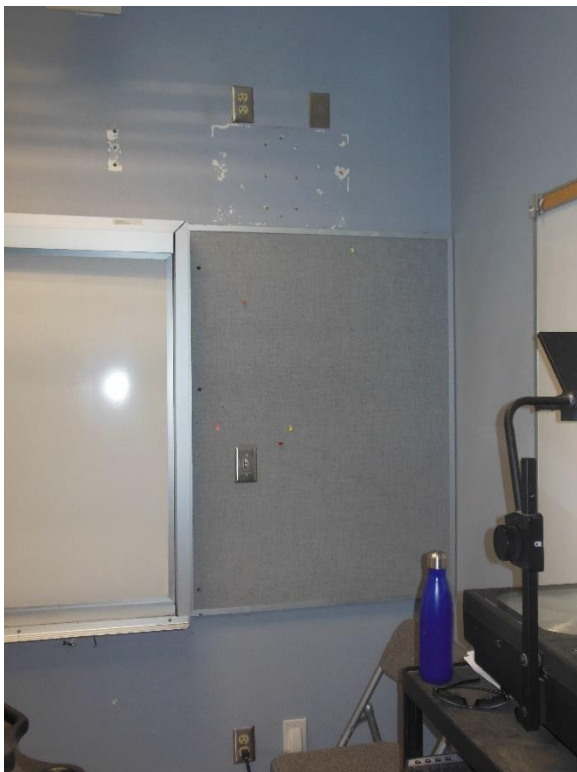
A6. Second floor classroom; wall repair damage.

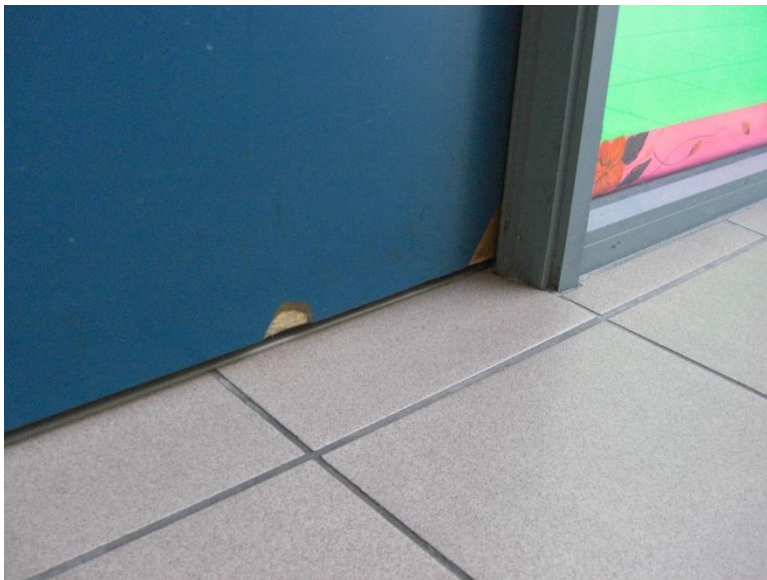
D3. Third floor; damaged and stained plastic laminate faced office door.

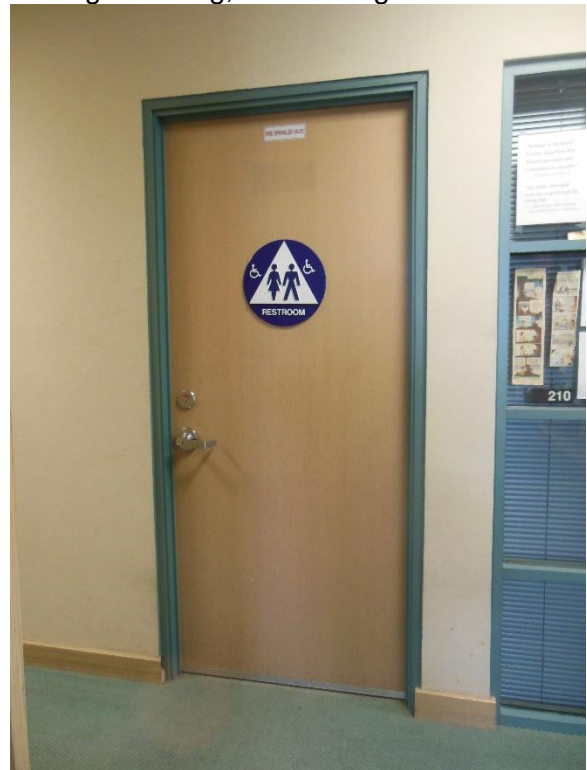
D7. Second floor staff unisex restroom. Missing wall mounted room ID signage.

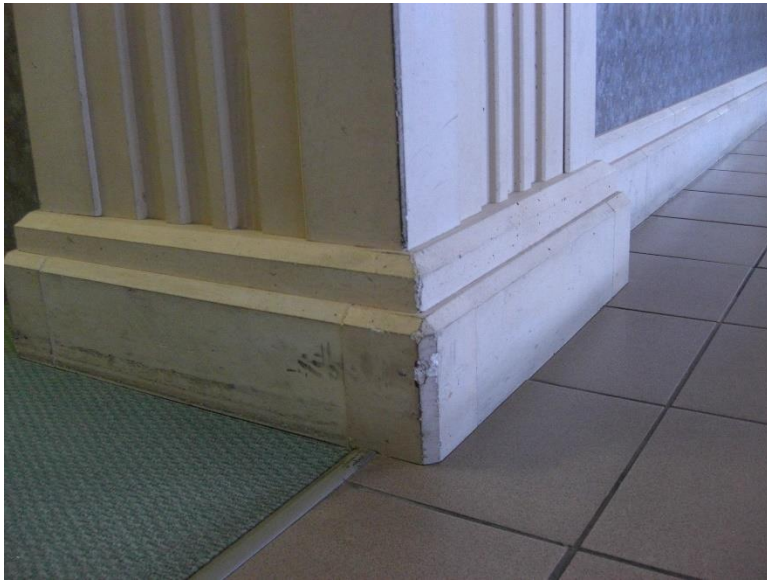
IF1. Second floor reception; wood base damage.

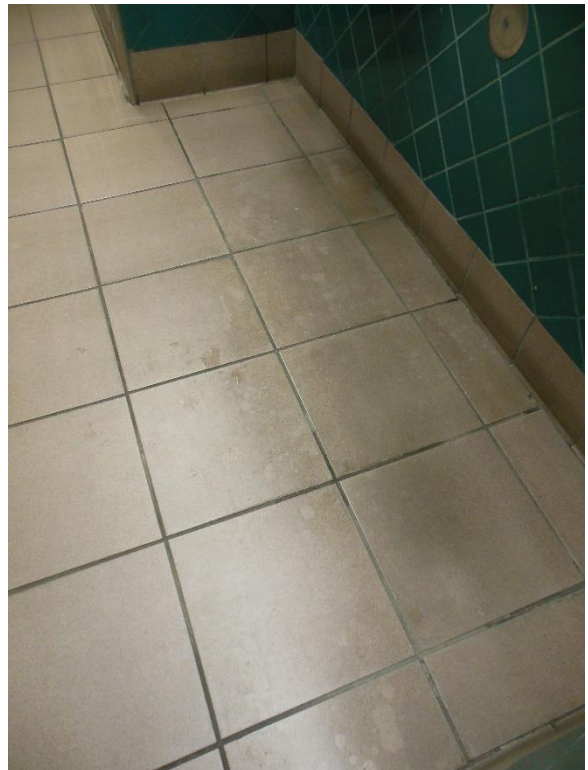
IF3. Second floor corridor, stained quarry tile under drinking fountains.

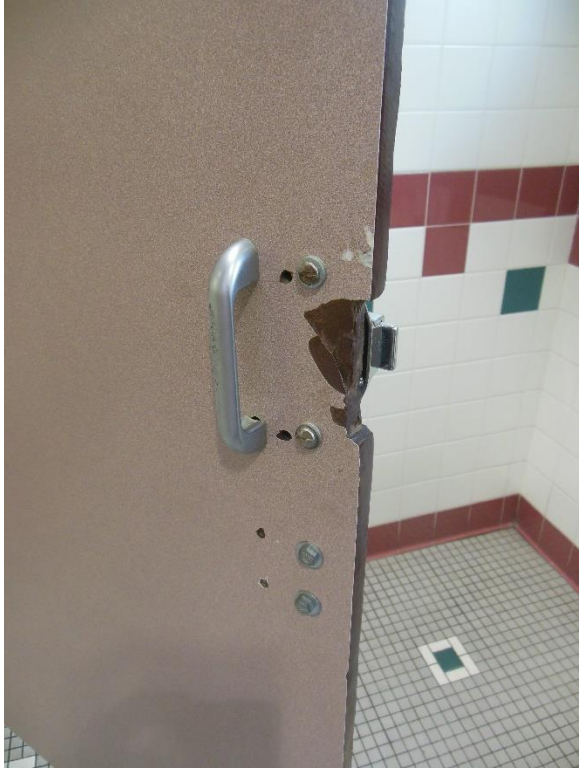
RR5. Café restrooms; damaged accessible stall hardware.

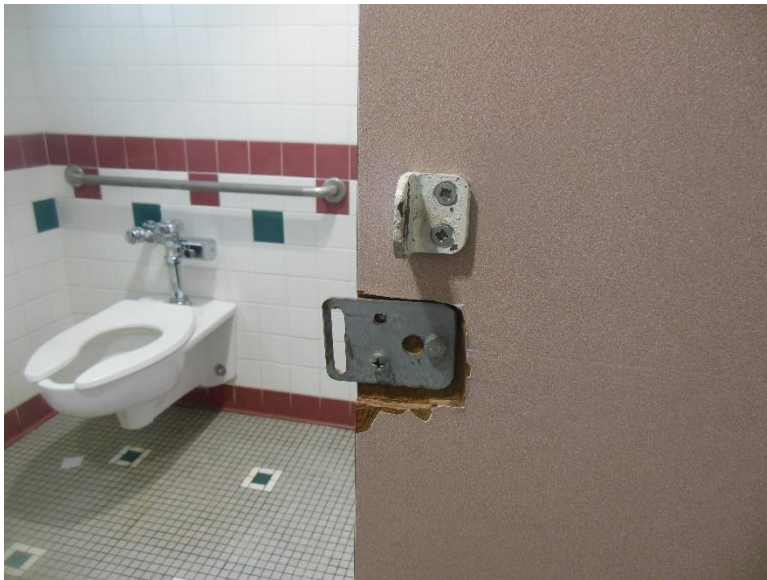
RR6. Café restrooms; damaged accessible stall hardware.

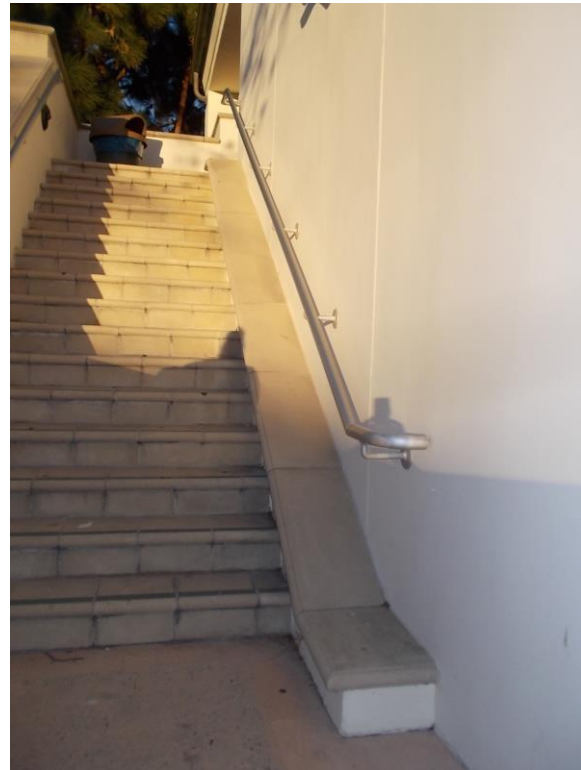
ST4. Exterior north stair exceeds distance to handrail from edge of stairs.

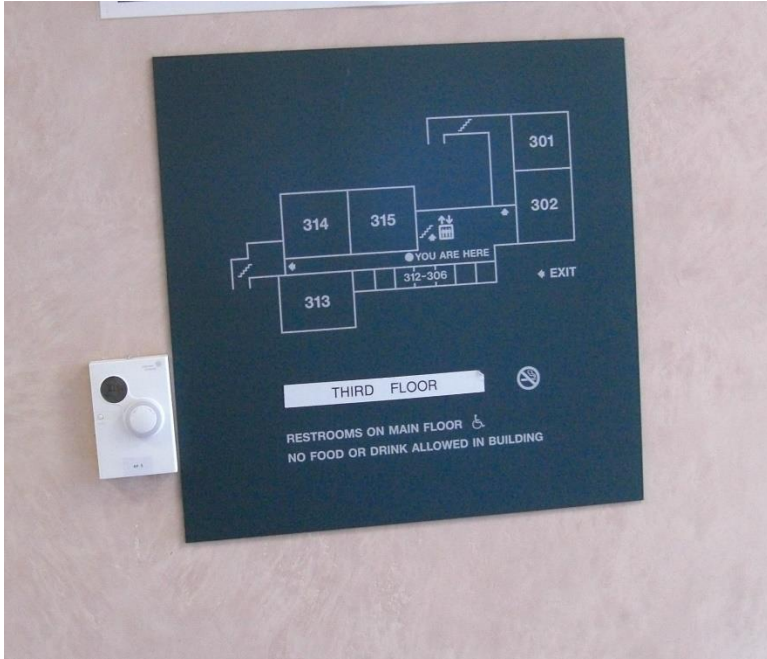
S3. Third floor, evacuation signage, missing extinguisher and fire alarm pull locations.

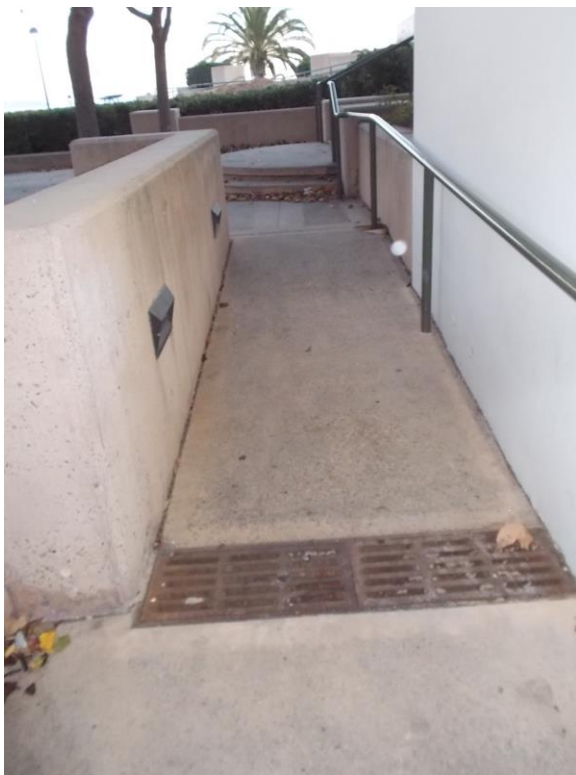
PT7. South side of building, ramp leading to Room 101; One handrail missing, non-compliant height at existing handrail, and drain grate creates abrupt and non-level lower landing.

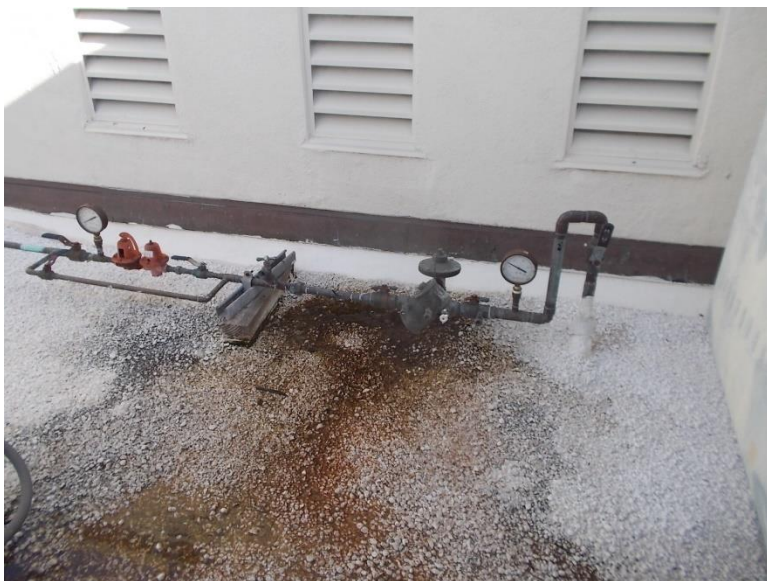
R2. Mechanical roof well with water damage at built up roofing system.

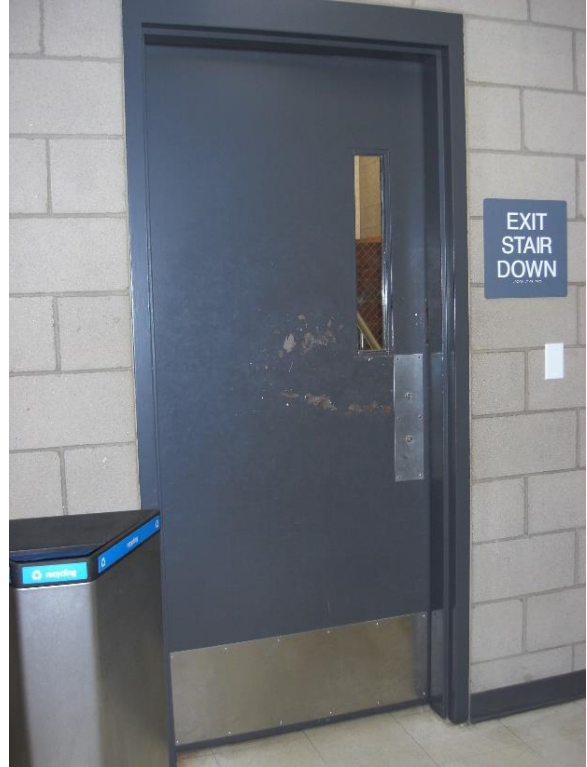
D4. Second floor stairwell door with damaged paint, and no panic hardware.

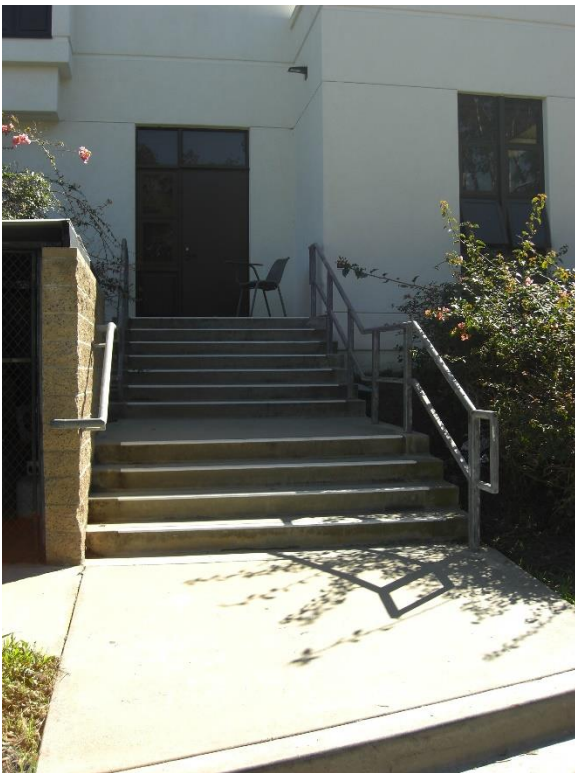
ST2. North exterior stairs with non-compliant and corroded handrails.

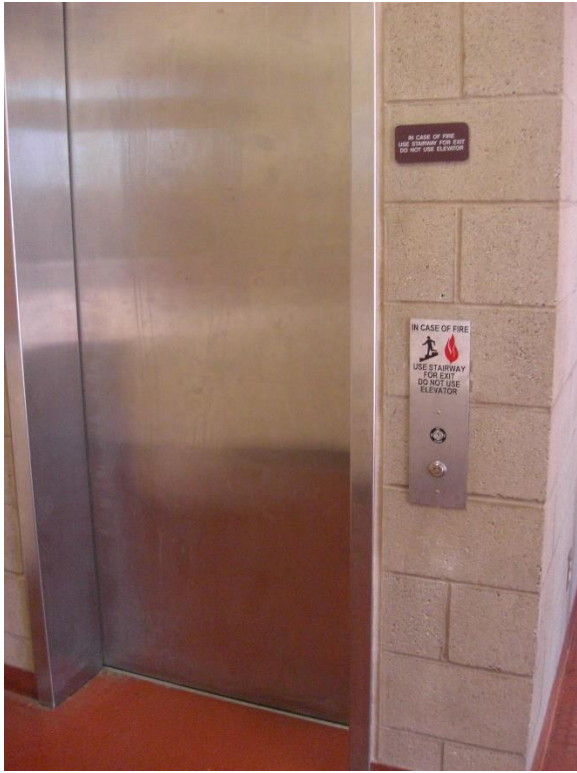
EV1. First floor elevator doors; missing proper signage.

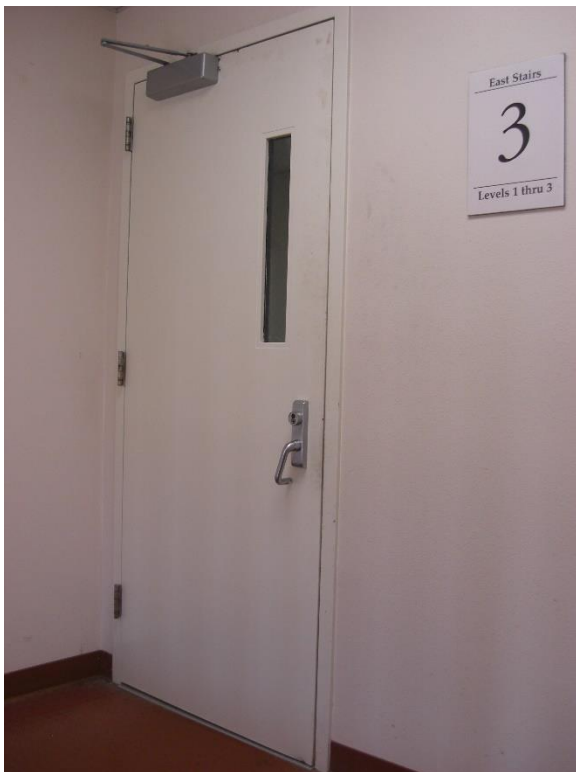
S2. Stairwell exiting signage is inadequate; second floor.

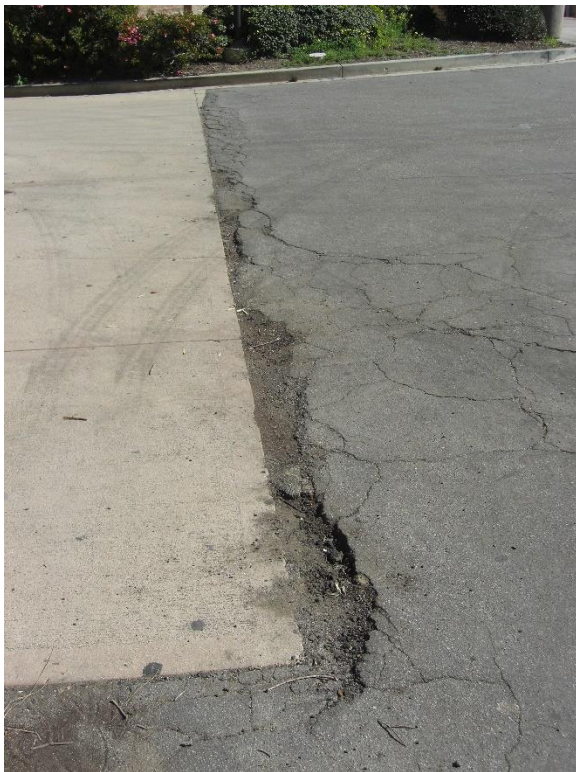
PT2. Asphalt to concrete transition along path of travel from the IDC building to the parking lot is crumbled, uneven and degraded.

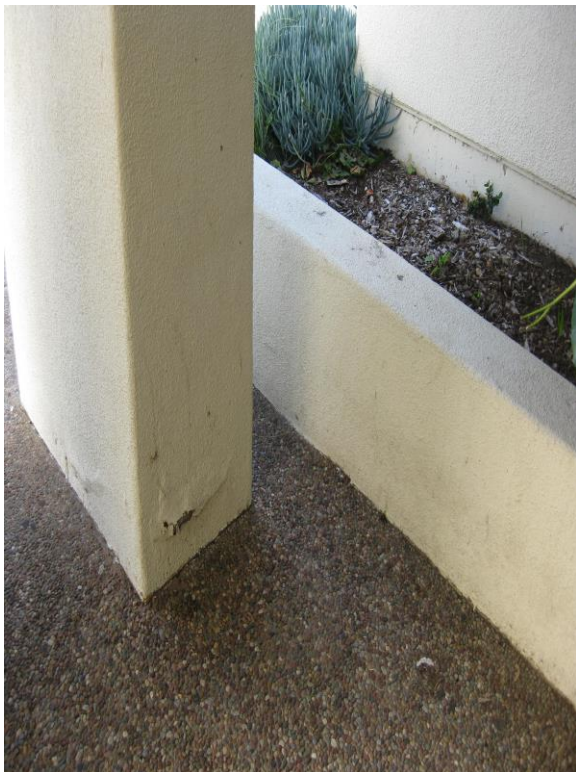
AE2. Cracked and bubbling plaster at south entry column.

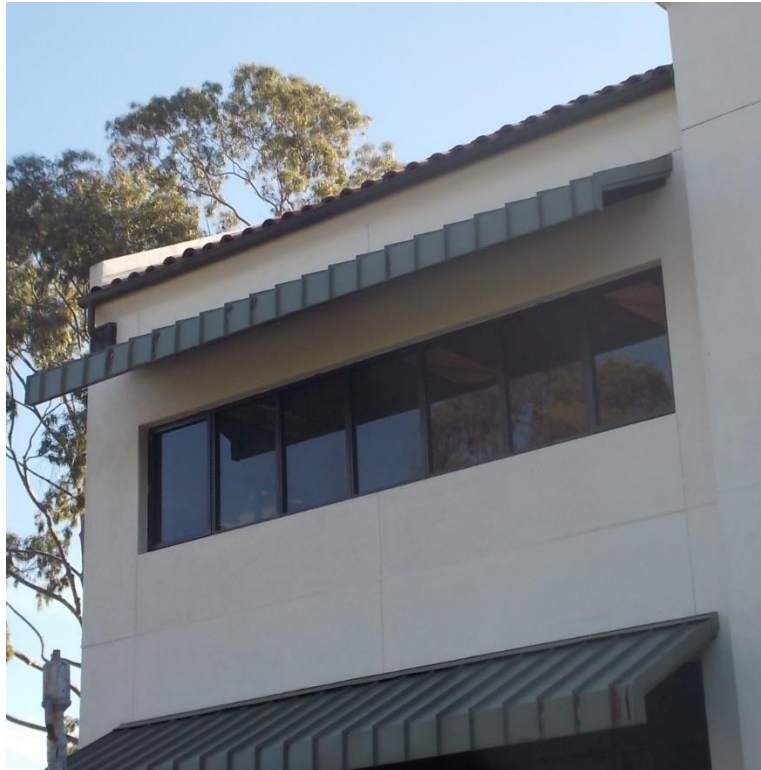
R1. Metal awning damage, northeast side of building.

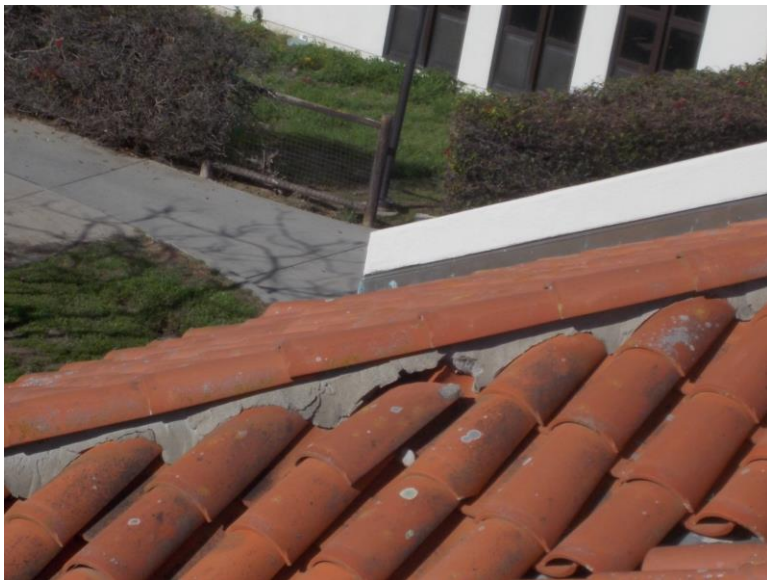
R2. Roof tile mortar damage at ridge, northeast side of roof.

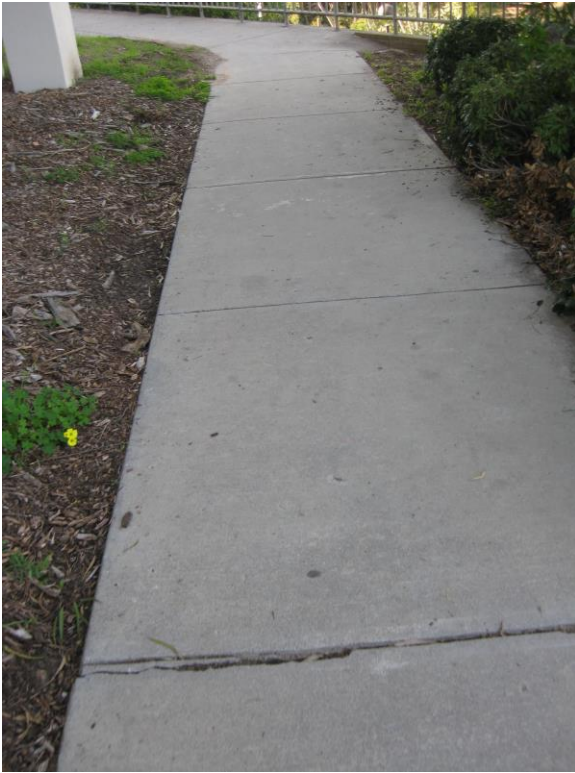
EF1. East side concrete walkway, with large cracks, tripping hazards and excessive cross slope.

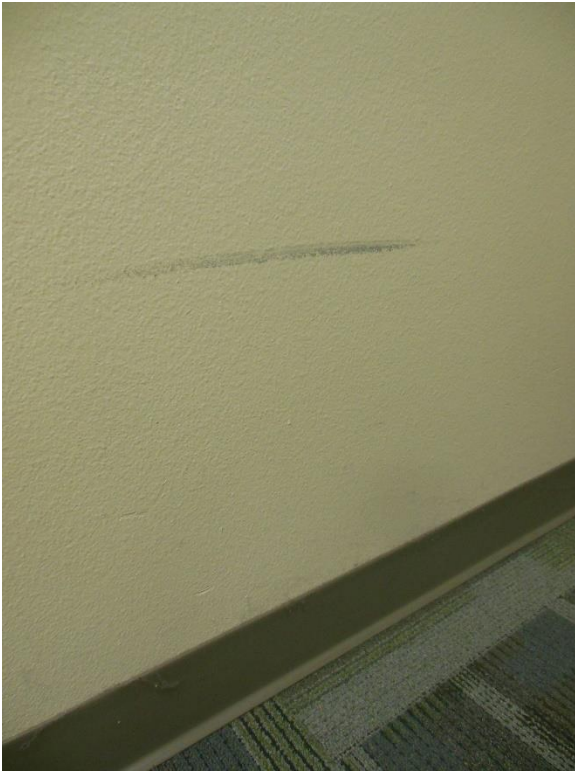
A1. Learning Center interior wall with minor damage.

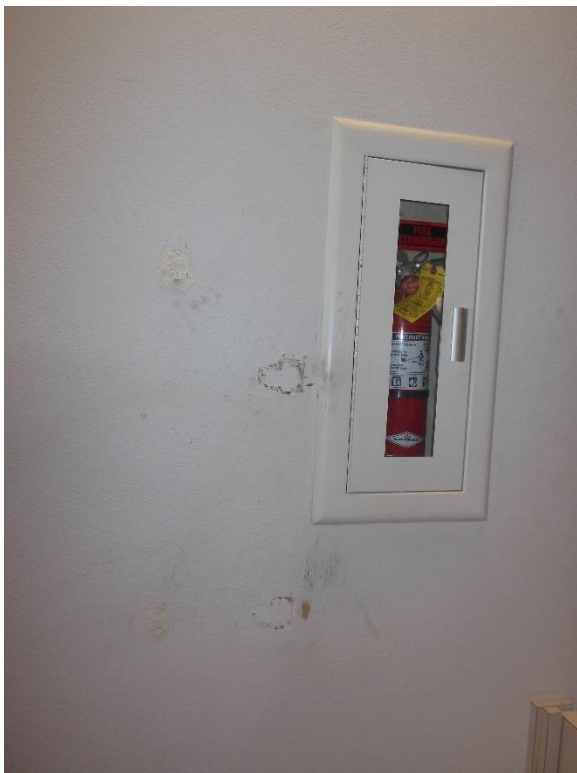
A7. Library lower level; wall damage.

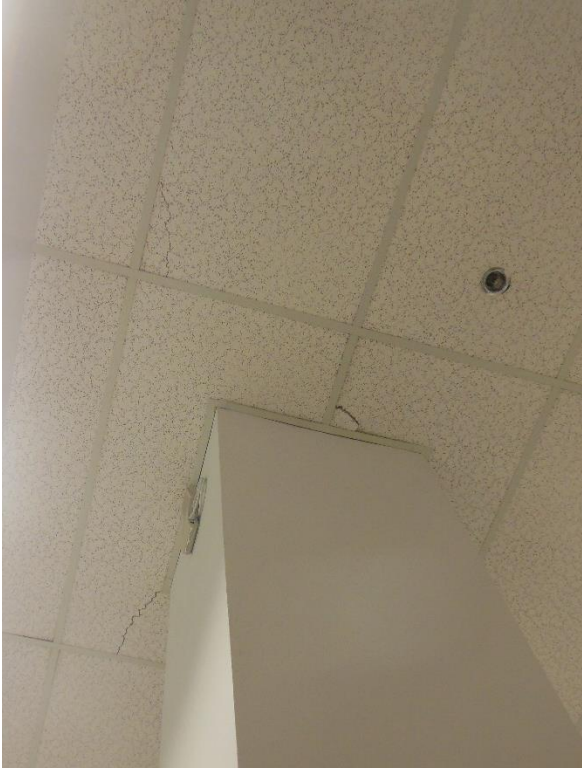
C3. Library upper floor; broken/damaged ceiling tiles.

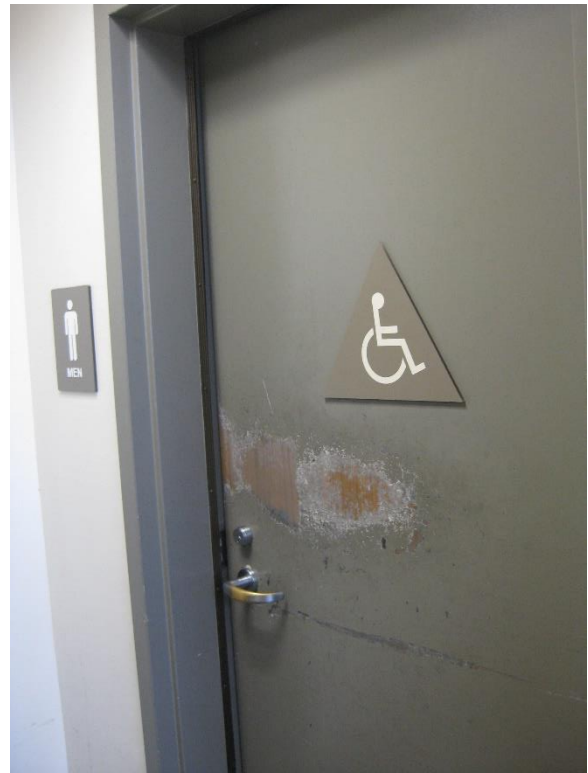
D2. Lobby Men's Restroom; damaged paint, and non-compliant door signage.

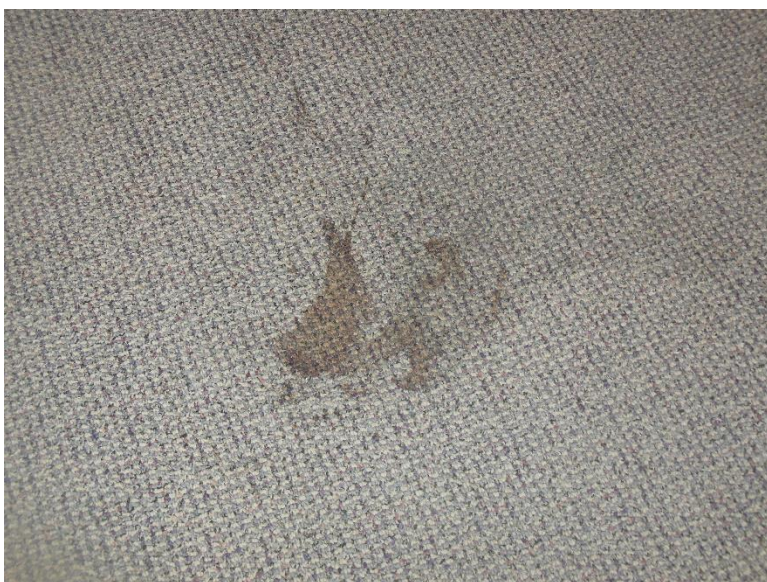
IF8. Library; broadloom carpet with stains throughout, typical.

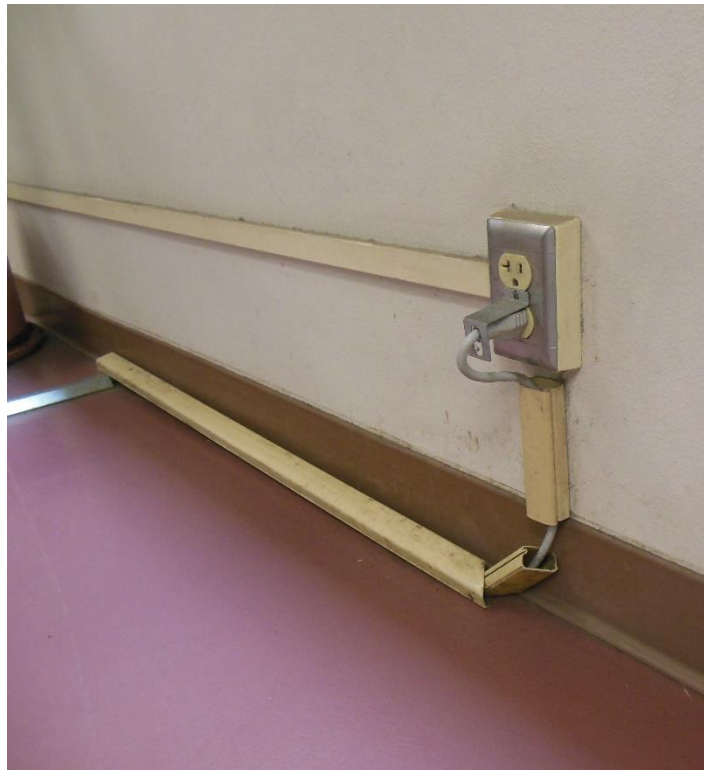
E5. Library, first floor; electrical duplex outlets, poor condition/installation.

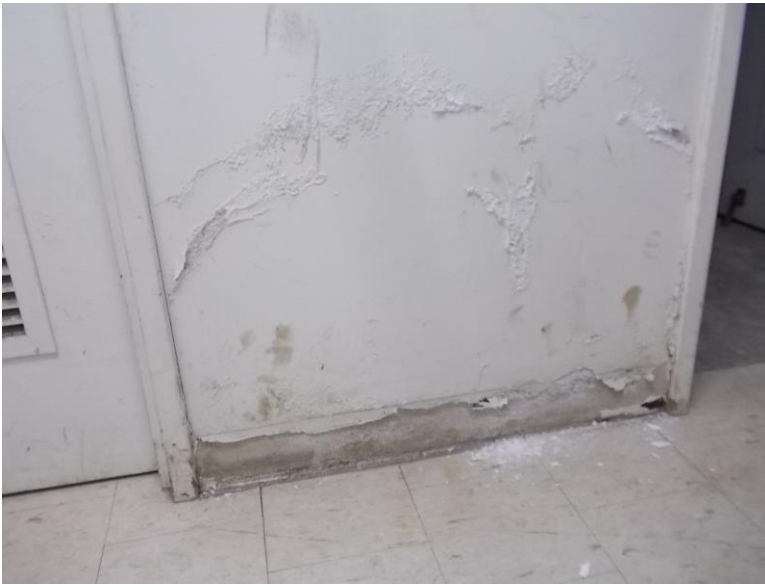
AI1. Basement; interior drywall and base damage.

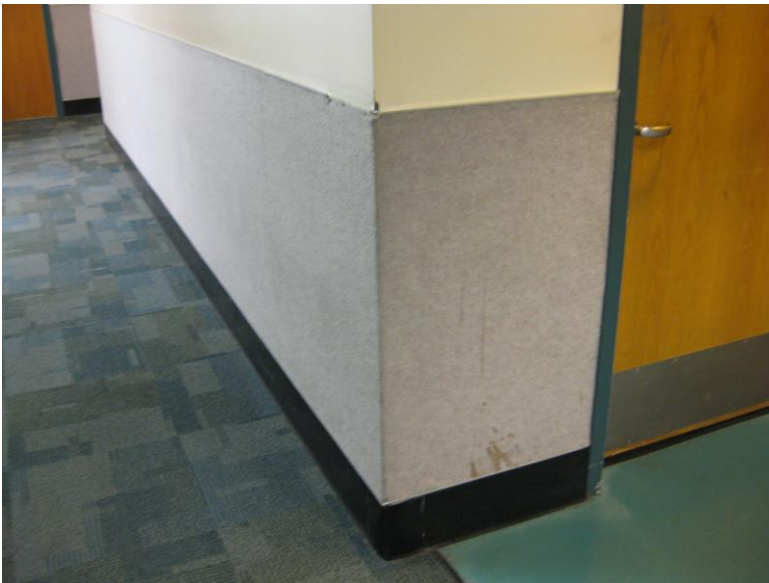
AI2. Second floor corridor; fabric covered wainscot stains and corner damage.

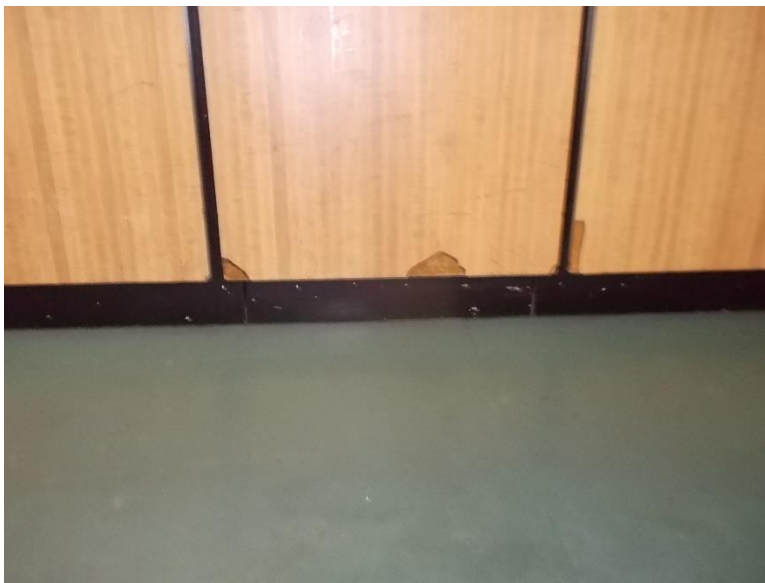
AI4. Elevator cab interior; damaged wall panels.

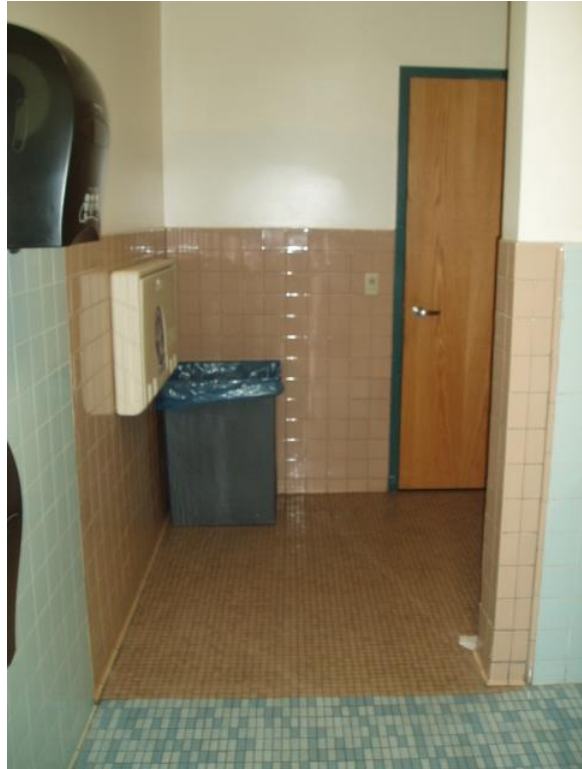
A16. Restroom wall tile mismatched.

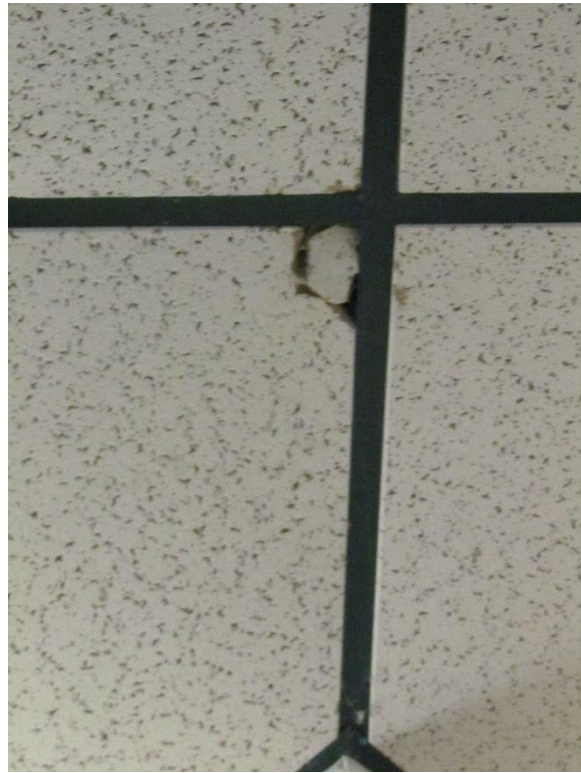
C2. Second floor; ceiling tile damaged.

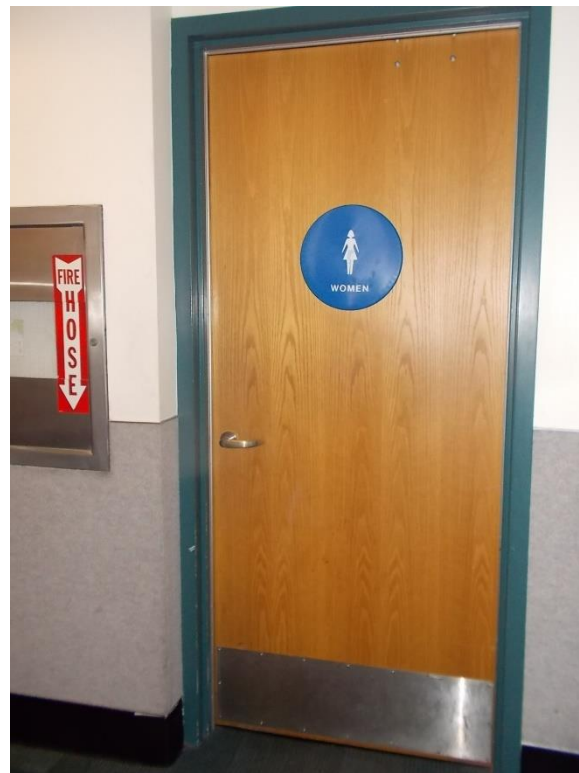
D5. Second floor restroom; push-side clearance not met, wall signage missing.

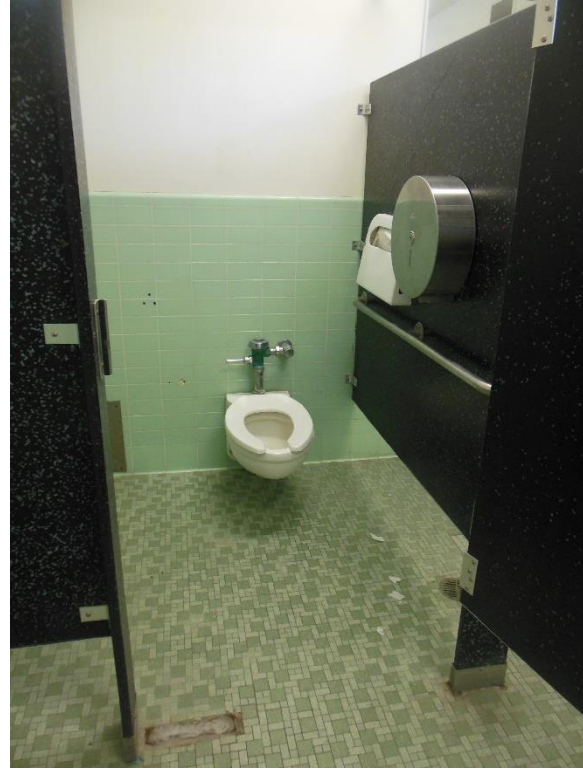
RR4. Men's Restroom; missing back handrail; and stall size too small.

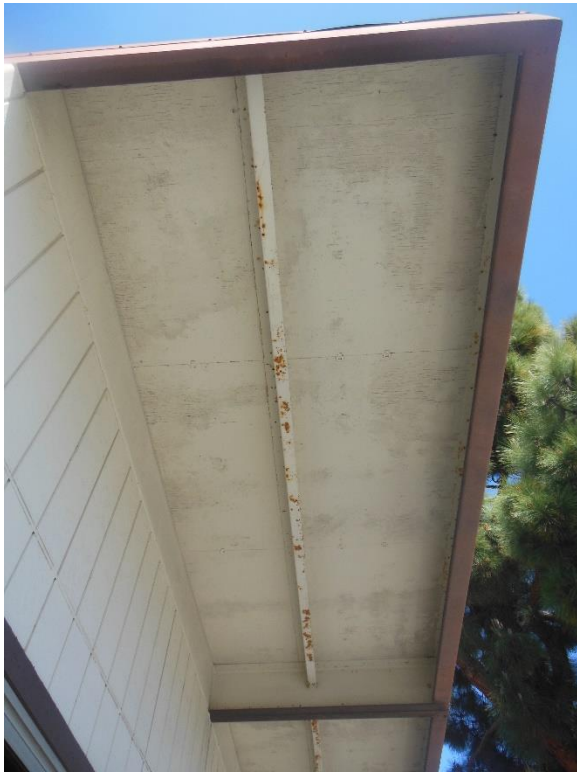
R1. Portable Classroom 28A; underside of roof overhang, rusted.

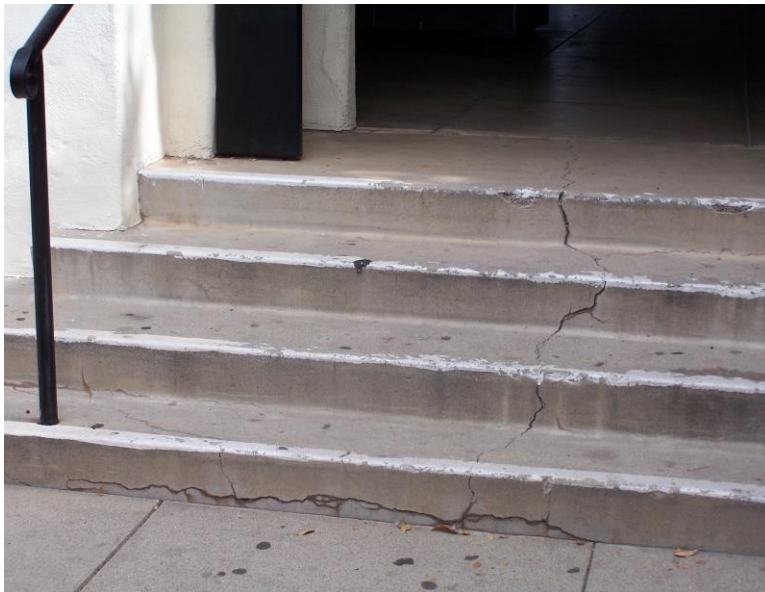
ST2. Stairs at west entrance; non-compliant handrails, stair nosing faded, and degraded concrete materials.

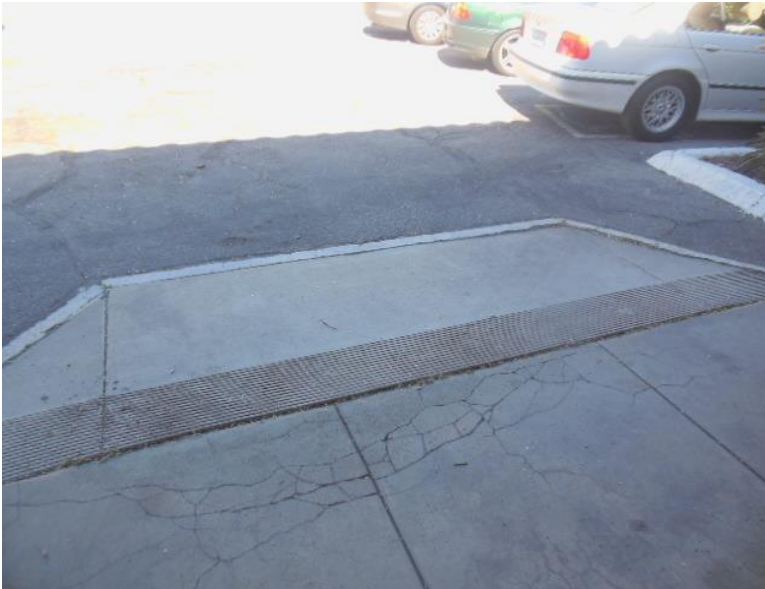
PT3. Curb ramp to parking lot; ramp cannot project into the path of cars, and are missing truncated domes. Concrete surface is cracked and degraded.
