# SANTA BARBARA CITY COLLEGE

## ADA PATH OF TRAVEL ASSESSMENT

# Facility Condition Assessment Report ADMINISTRATION BUILDING

**Facility Condition Assessment Report**  
**Santa Barbara City College – Main Campus**  
**Administration Building**  
**721 Cliff Drive**  
**Santa Barbara, CA 93109**

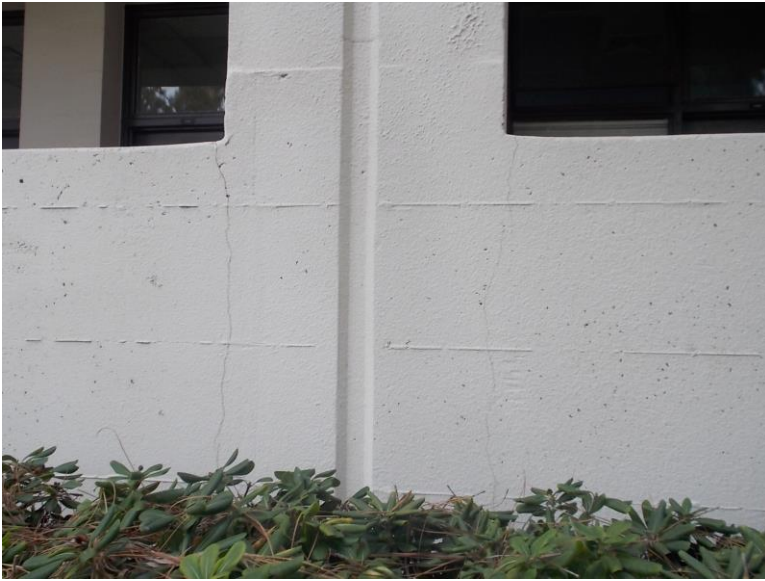
AE1. Northeast exterior walkway wall.

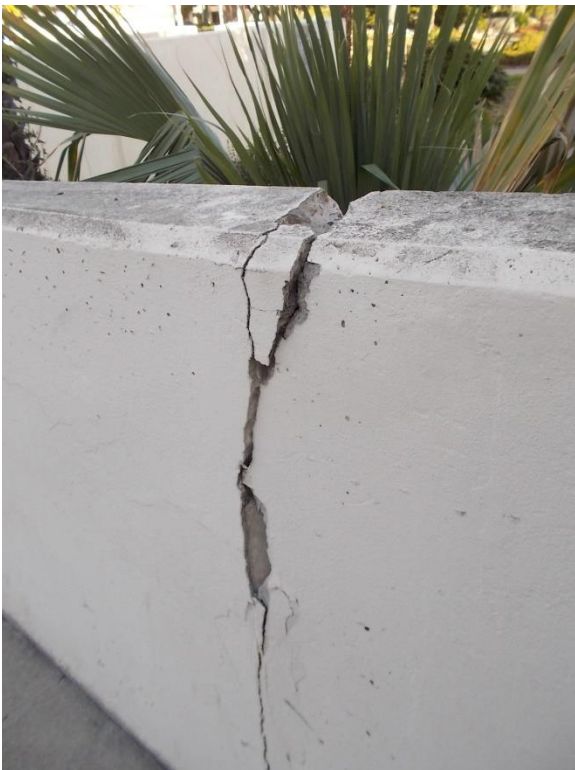
AE2. Northeast exterior ramped entrance walkway wall.

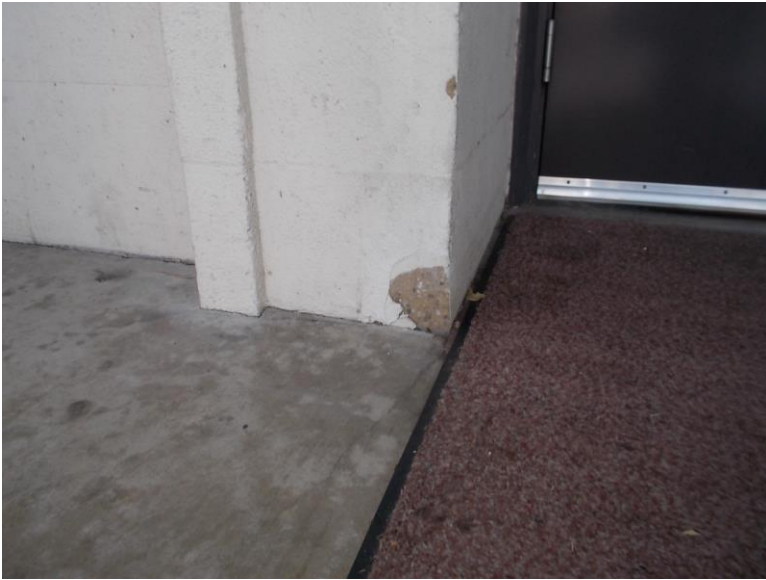
AE3. Northeast exterior entrance column.

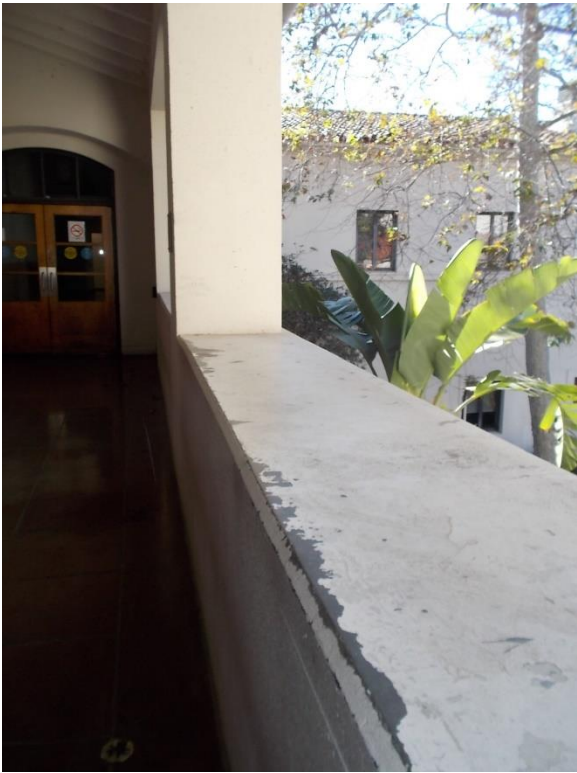
AE4. Northwest exterior walkway wall.

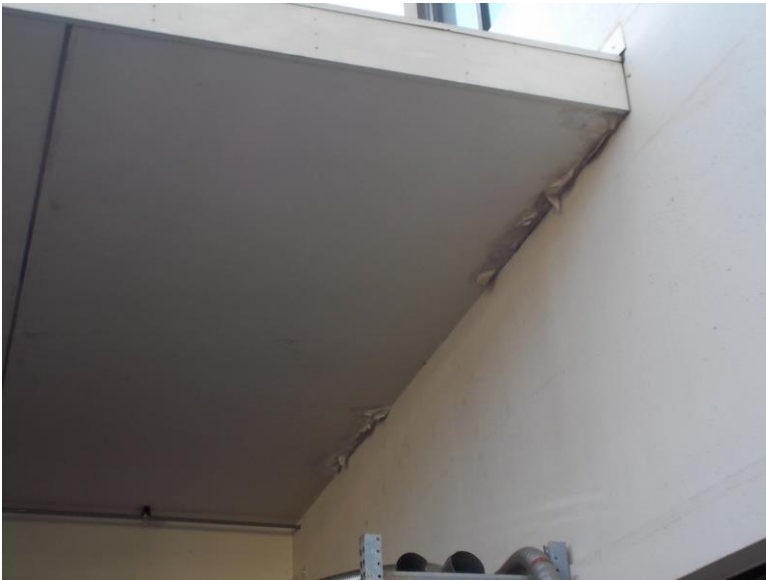
AE6. OE building, southeast exterior overhang.

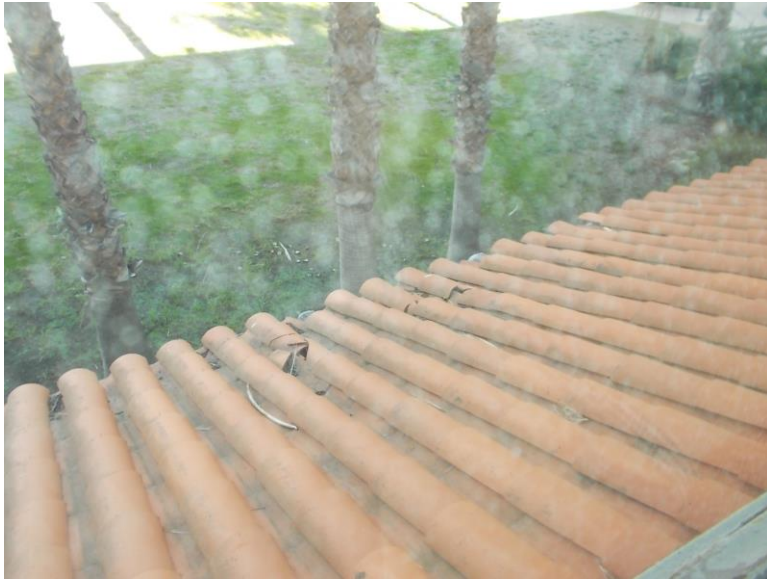
R1. Northeast roof overhang with damaged tiles.

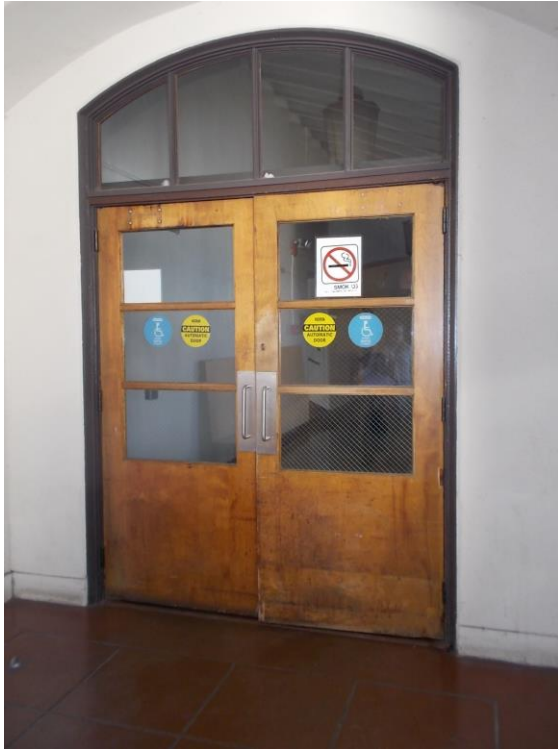
D1. First Floor entrance doors near elevator.

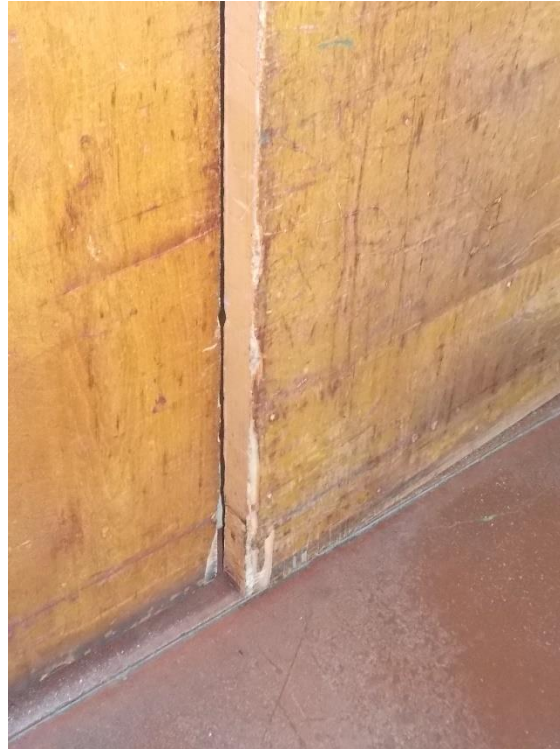
D2. Edge Damage at entrance doors.

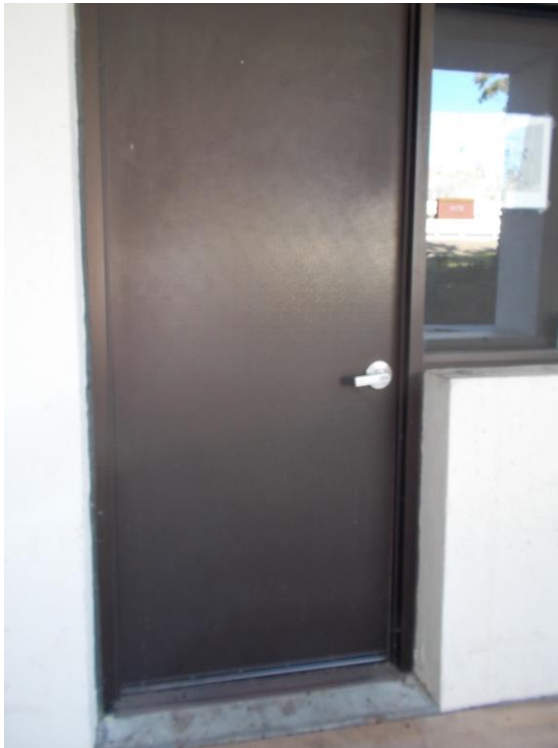
D3. Painted office door at north east side of building, with non-compliant threshold.

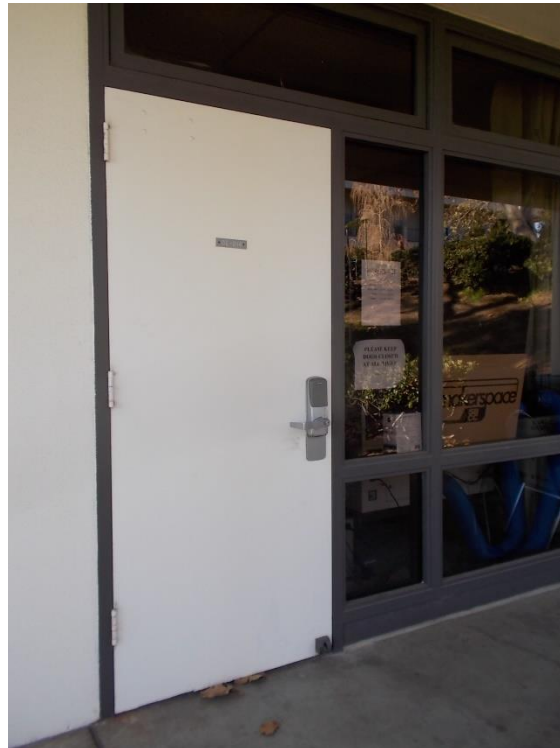
D4. Classroom door at OE build first floor storefront system.

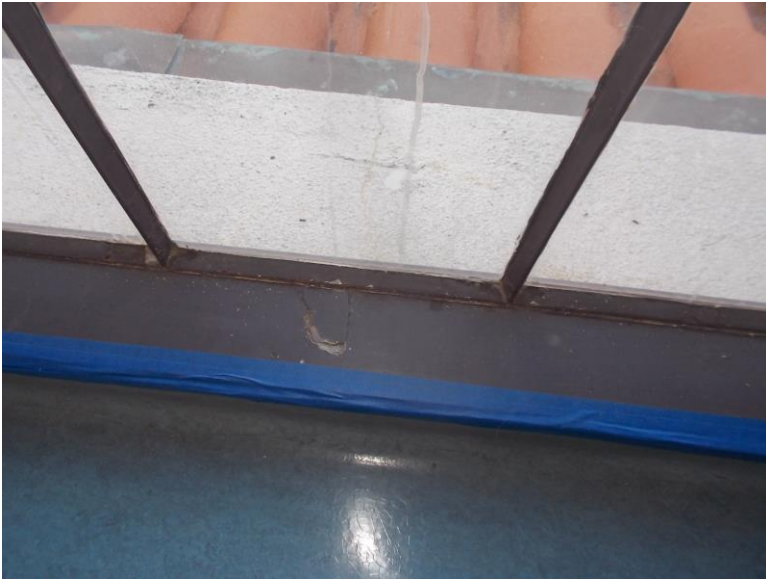
EW4. Southeast wing second floor corridor.

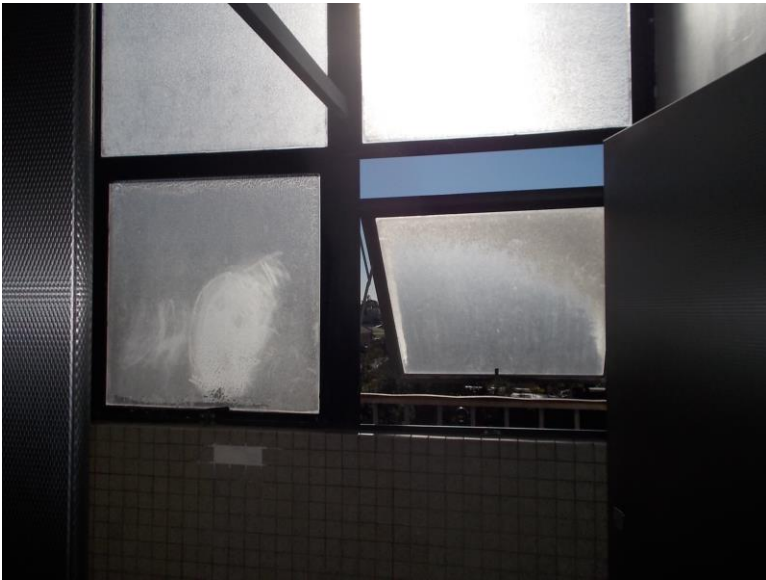
EW5. Second floor Women's restroom.

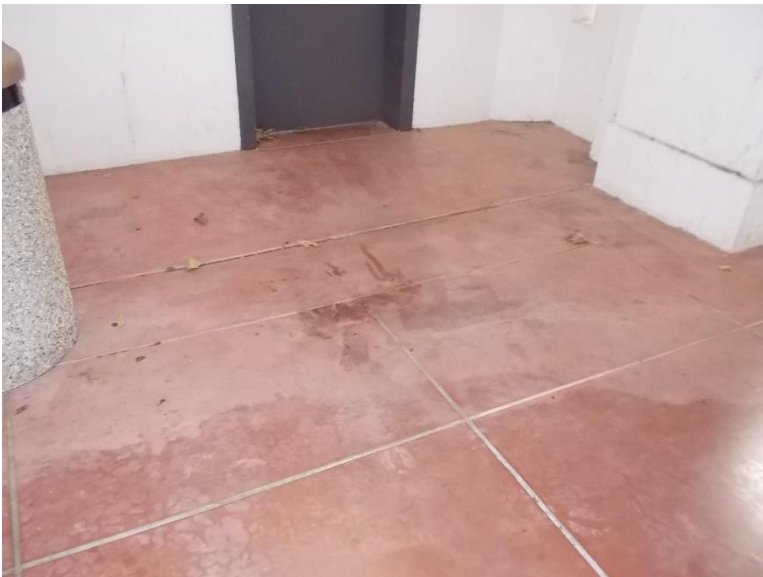
EF2. Northwest entrance to Elevator.

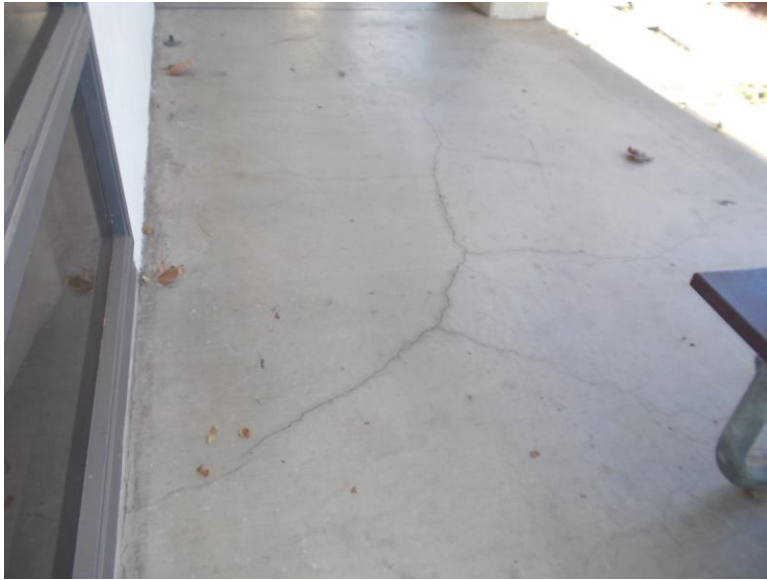
EF3. Southeast OE exterior corridor.

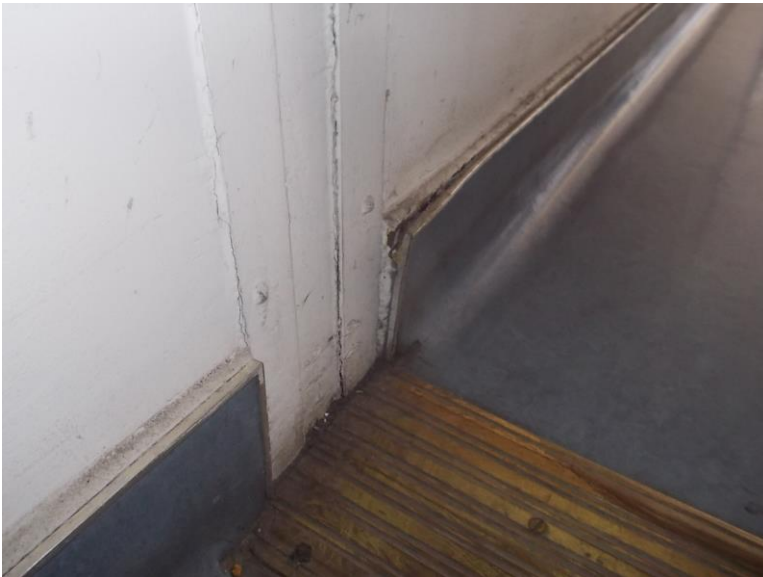
AI2. Second floor southeast interior corridor building joint.

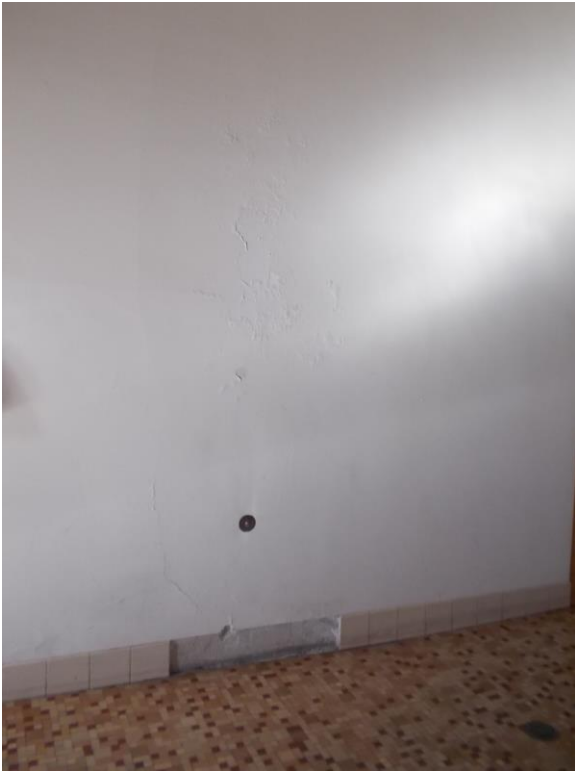
A13. First floor Men's Restroom.

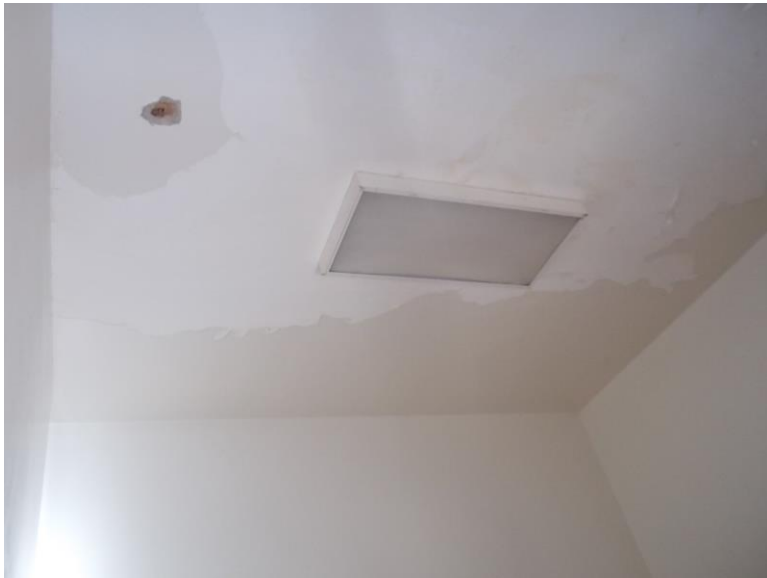
C1. First floor Women's Restroom.

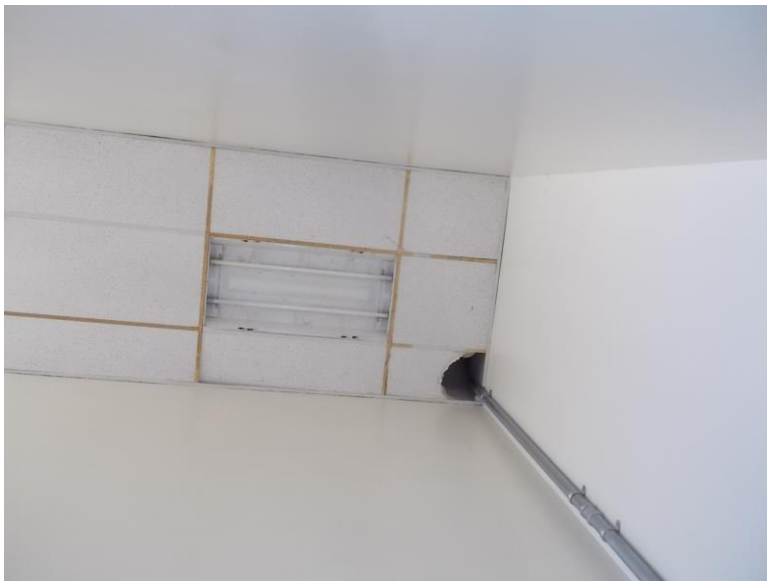
C2. OE stairway ceiling.

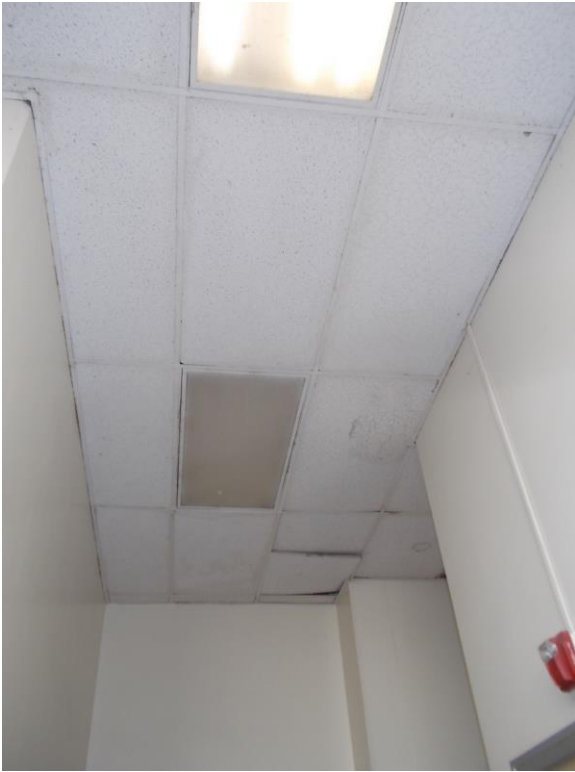
C3. OE second floor corridor.

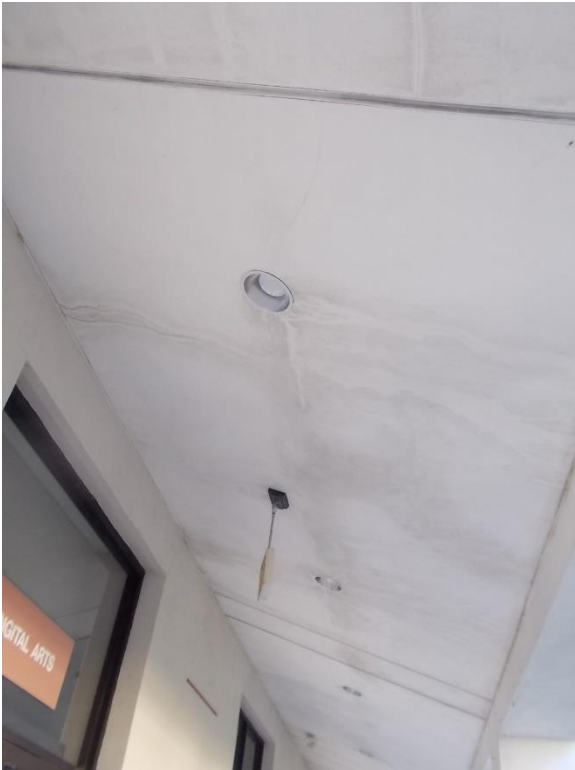
C4. Southeast corridor ceiling at offices.

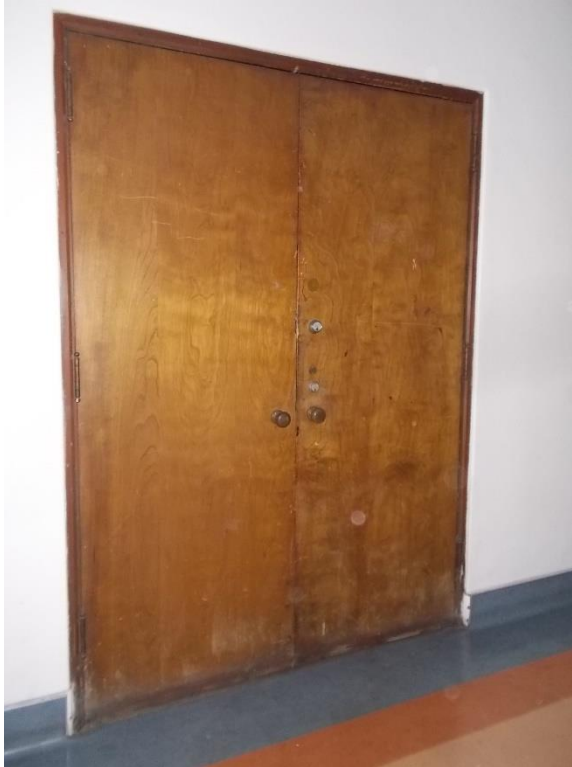
D1. Second floor equipment room doors.

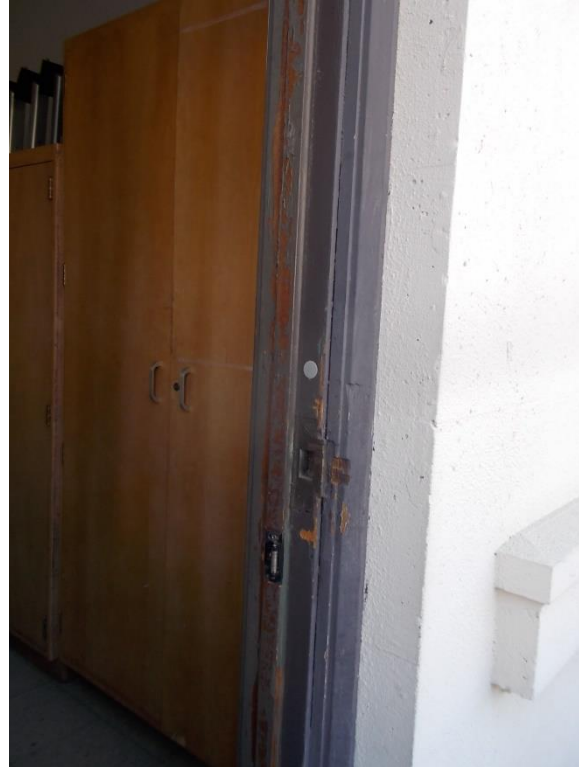
D2. 2nd floor exit door to stairs.

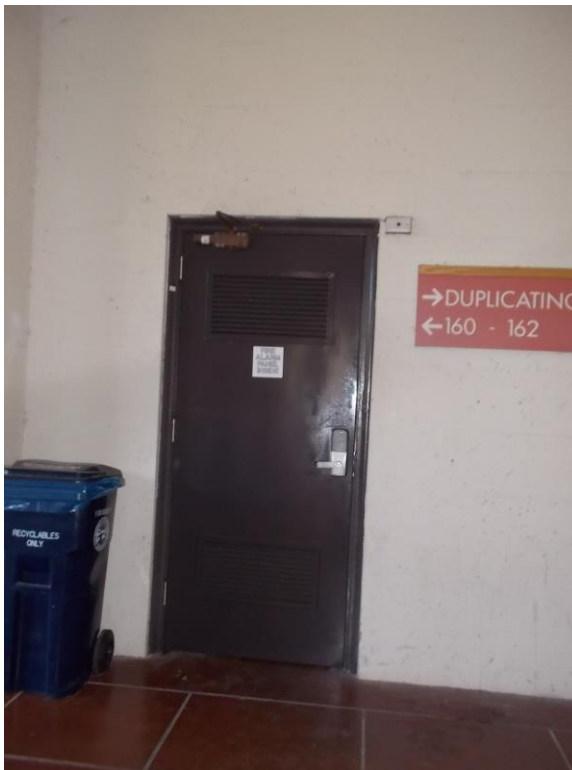
D3. Entry door to 1st floor Duplicating.

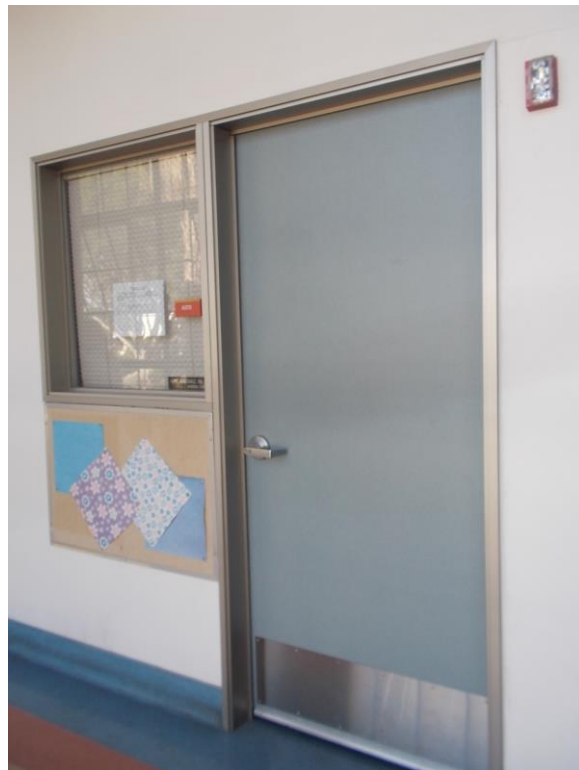
D4. Office door 2nd floor Health Occupations.

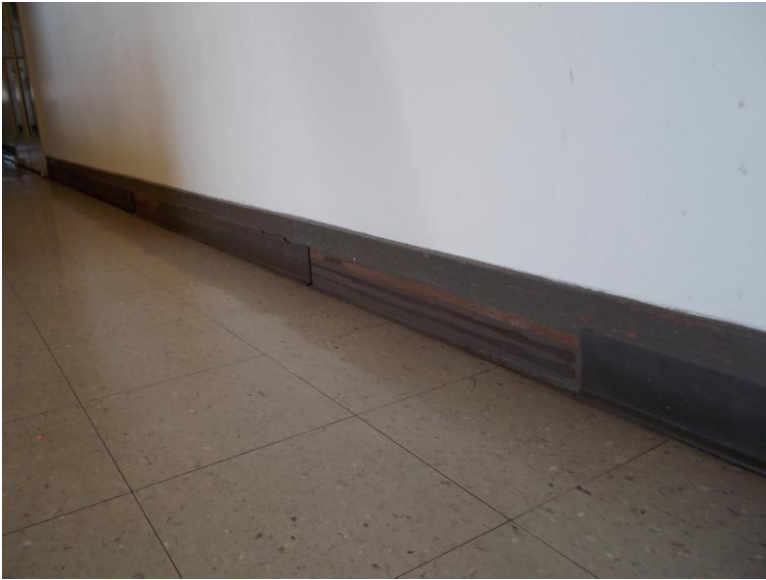
IF3. Southwest corridor second floor.

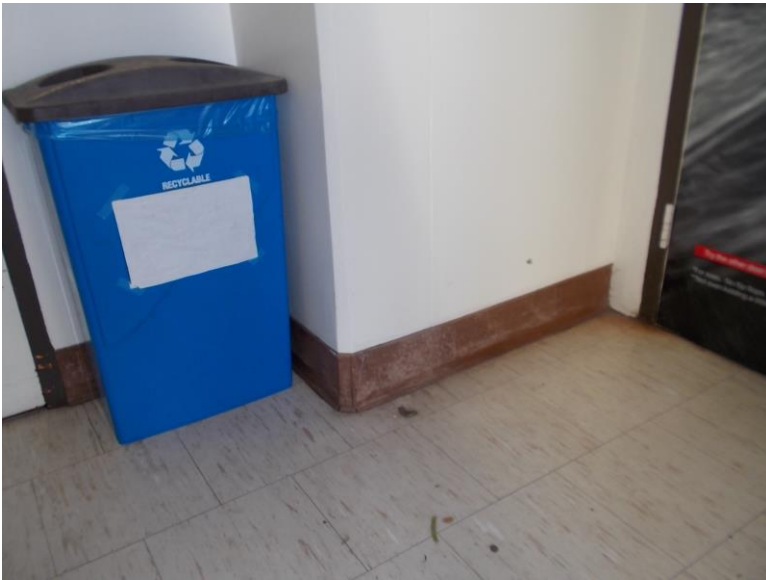
IF4. OE corridor second floor.

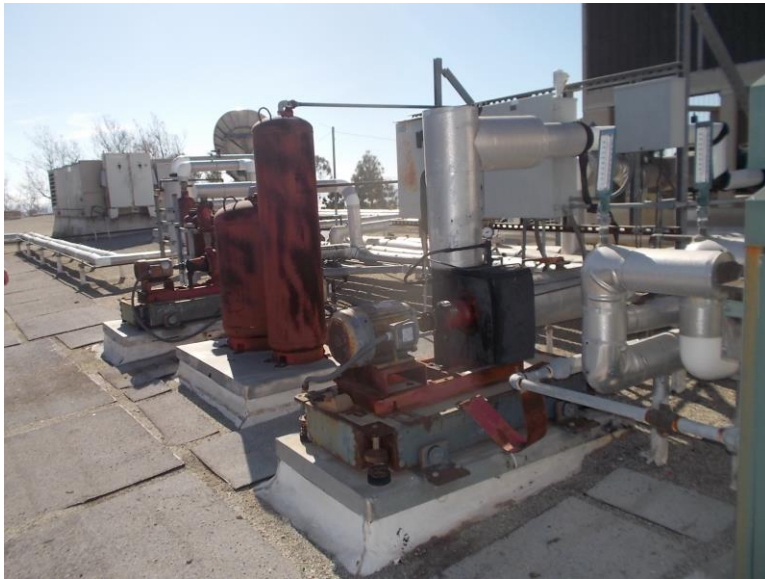
M2. Rooftop mechanical equipment.

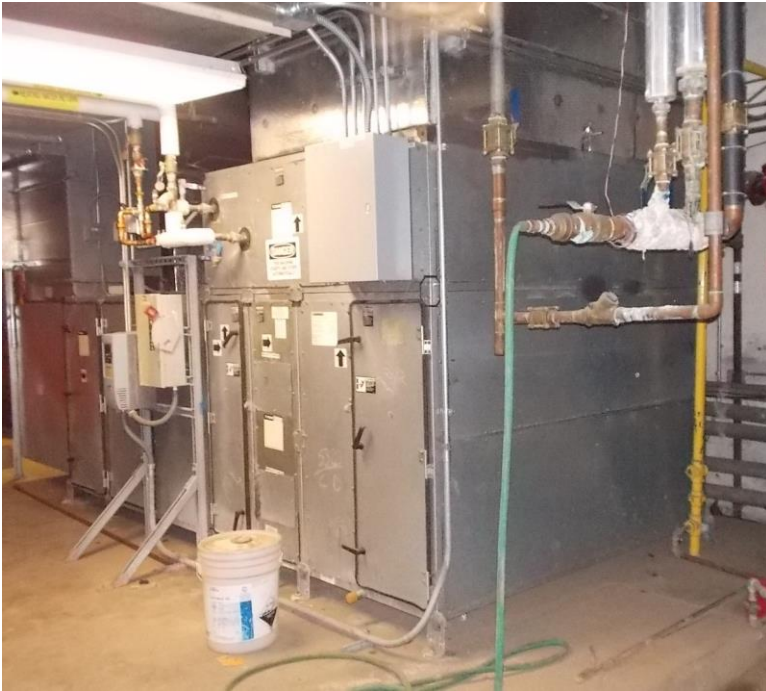
M2. AHU in basement.

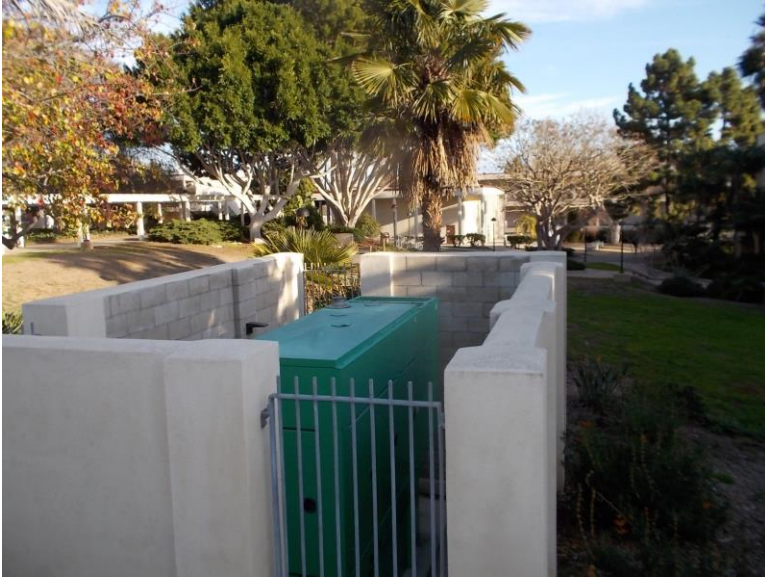
E1. 2006 New generator behind east side of the building.

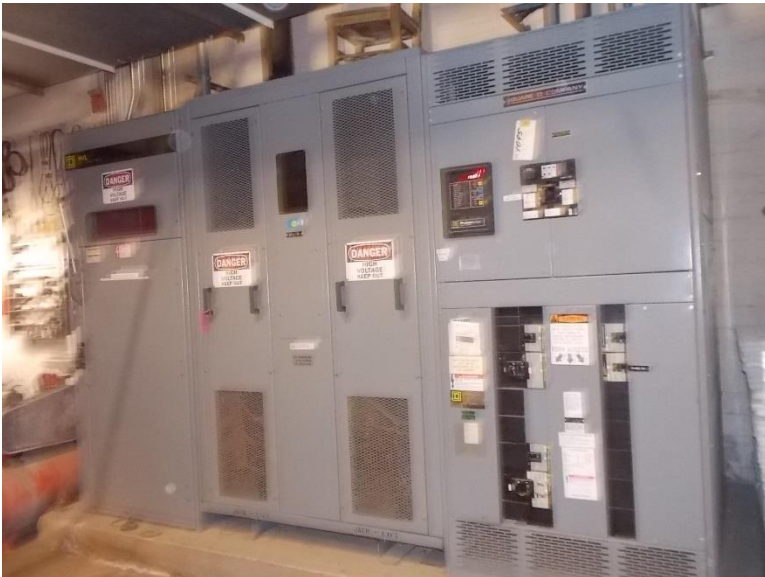
E2. Switchgear in basement.

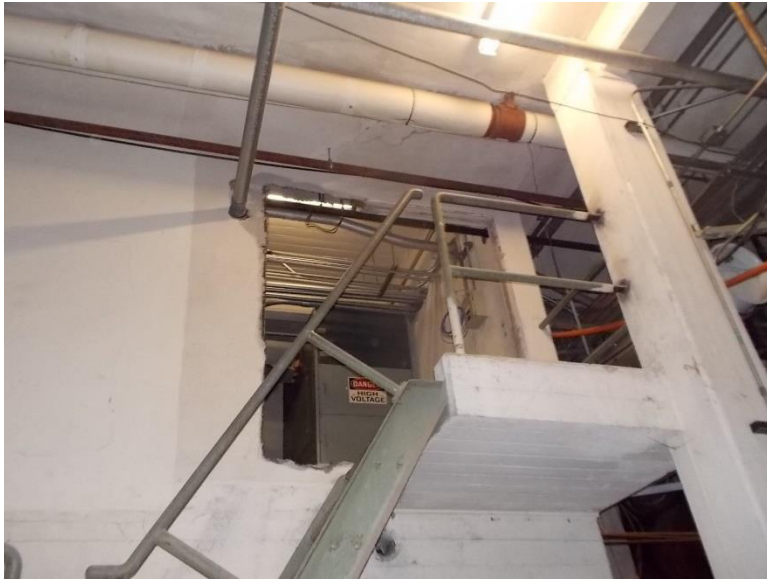
E3. Access to Electrical equipment in basement.

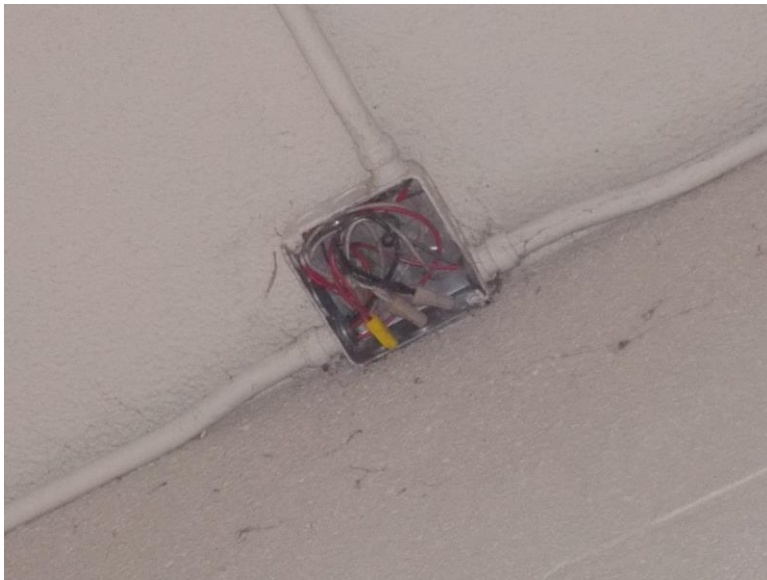
E4. Exposed wiring in j-box.

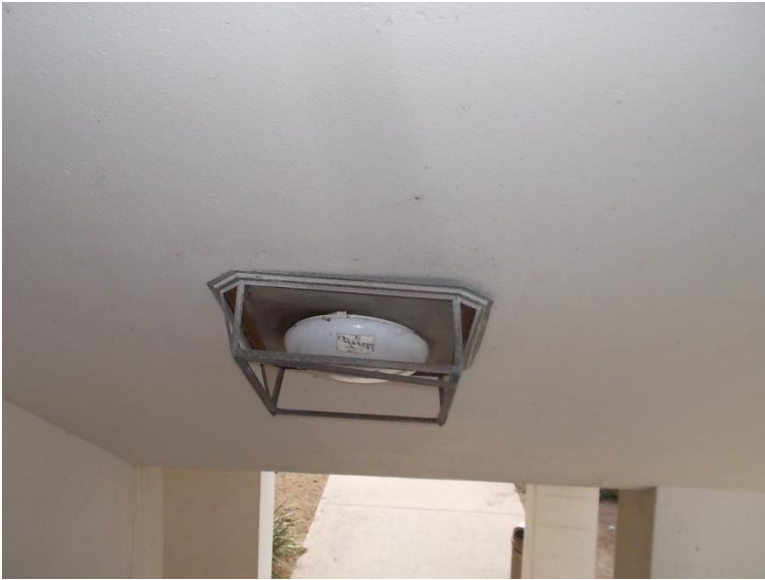
E5. Exterior lighting at northeast stairs.

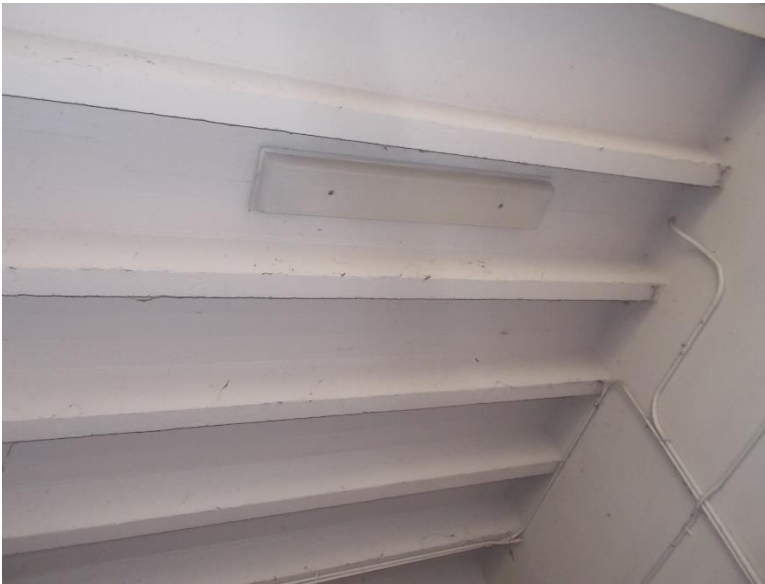
E6. Exterior lighting with surface mounded conduit by elevator.

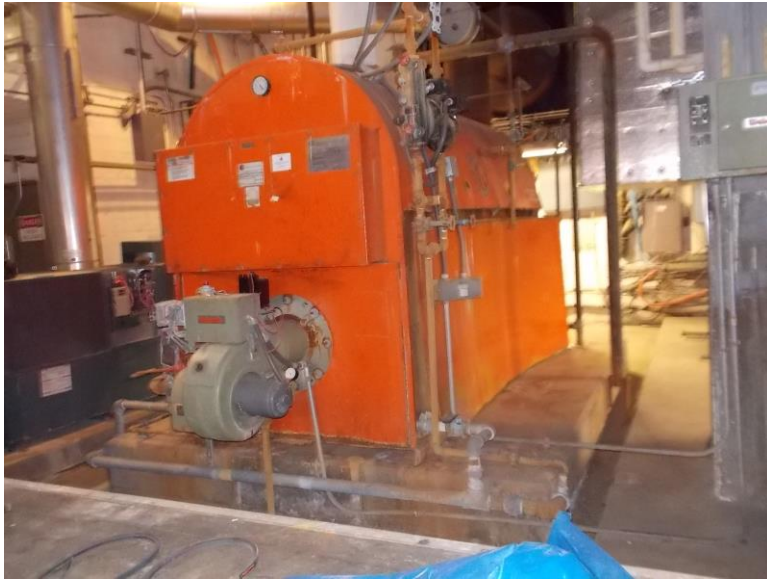
P1. Boiler in basement.

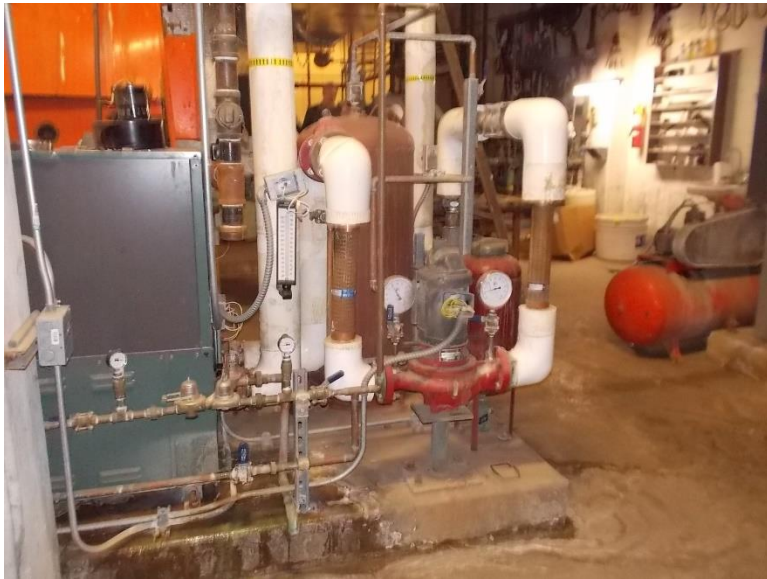
P2. Boiler piping in basement.

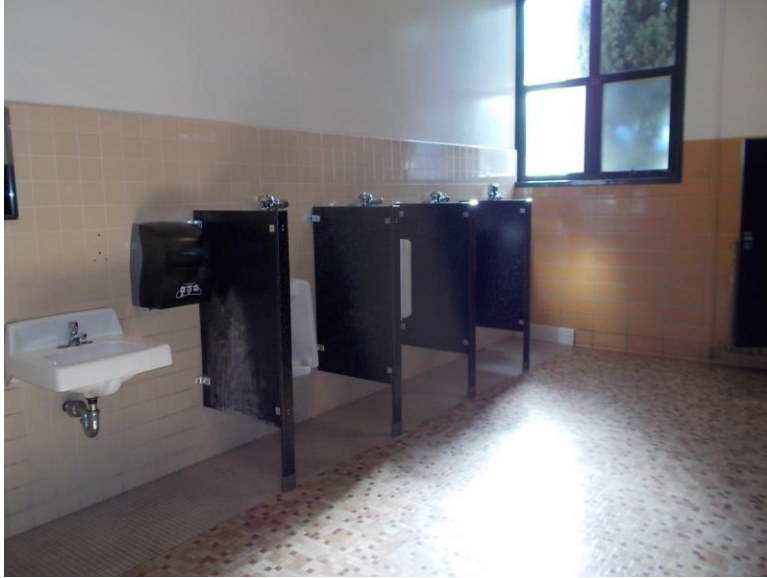
RR3. Mens restroom, first floor southwest wing.

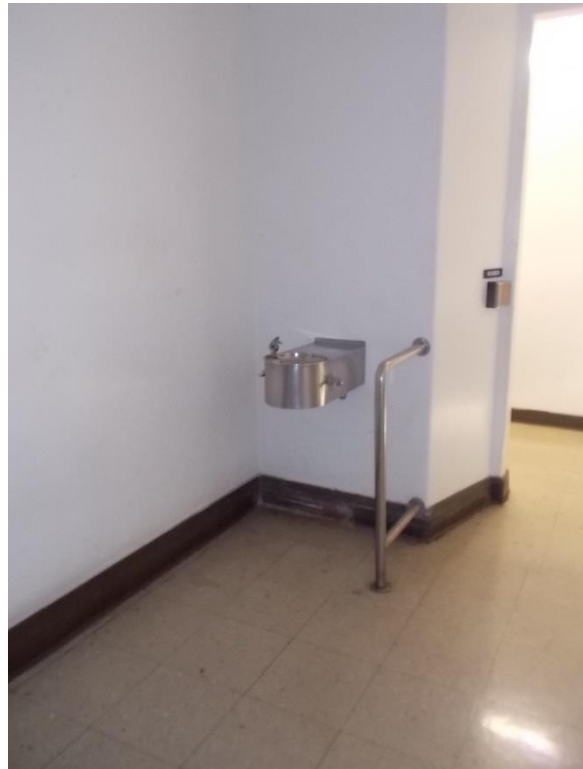
DF1. Second floor drinking fountain at restrooms.

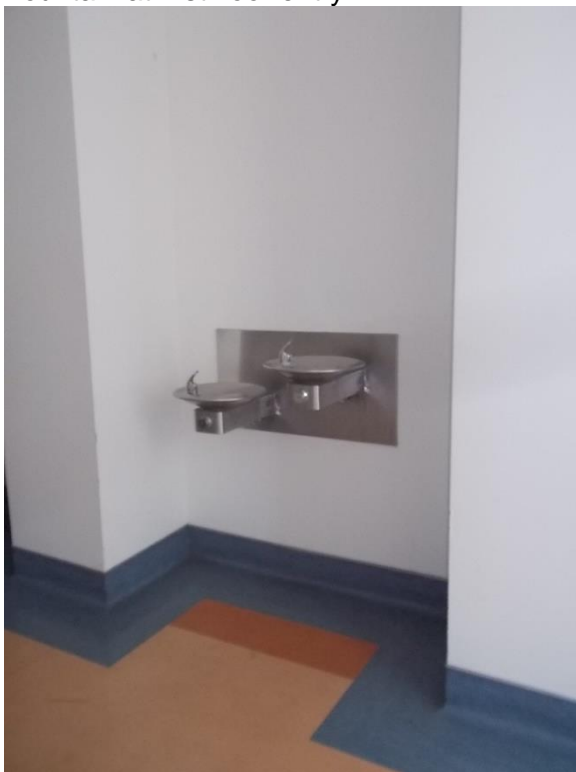
DF3. Compliant DF at second floor SE wing.

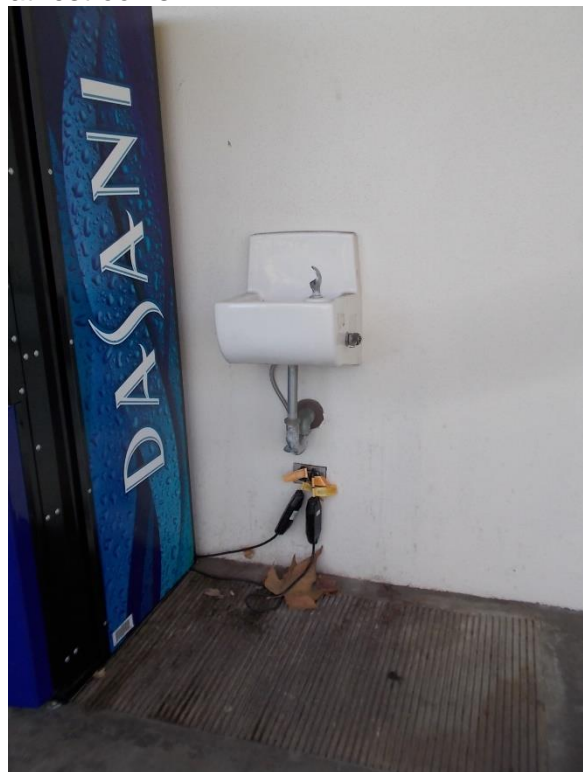
DF4. Non-compliant DF at OE first floor.

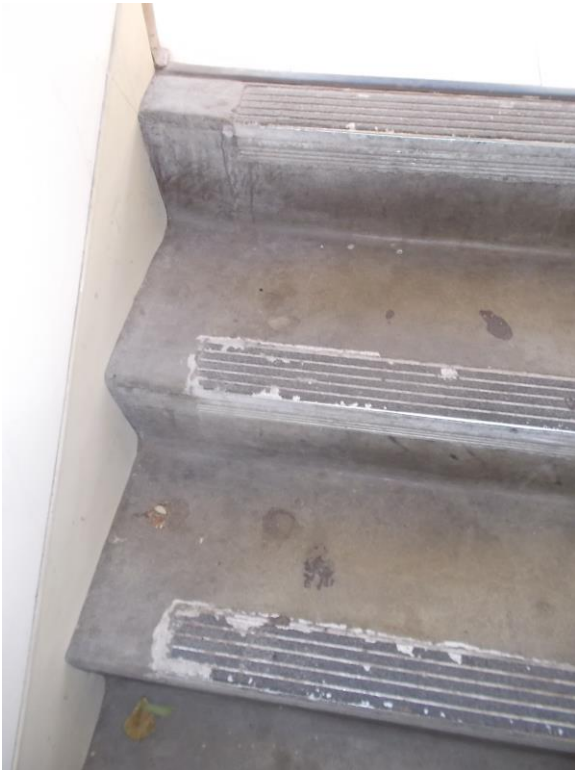
S1. Exterior stairs with non-compliant nosings.

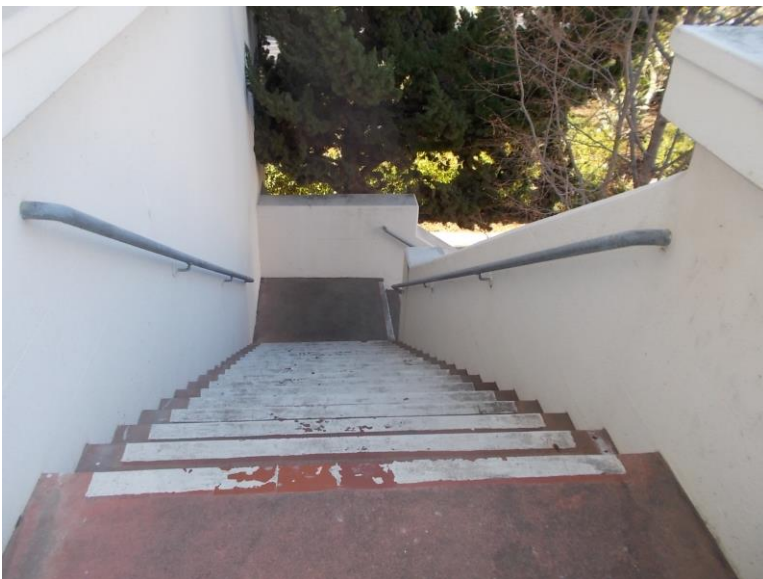
S2. Exterior stairs with non-compliant nosings and handrails.

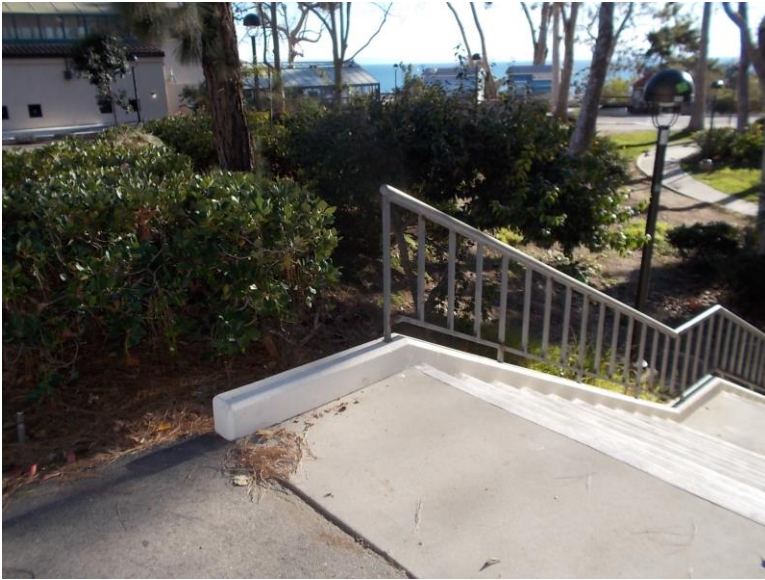
S3. Exterior stairs to OE with non-compliant handrails.

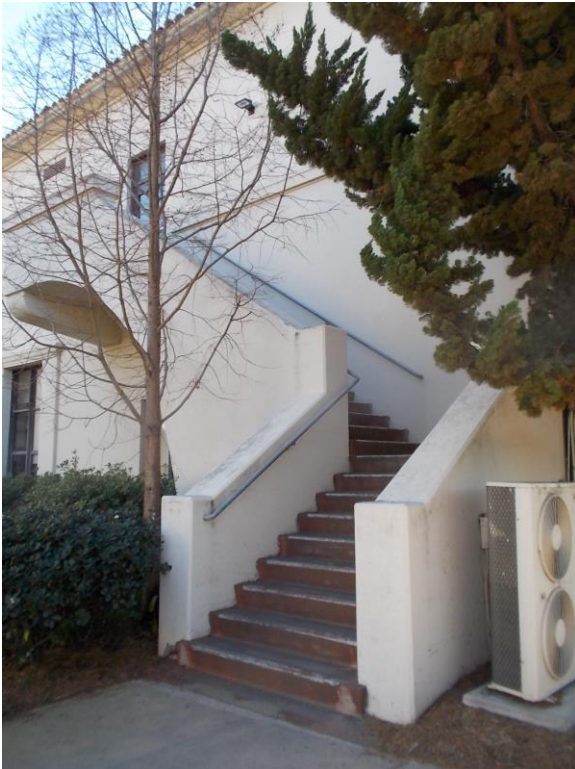
S4. Exterior stairs with non-compliant handrails, and no level landing.

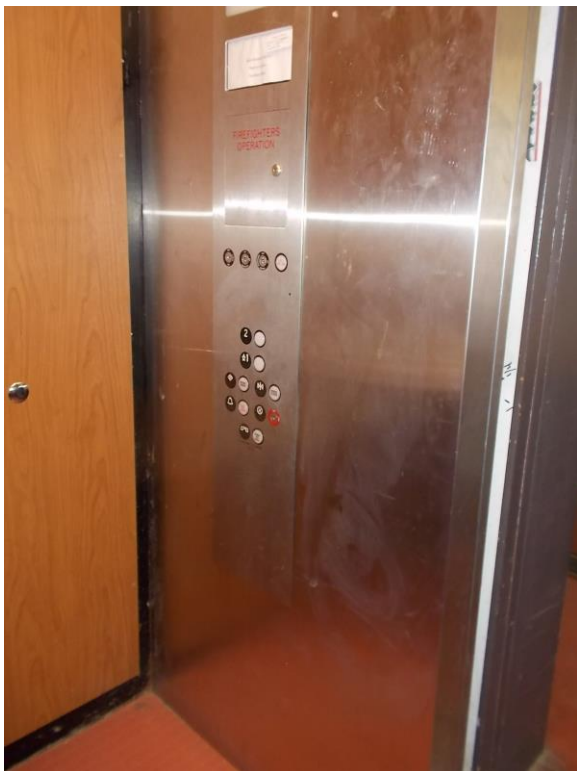
EV2. Elevator car interior.

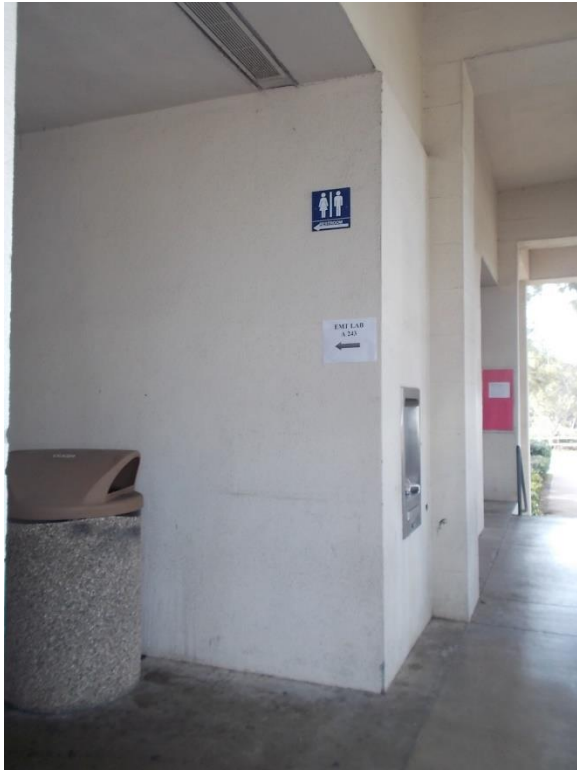
S5. Non-compliant RR signage – 2nd floor.

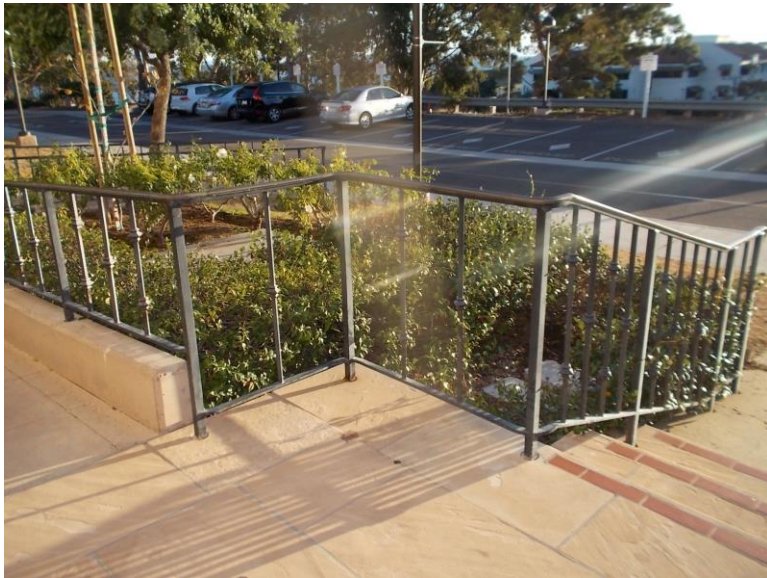
PT1. Non-compliant stairs at West main entry.

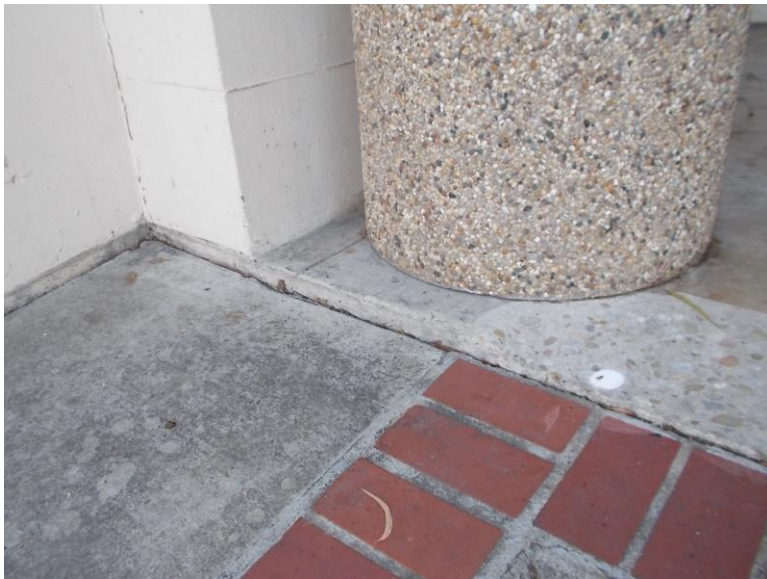
PT2. Non-compliant transition at East ramped entry.

The sloped sidewalk approach on the east side of the building also has excessive cross and longitudinal slopes, is interrupted by a drainage grate, and leads to an entry with stairs. No signage exists to indicate this entry is not intended for wheelchair use. The adjacent exterior stair to the third floor does not provide a level lower landing, nor the 36" minimum length in the direction of travel. The finishes in this area are stained, worn and aging.

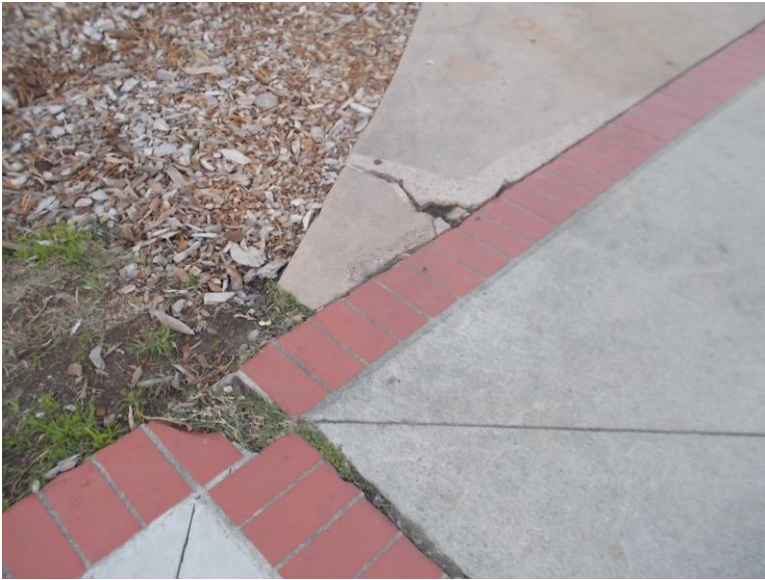
PT3. Non-compliant transition at East ramped entry.

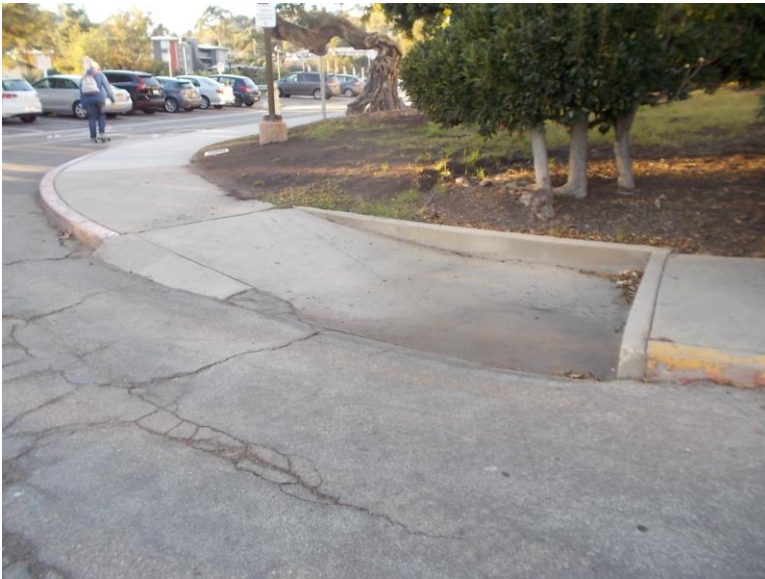
PT4. Non-compliant curb ramp at OE Auto Quad entry.
