# SANTA BARBARA CITY COLLEGE

## ADA PATH OF TRAVEL ASSESSMENT

# Facility Condition Assessment Report ADMINISTRATION BUILDING

**Facility Condition Assessment Report**  
**Santa Barbara City College – Main Campus**  
**Administration Building**  
**721 Cliff Drive**  
**Santa Barbara, CA 93109**

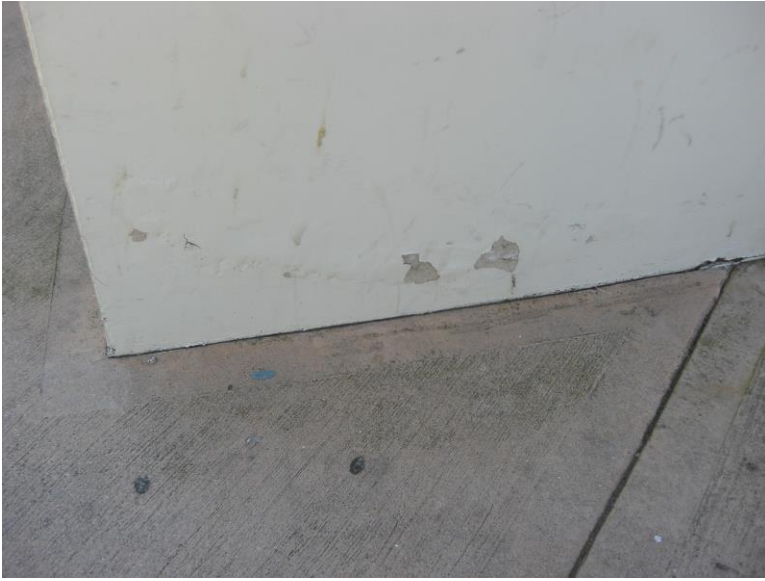
**WALLS:** The exterior wall finish is painted plaster over both concrete and steel stud construction, and at numerous locations, is in very poor condition. The finish is bubbled, peeling, has below surface plaster deterioration, and is in dire need of repair.

AE1. Exterior wall with paint damage.

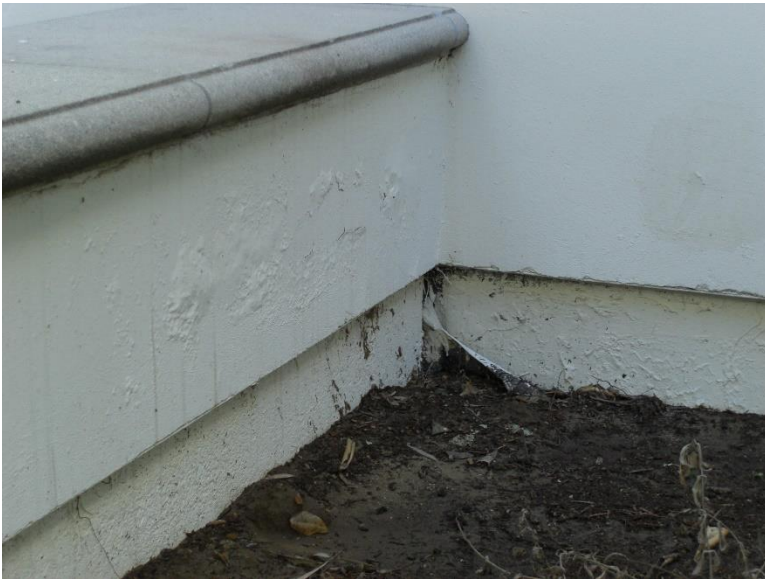
AE2. East exterior wall with bubbling paint.

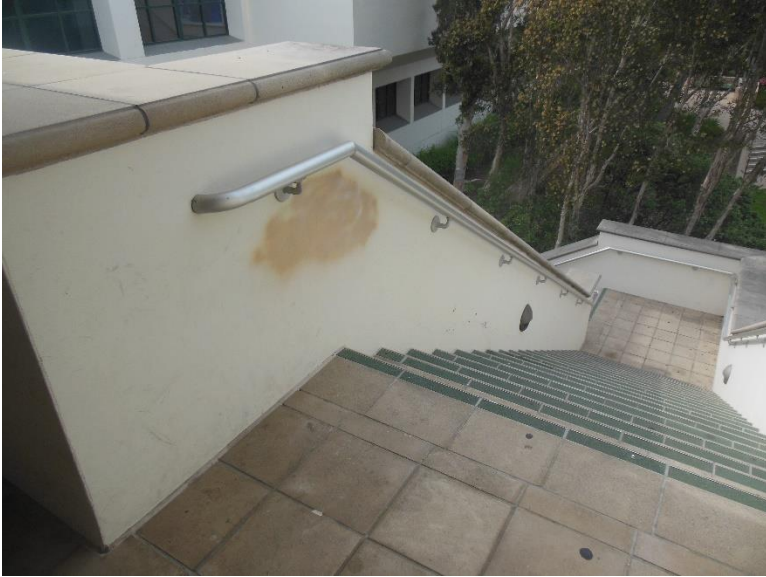
AE3. Exterior east staircase with paint damage.

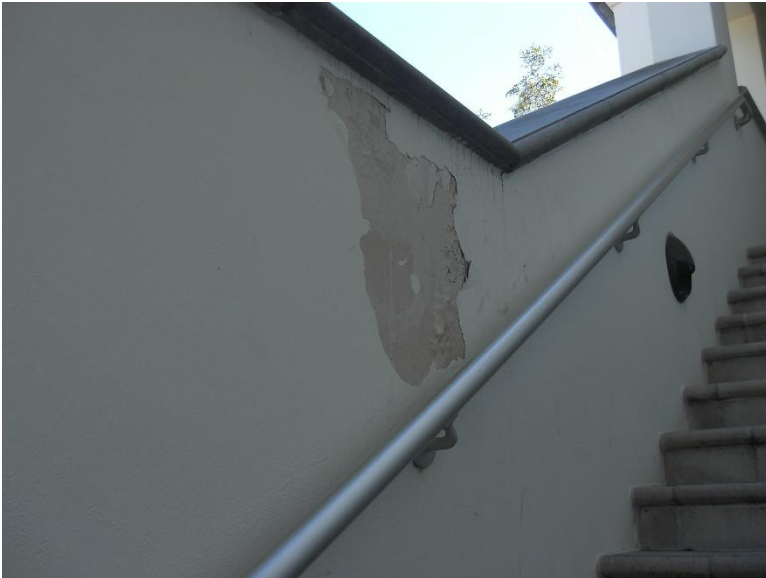
AE4. Exterior east staircase with peeling paint.

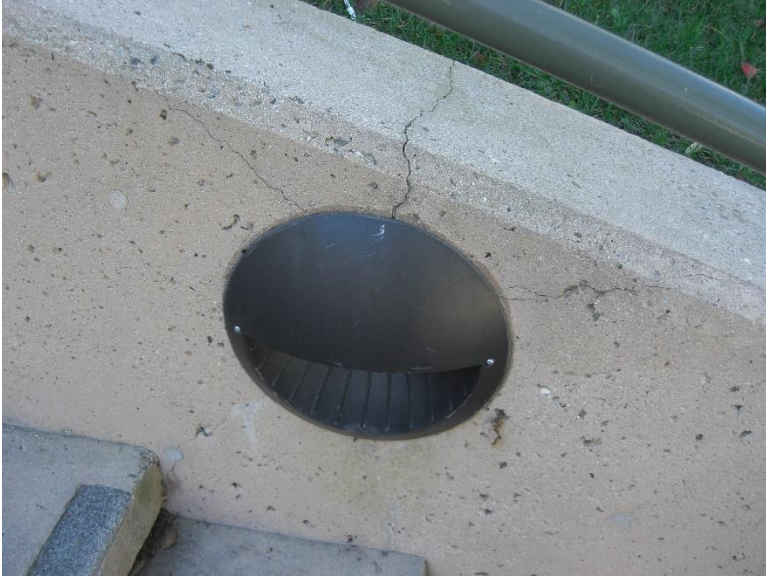
AE5. Cracked concrete wall at exterior stair.

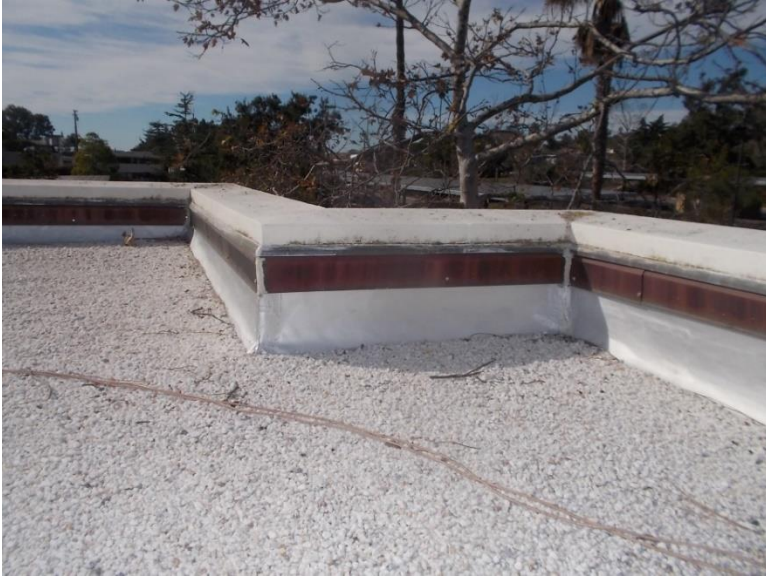
R3. Built up roof with plaster parapet.

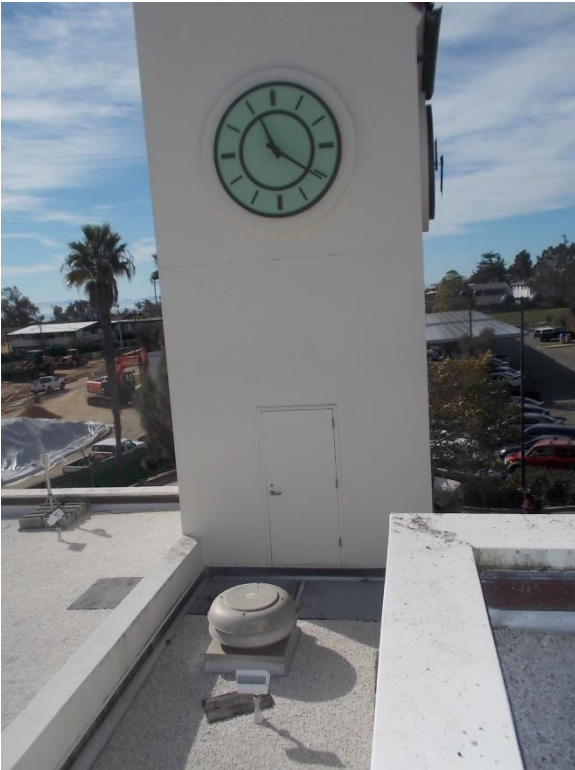
R4. Clock tower at plaster parapet.

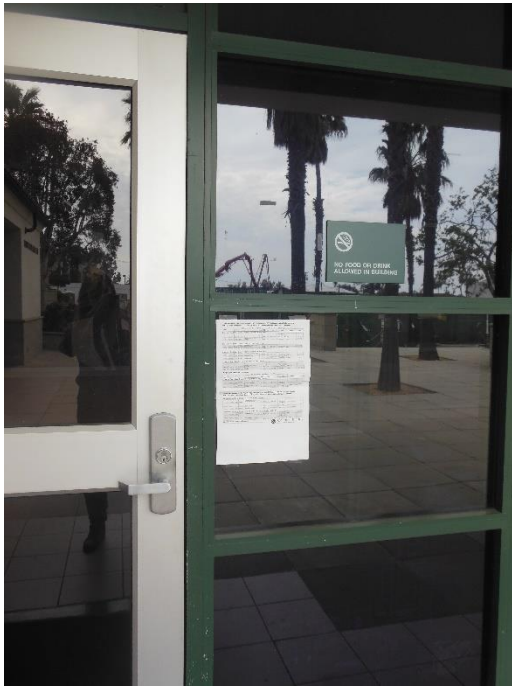
D1. Main entry; lacking wall mounted room ID signage, and an ISA symbol.

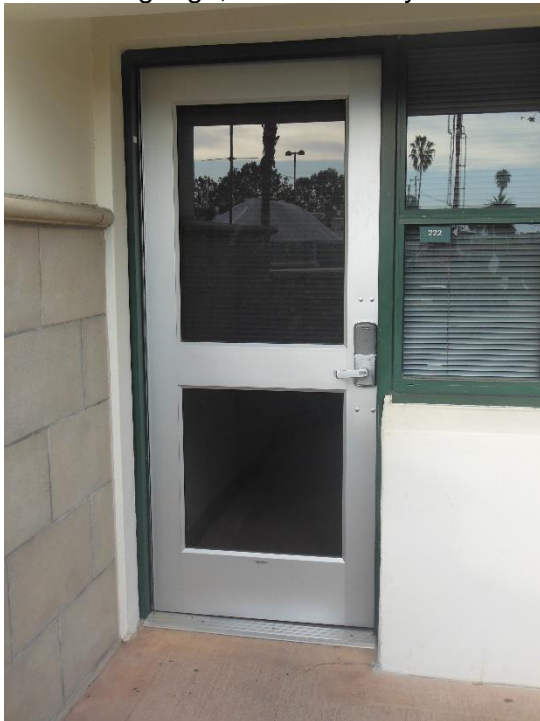
D3. Second floor entry Room 222; lacking wall mounted room ID signage, and pull-side clearance.

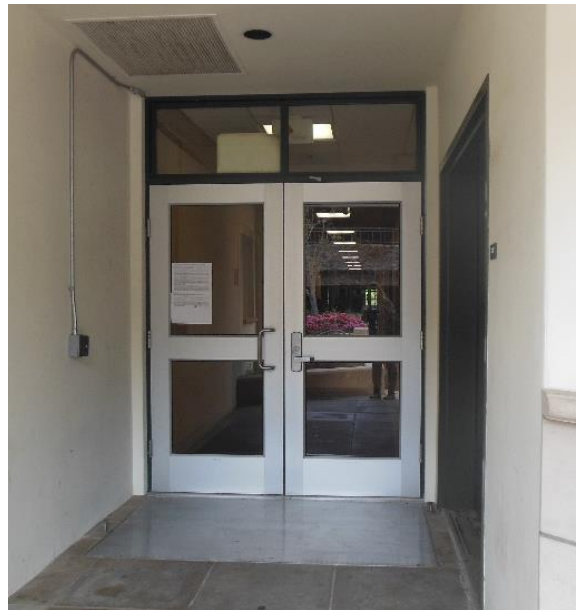
D4. Third floor entry; doors lacking wall mounted room ID signage.

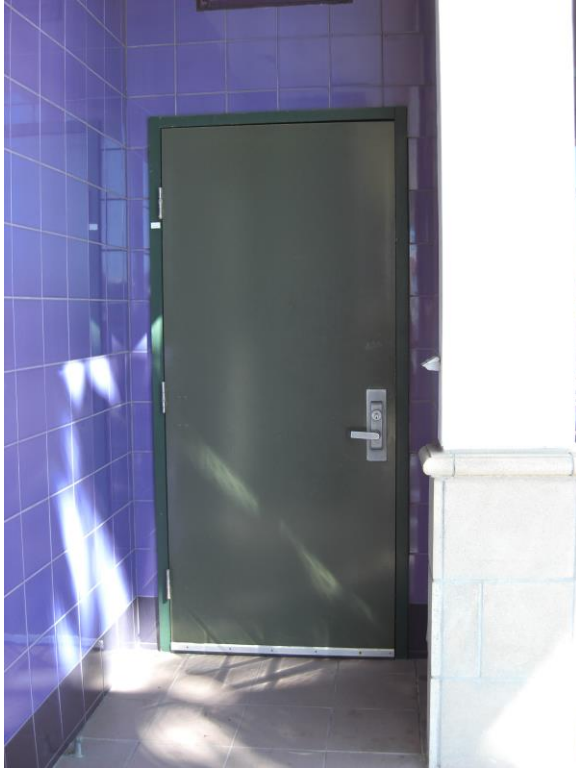
D5. Forum door; non-compliant pull-side clearance, and lacking code required door ID signage.

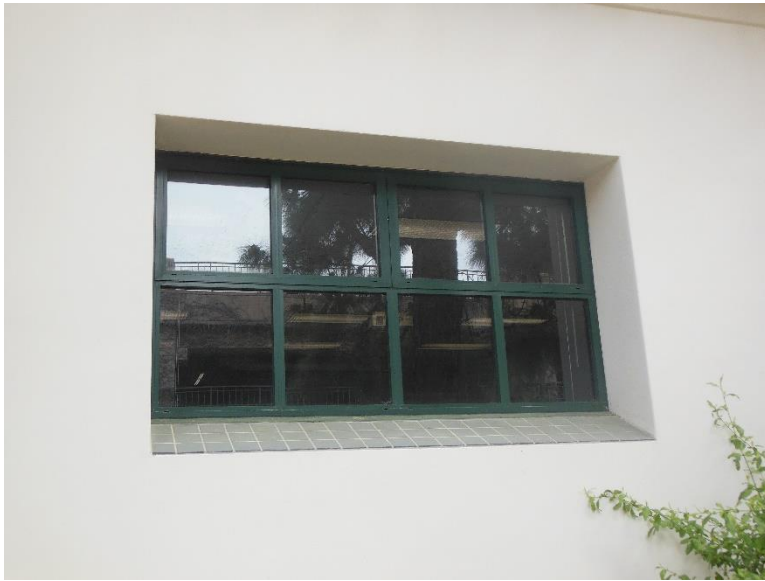
EW1. Aluminum framed lower floor windows and sill in good condition.

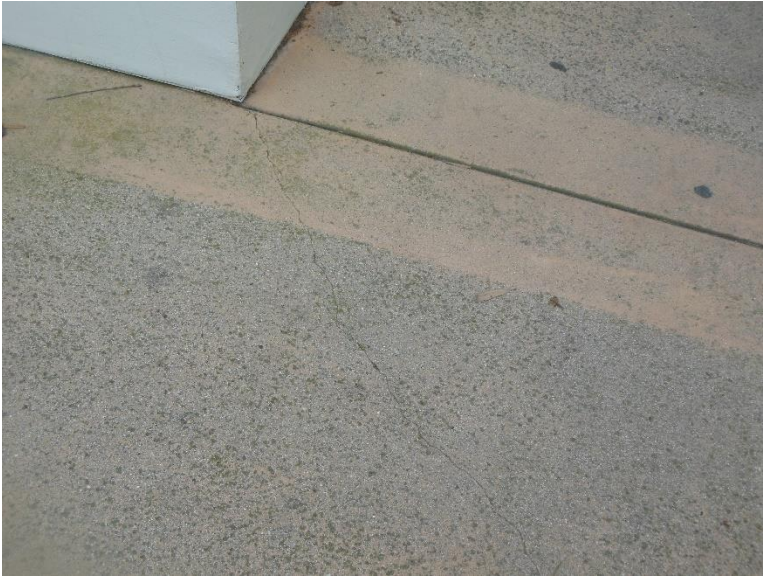
EF1. Colored concrete walkway with cracks.

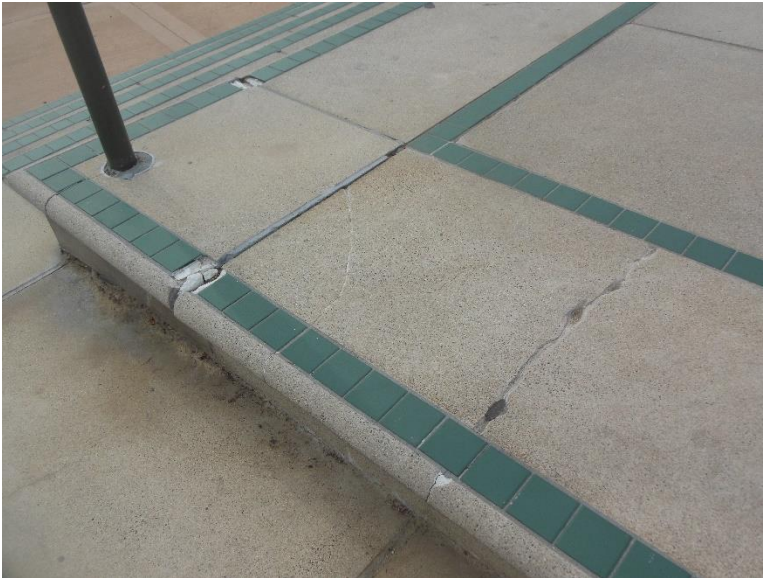
EF2. Front entry plaza stairs; concrete cracks and tile missing.

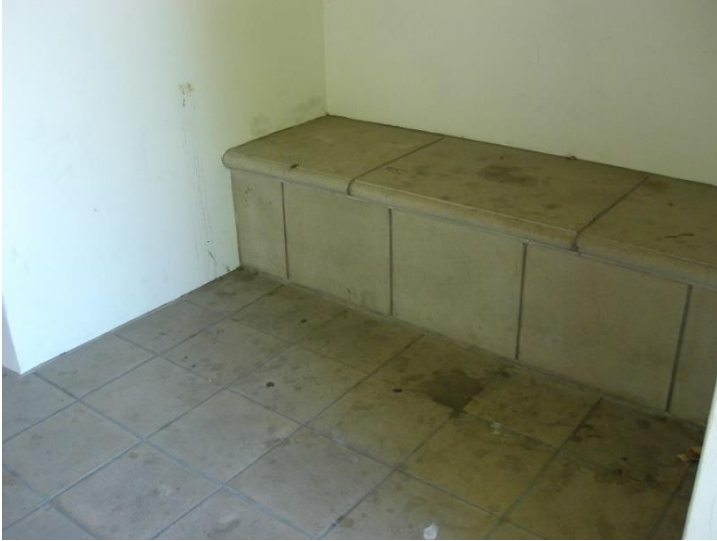
EF3. Third floor exterior concrete pavers and concrete stained finish.

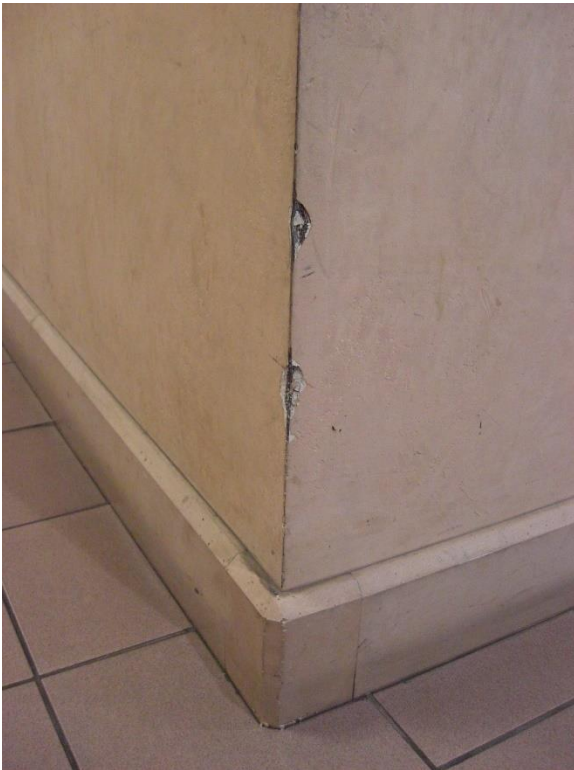
A2. Second floor corridor; veneer plaster corner damaged.

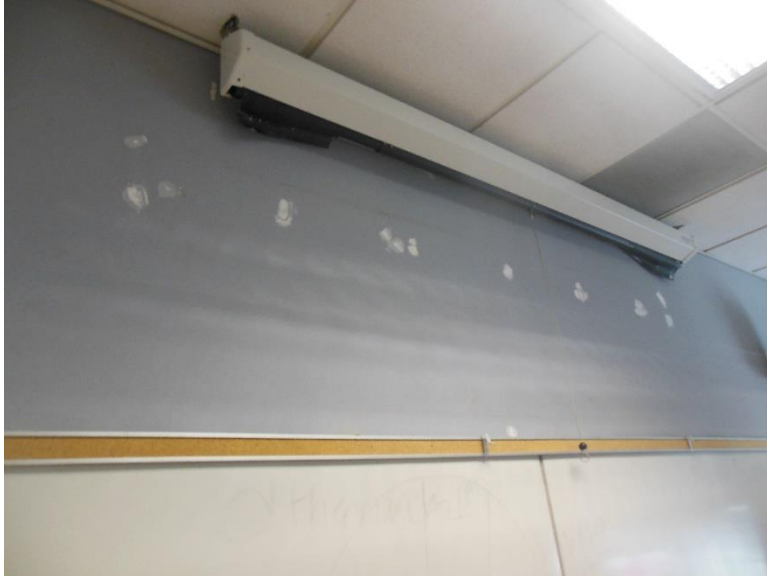
A5. Second floor classroom; wall repair damage.

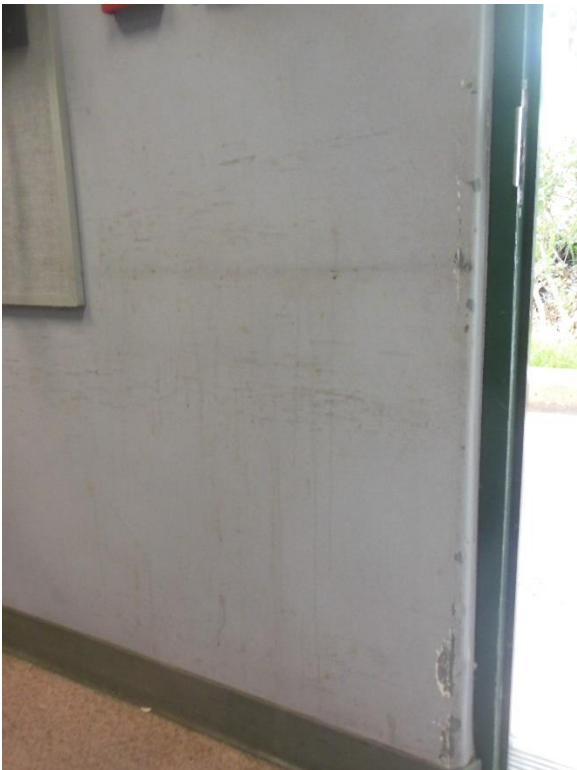
A7. Second floor classroom; wall and paint damage.

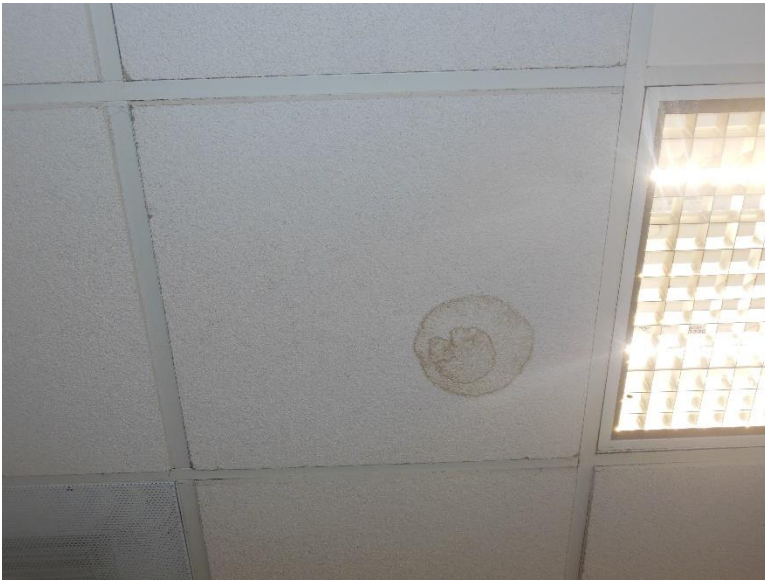
C1. Second floor classroom; stained ceiling tile.

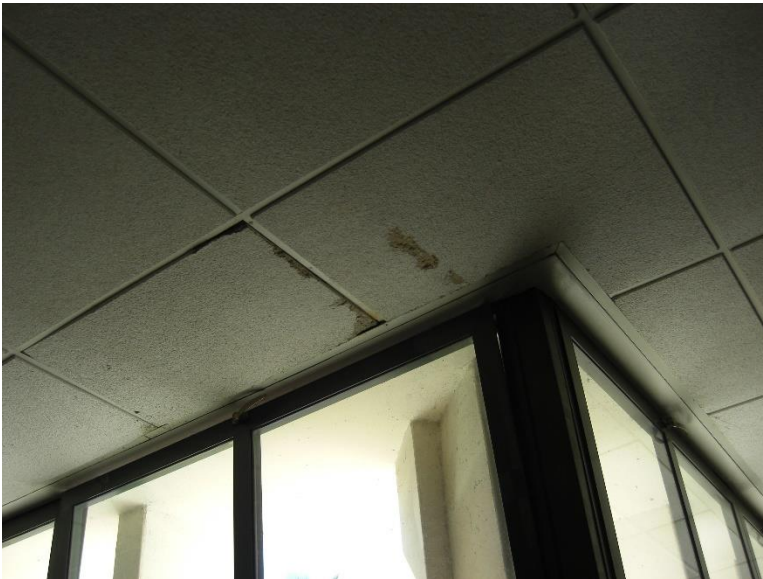
C4. Third floor corridor; damaged ceiling tiles.

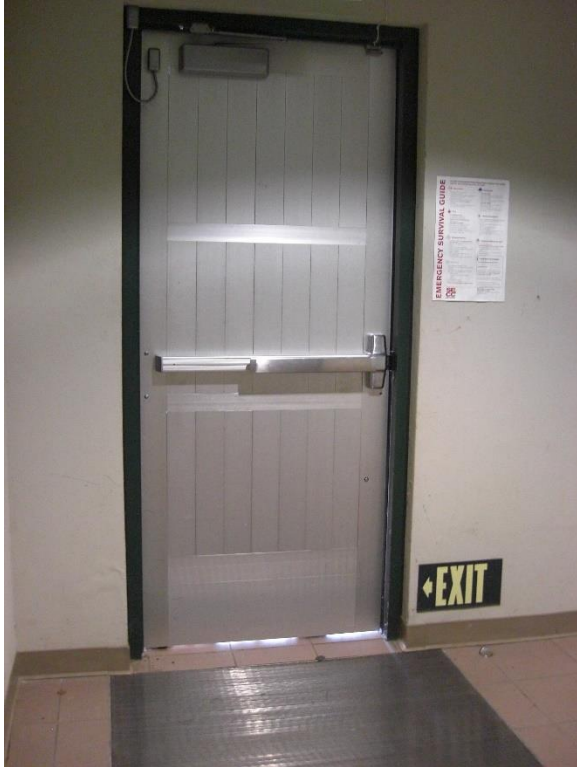
D4. Exit door from Forum lecture hall foyer. Tactile exit sign missing.

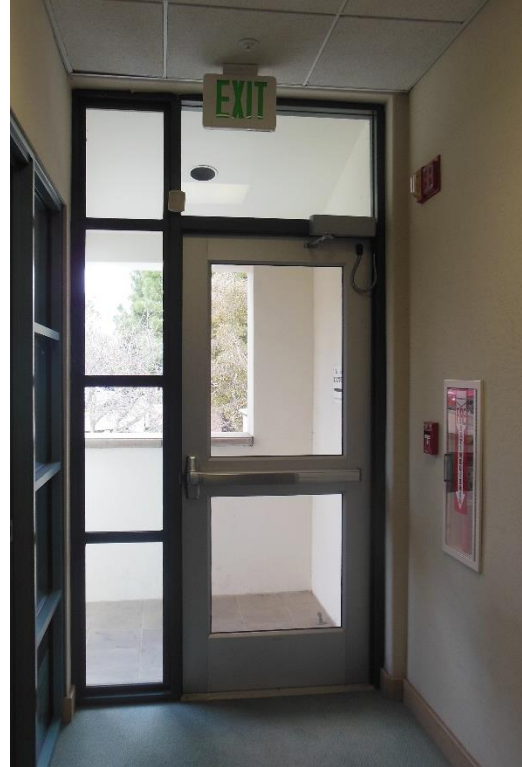
D5. Second floor corridor exit door. Tactile exit sign missing, and exit sign not illuminated.

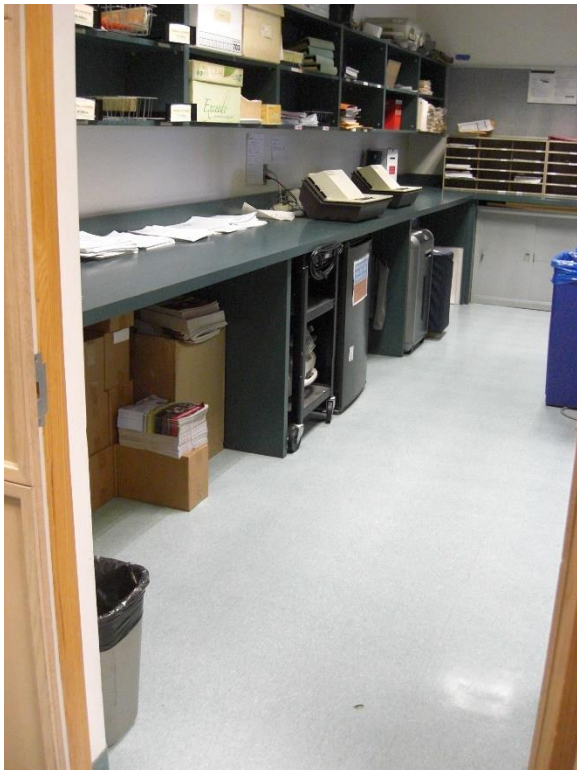
IF2. Second floor Workroom, damaged resilient floor.

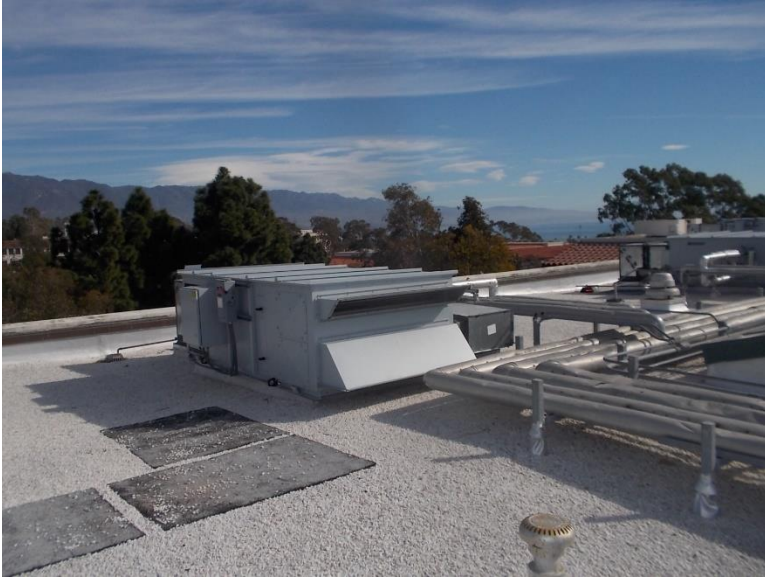
M1. Rooftop mechanical equipment.

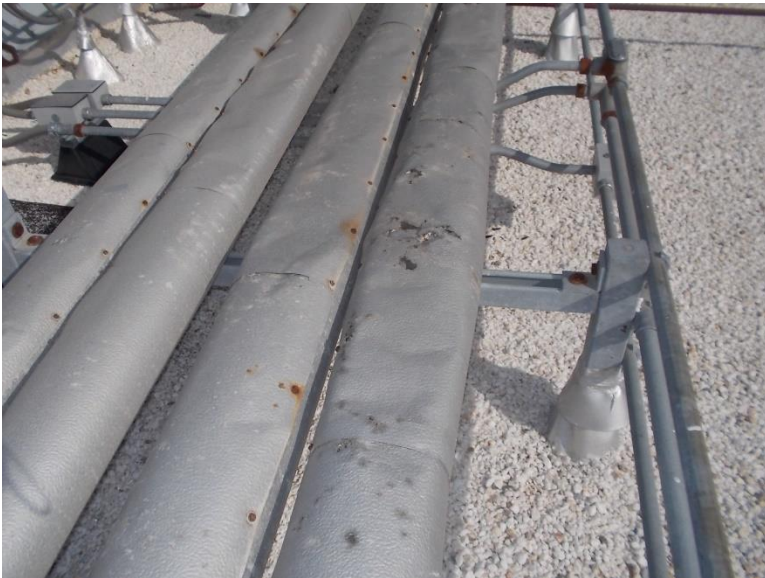
M2. Rooftop mechanical piping damaged.

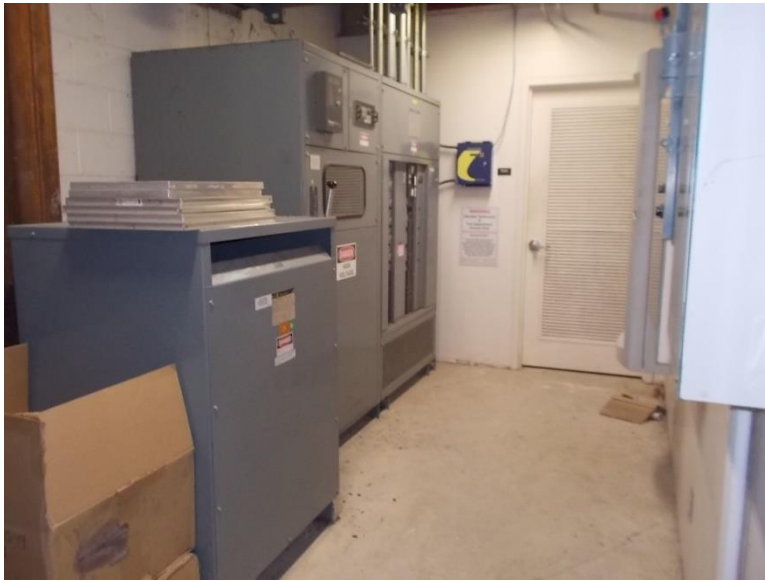
E1. Electrical switchgear.

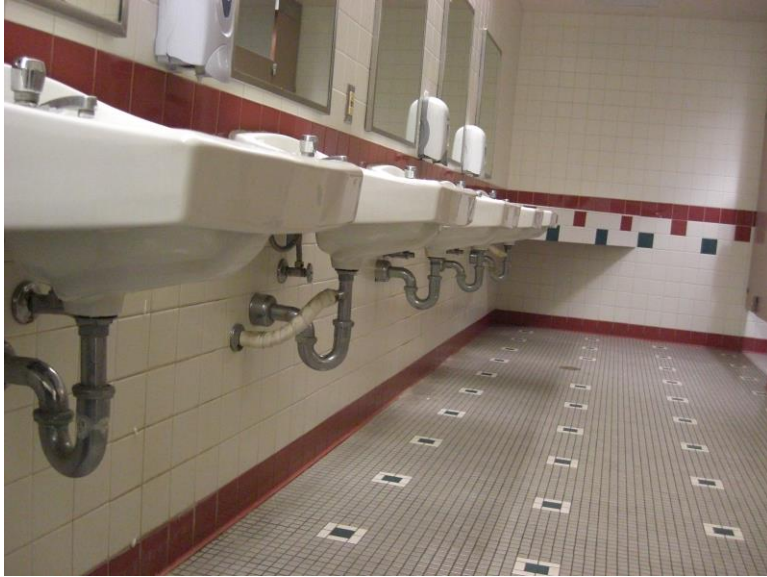
RR3. Second floor restrooms; knee protection is not provided at under sink plumbing trap.

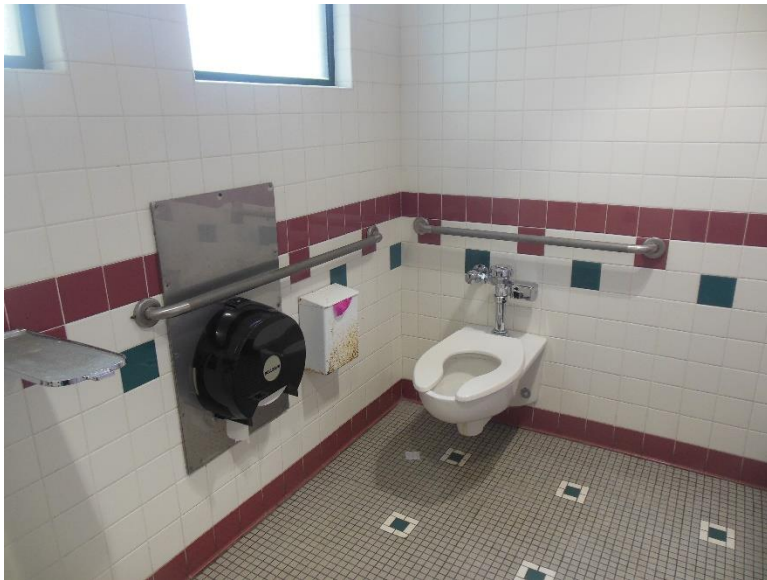
RR4. Cafe restrooms; dispensers may impede forward clear space at accessible stall.

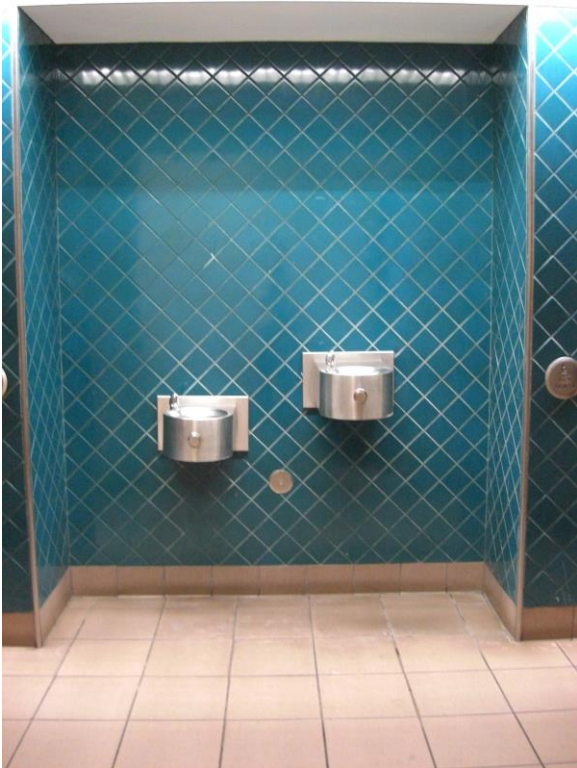
DF1. Second floor; hi-low drinking fountains.

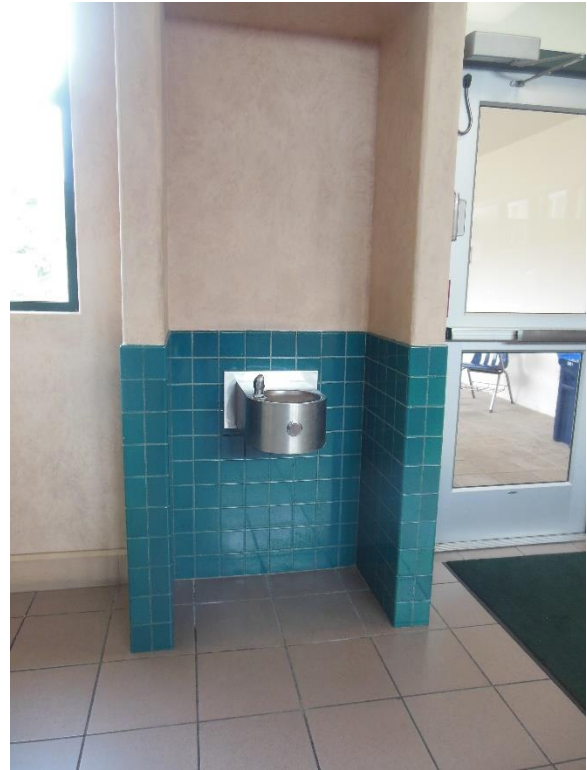
DF2. Third floor; single drinking fountain.

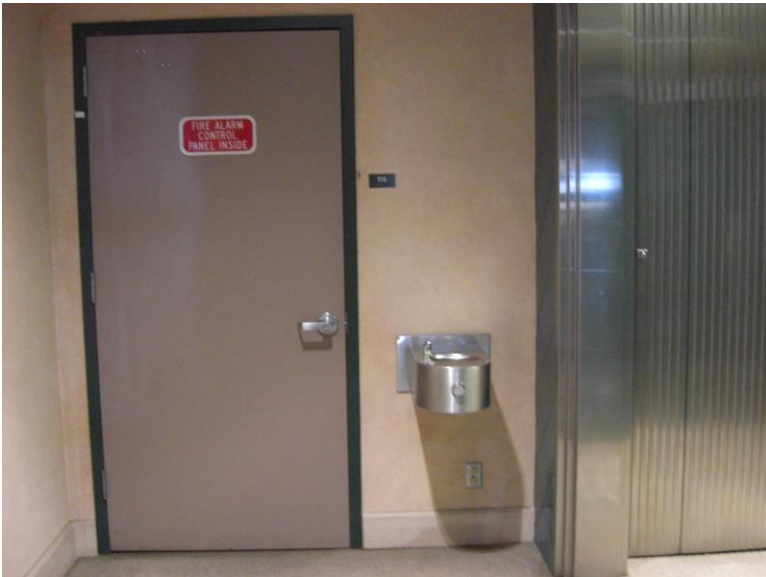
DF3. First floor single drinking fountain; maneuvering clearances not provided.

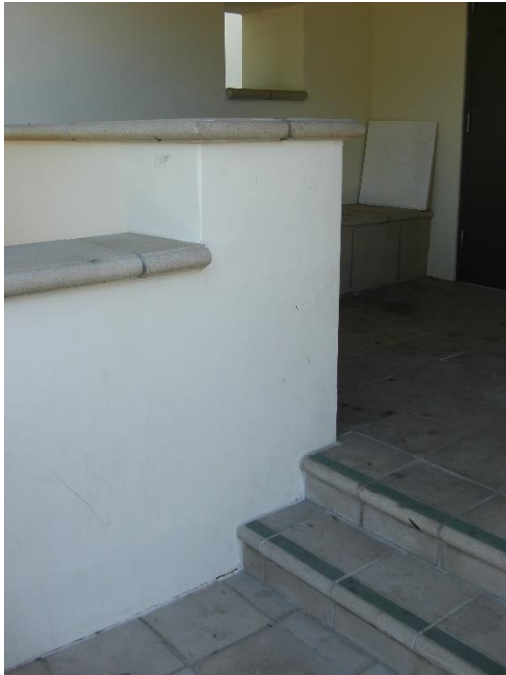
ST1. Exterior north stairs; missing required handrails.

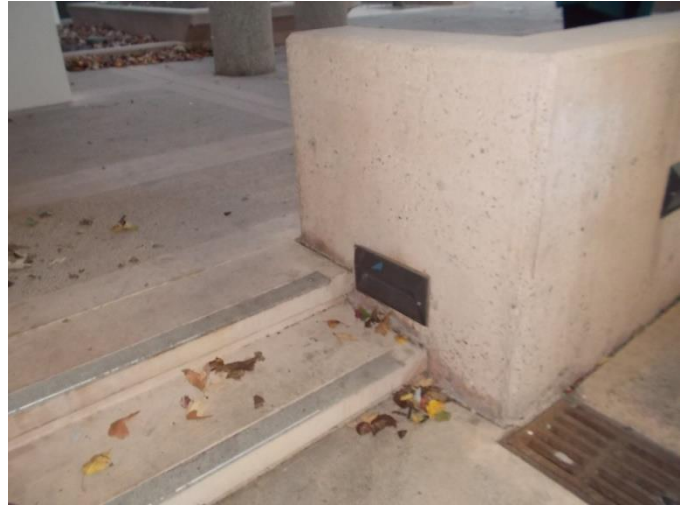
ST2. Exterior south stairs; missing required handrails.

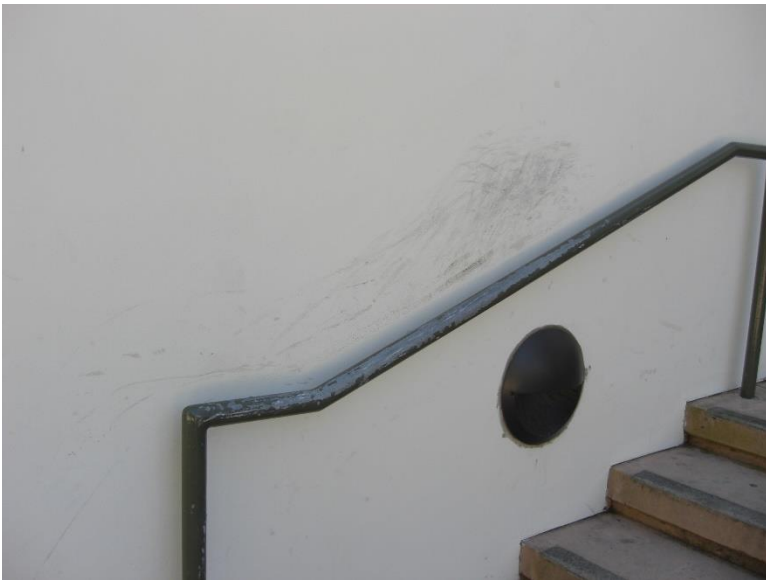
ST6. East side of building; exterior stair handrail finish degraded, and non-compliant height.

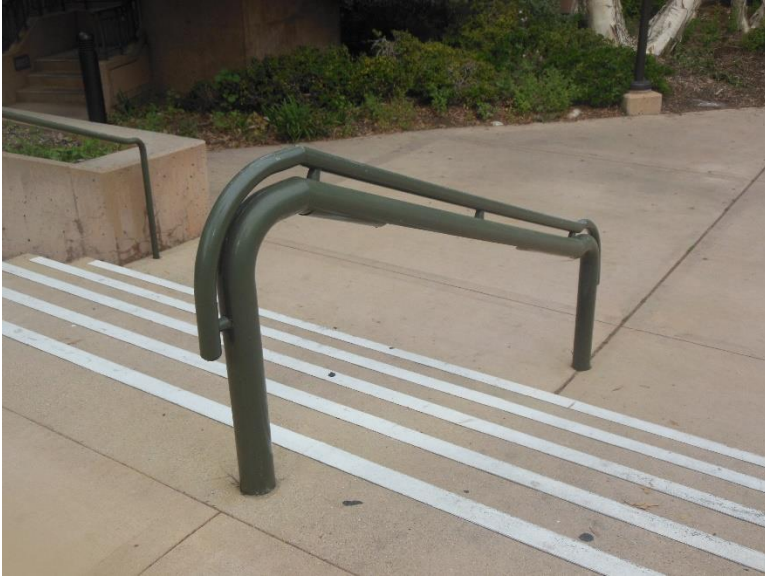
ST7. North side of building; exterior stair with non-compliant handrail heights and returns.

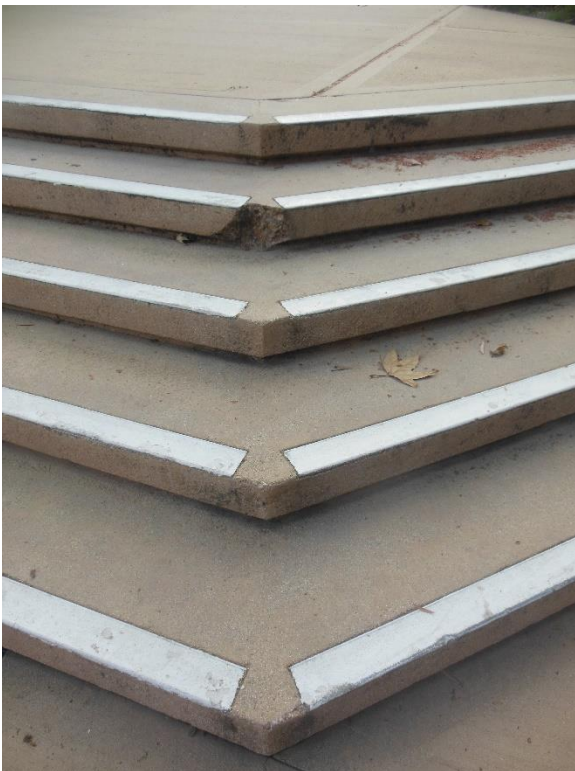
ST8. North side of building; exterior stair with damaged nosing, and missing handrail at change in stair direction.

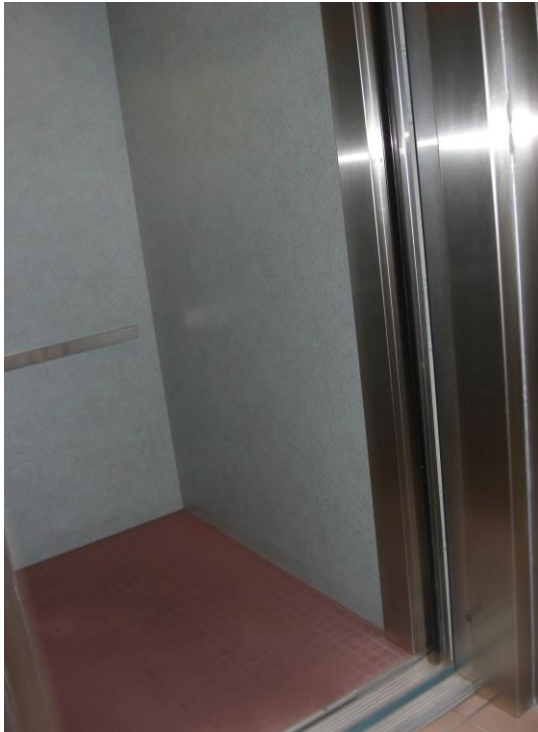
EV1. Elevator access to all floors.

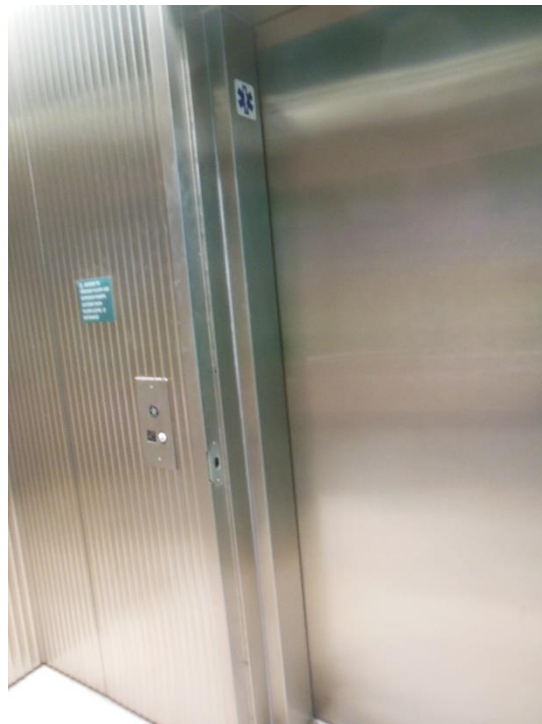
EV2. Braille floor level signs lacking.

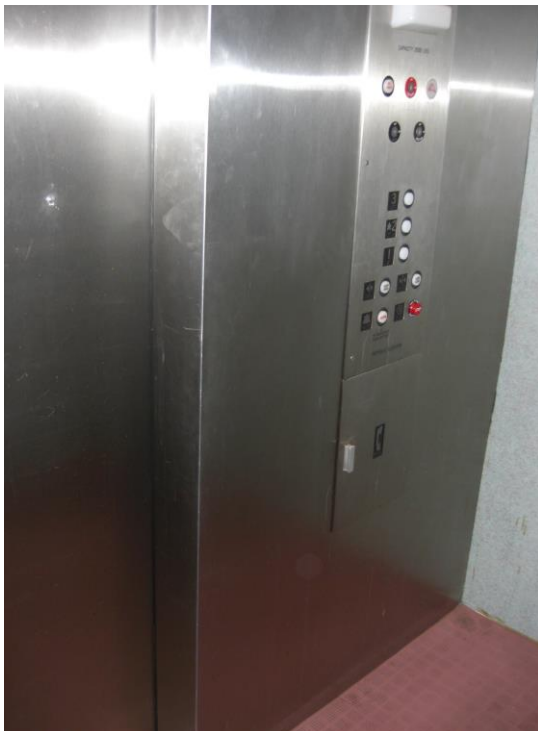
EV3. Elevator car interior.

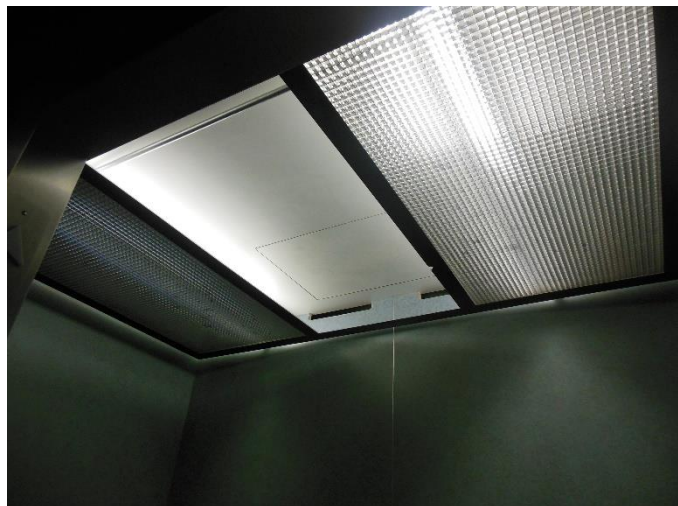
EV4. Elevator car ceiling; missing light lens.

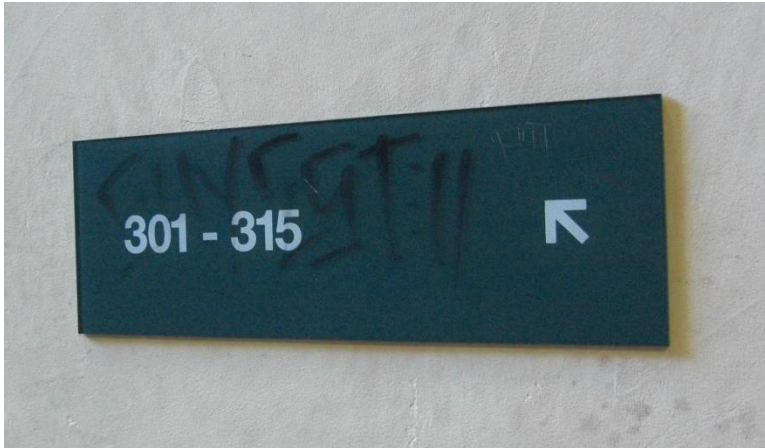
S2. Third floor; wayfinding signage vandalized.

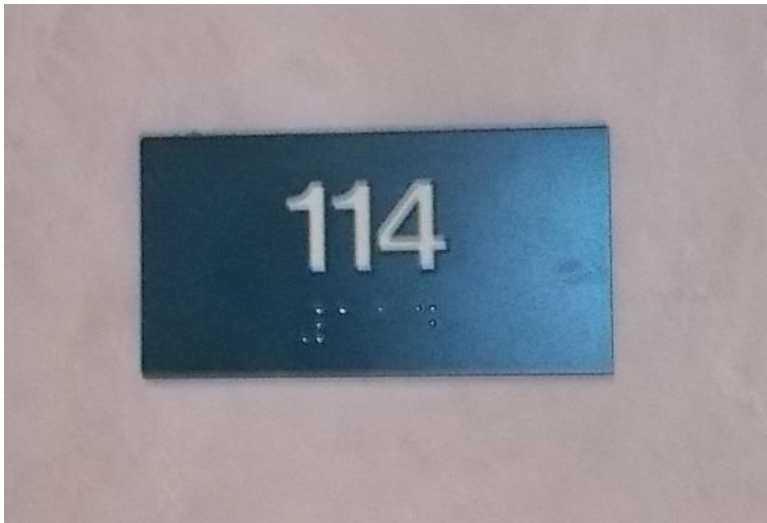
S4. First floor; typical room ID signage.

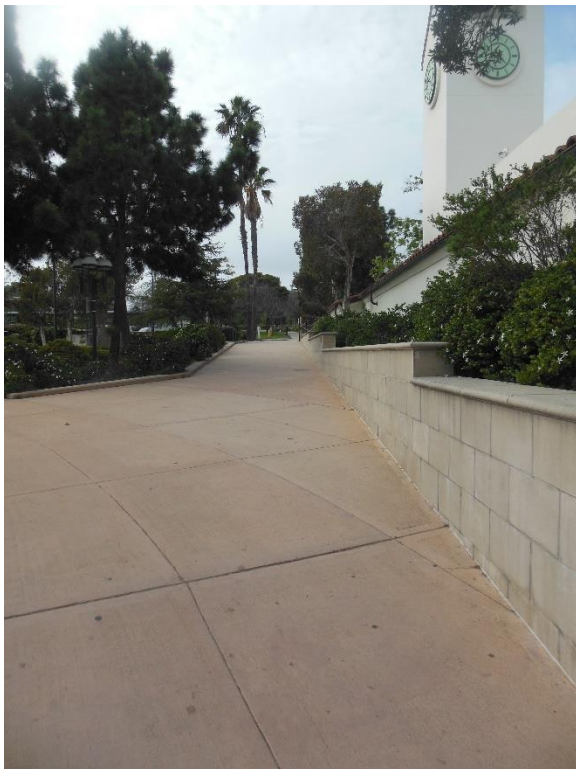
PT2. West side of building; excessive cross and longitudinal slopes along path of travel.

Exterior circulation around the building is upon both asphalt and concrete paving. At multiple locations along the presumed accessible path of travel, cross slopes exceed the maximum 2% allowed, and longitudinal slopes exceed the maximum-allowed 5% and are without handrails. There are various points along the path of travel that have abrupt changes in level and hazardous surface features.

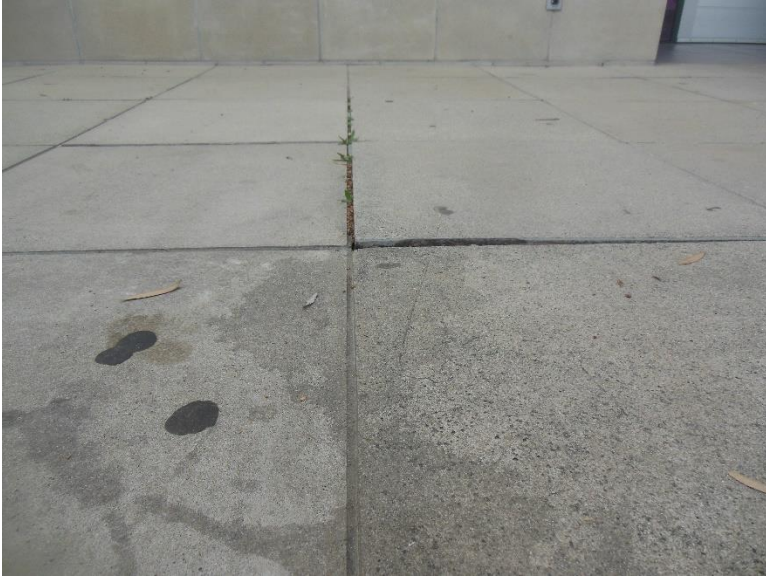
PT3. West entry plaza; abrupt change in level and hazardous surface features along path of travel.

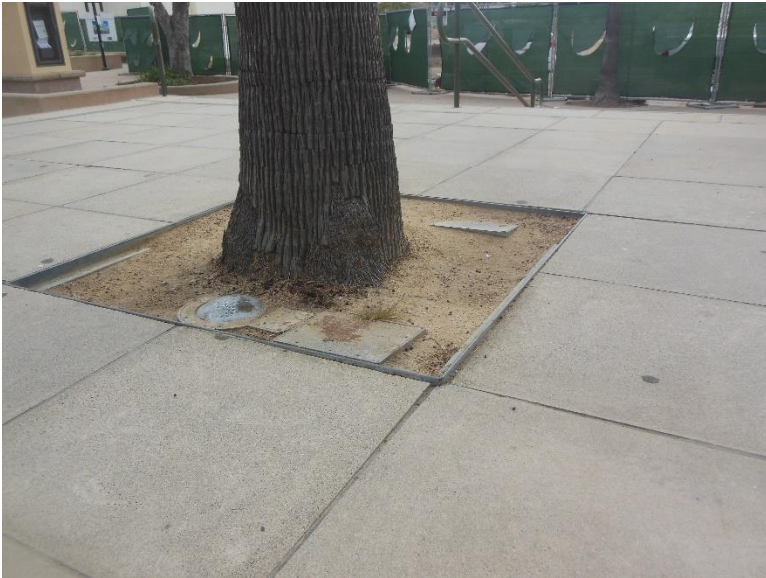
PT4. West entry plaza tree well; hazardous surface feature along path of travel.

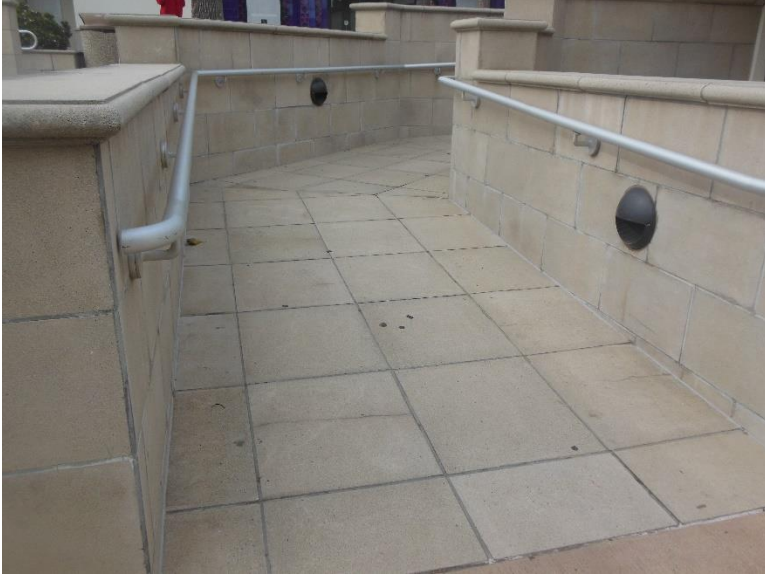
PT3. West side ramp to main building entry; intermediate landing exceeds the 2% allowed maximum cross slope.

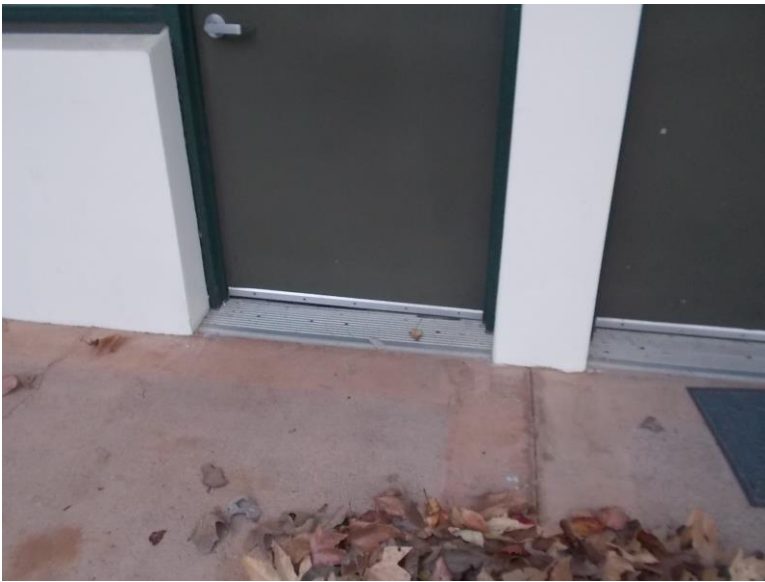
PT5. South side of building, Offices 115-117; door threshold slopes exceeds the ½" maximum height, and push-side dimensional clearances not provided.

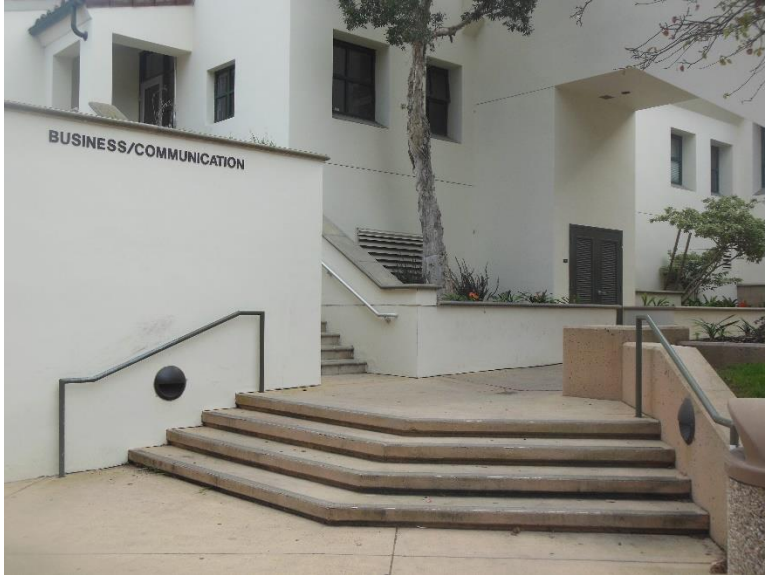
PT6. East side of building; non-accessible entry lacks wayfinding signs directing user to ramped entry location.

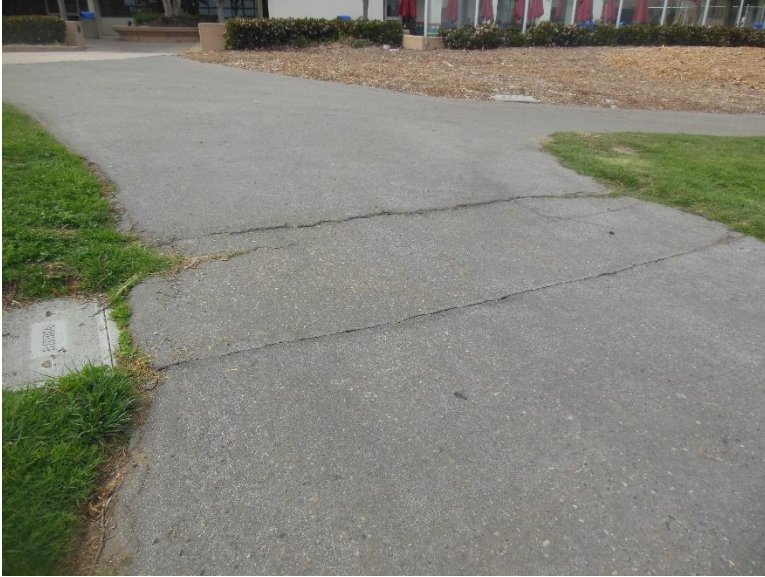
PT8. South side of building; excessive cross and longitudinal slopes, and abrupt change in level and hazardous surface features along path of travel.

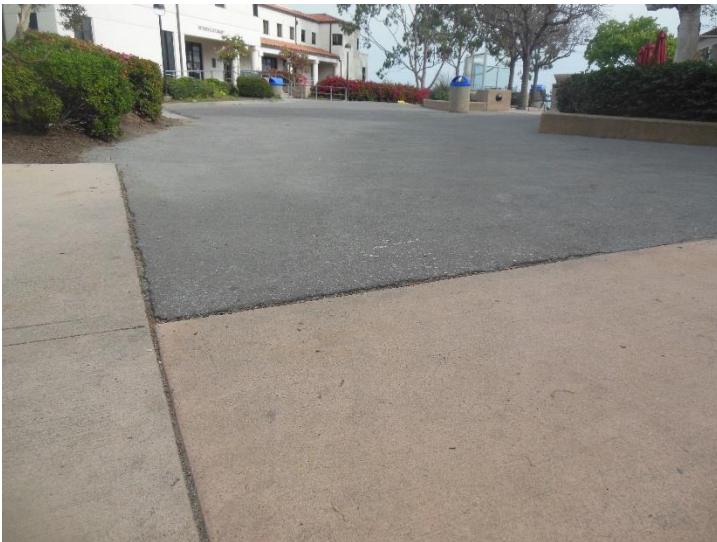
PT9. Northeast exterior walkway; uneven asphalt to concrete transitions. Abrupt change in level and hazardous surface features along path of travel.

The paved surface from the IDC building to the accessible parking spaces in the adjacent parking structure is not ADA compliant. There are crumbled, uneven and degraded asphalt to concrete transitions, ground down high spots in the concrete walks, no wayfinding signs, and no detectable warning pavers at the flush vehicular influences.

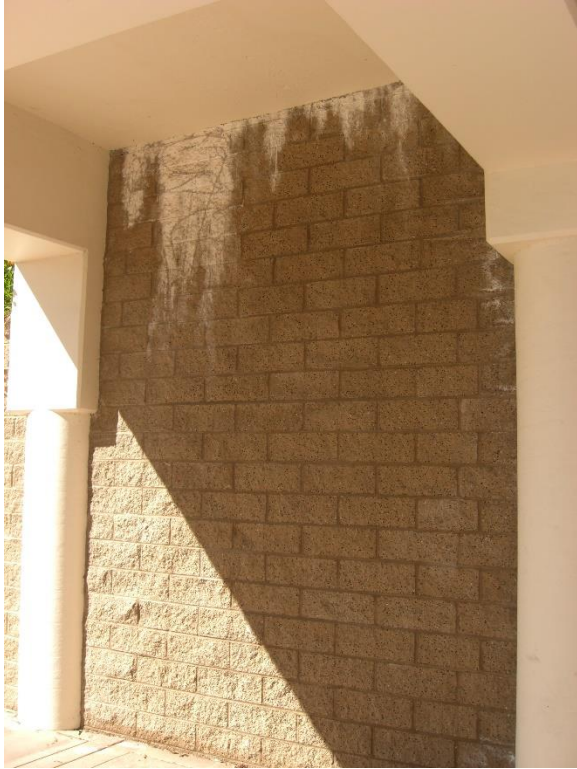
AE3. First floor CMU wall under overhang with efflorescence (white mineral deposits) from water intrusion above.
