# SANTA BARBARA CITY COLLEGE

## ADA PATH OF TRAVEL ASSESSMENT

# Facility Condition Assessment Report ADMINISTRATION BUILDING

**Facility Condition Assessment Report**  
**Santa Barbara City College – Main Campus**  
**Administration Building**  
**721 Cliff Drive**  
**Santa Barbara, CA 93109**

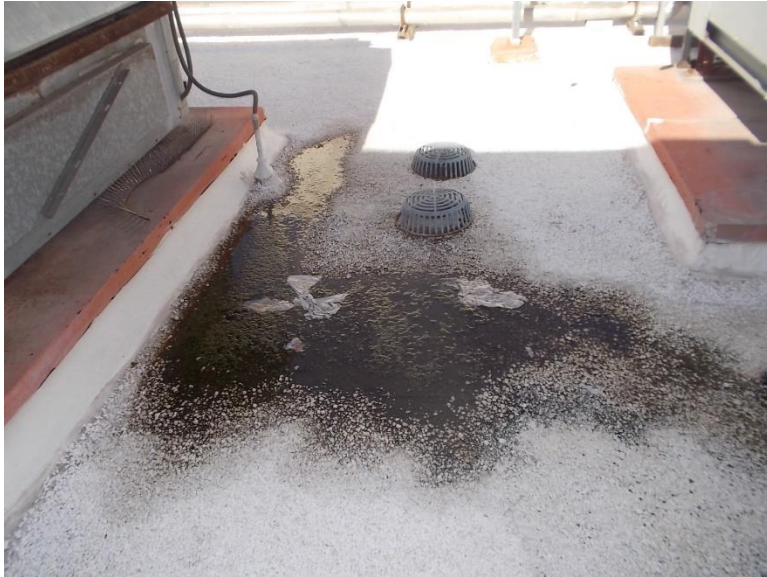
**ROOF:** Built up roofing at the mechanical roof wells have standing water, poor roof drainage, and potential underlying damage possibly caused by the old, poorly maintained mechanical equipment in the same location.

R1. Mechanical roof well with water damage at built up roofing system.

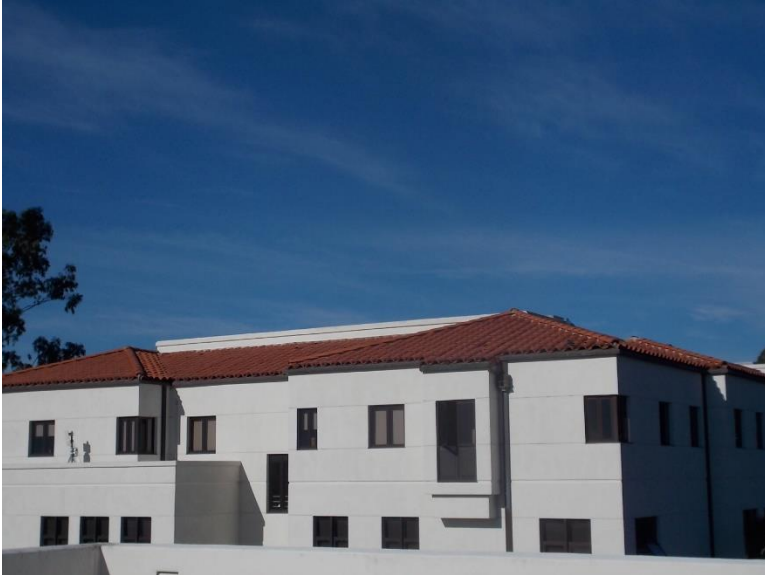
R3. Clay tile roof system, in good condition.

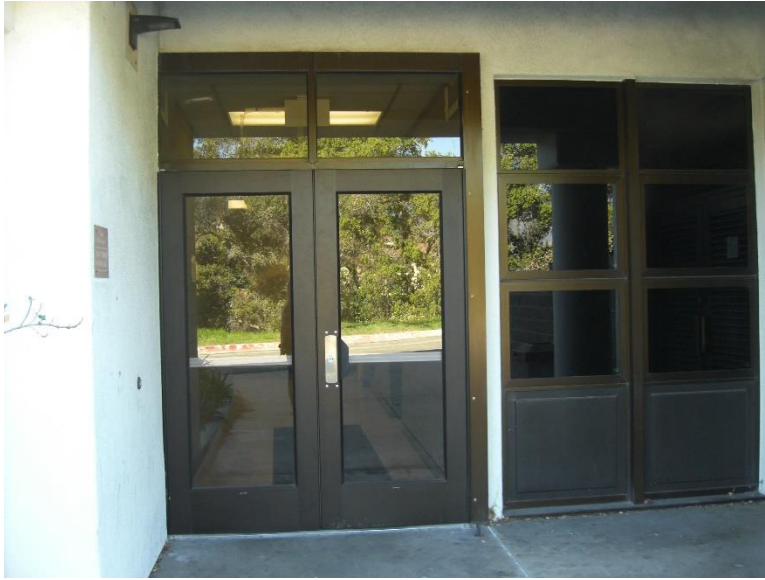
D1. First floor south entrance doors.  
Doors are lacking code required signage and ISA symbols.

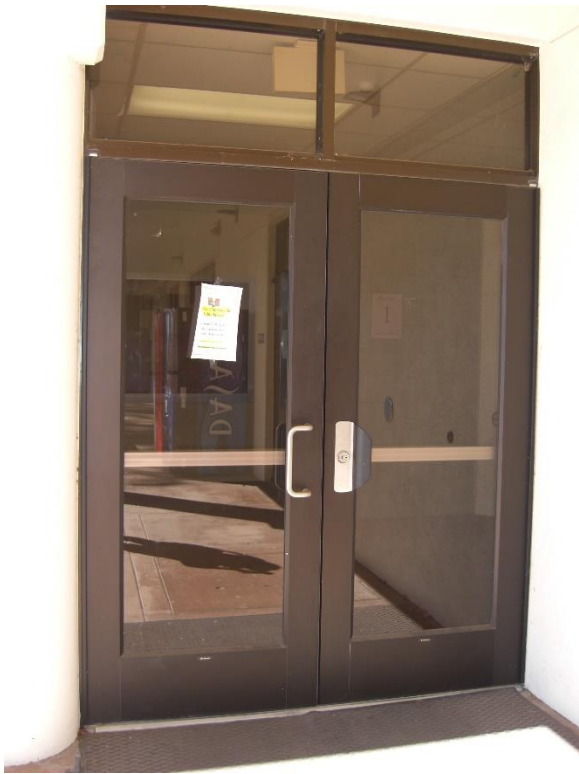
D3. First floor west lower entrance doors;  
Right hand door abuts the adjacent wall without  
providing hand clearance to avoid pinching.

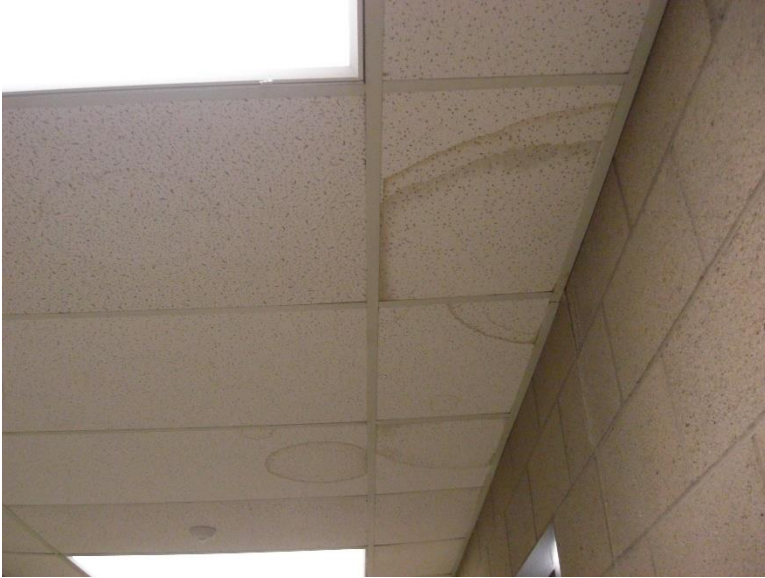
**CEILINGS:** The ceilings in the facility are the original 2x4 suspended acoustic tile and plaster ceiling systems. Some lay-in tegular ceiling tiles have water and stain damage, and at various locations grid members are bent and require refurbishment. The suspended ceiling system may no longer meet current code requirements and regulations, were not included in any of the upgrades done between 2013 and 2015, and would greatly benefit from refurbishing.

C1. First floor corridor ceiling system; water damaged.

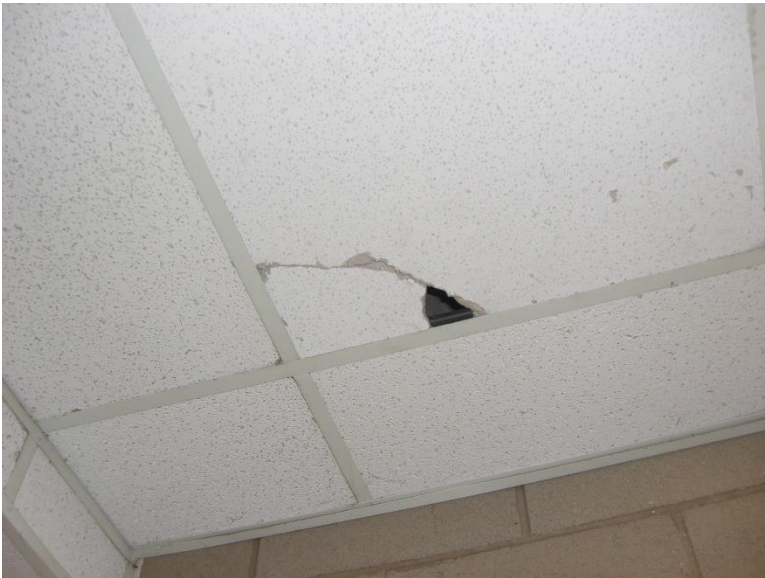
- Ceiling systems – The suspended ceiling system is original, and many of the 2x4 acoustical ceiling tiles are damaged or stained and are in need of replacement. The ceiling suspension grid system is bent or damaged in some locations and requires repair. Additionally, the suspended ceiling system components such as: suspension hanger and bracing wire types and attachments, compression posts, main and cross runners, splices, expansion devices, intersection connectors, fire rating, and total system weight, likely no longer meet current ASTM ratings, the CBC, nor Department of the State Architect (DSA) requirements.

C2. First floor corridor ceiling tile; damaged.

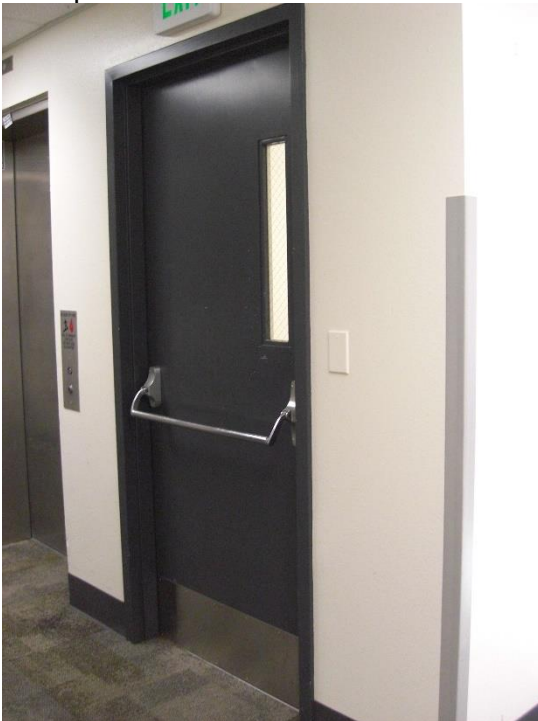
D2. Third floor stairwell door; crossbar style panic hardware does not match other exit doors touchpad style.

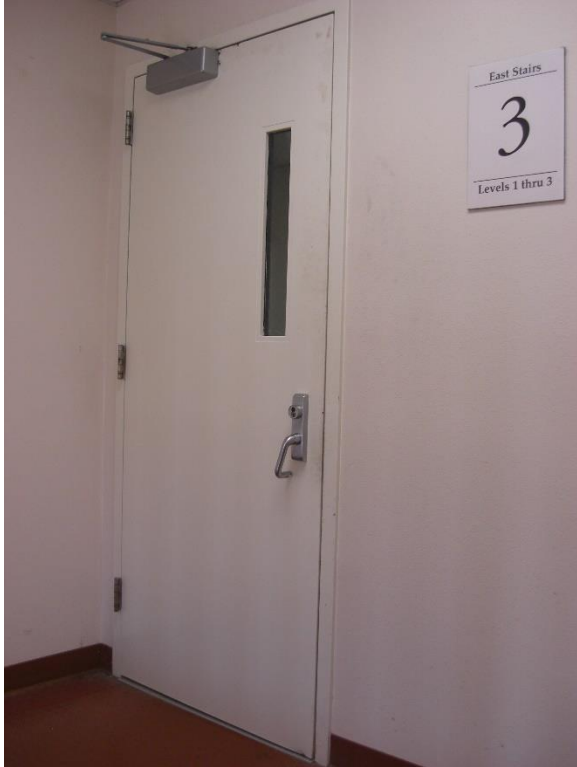
D3. Third floor stairwell door with damaged lever hardware.

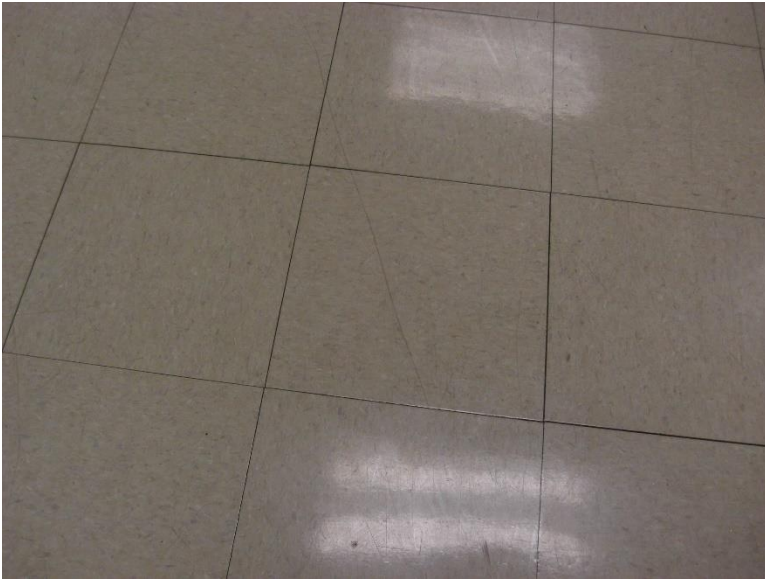
IF2. Second floor corridor; scratched/damaged VCT flooring.

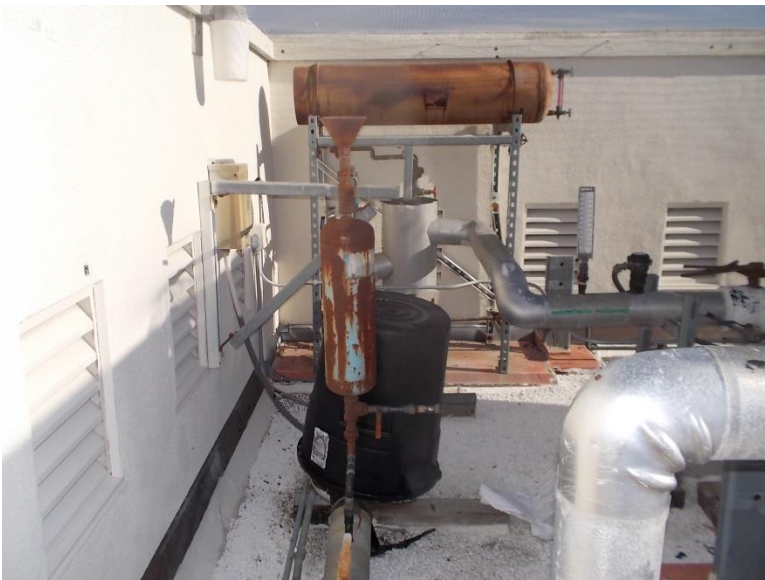
M2. Rooftop mechanical equipment at end of useful life.

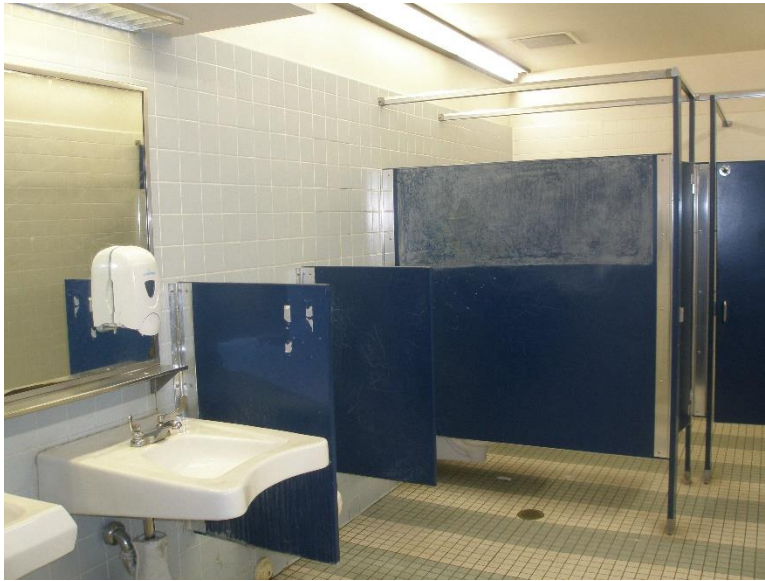
RR1. Mens restroom, accessible clear floor space not provided. Mirror and soap dispenser mounted above ADA compliant heights.

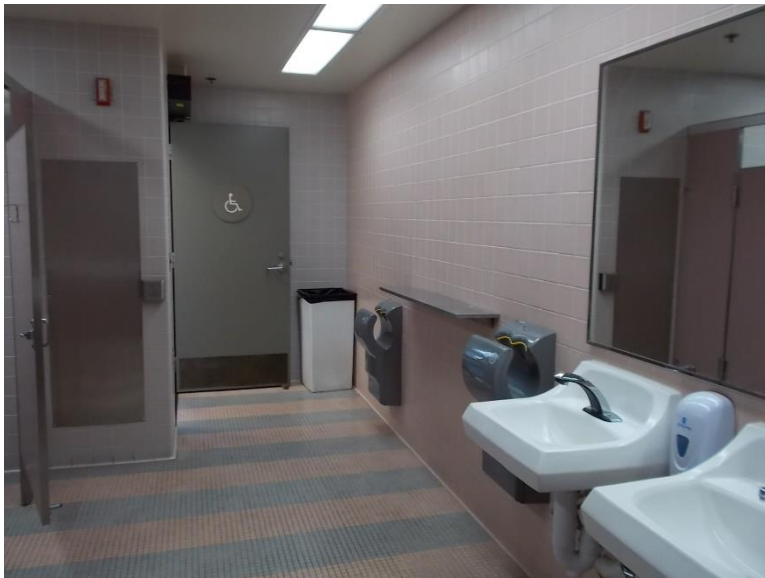
RR2. Womens restroom. Door signage does not meet minimum contrast requirements with adjacent surface.

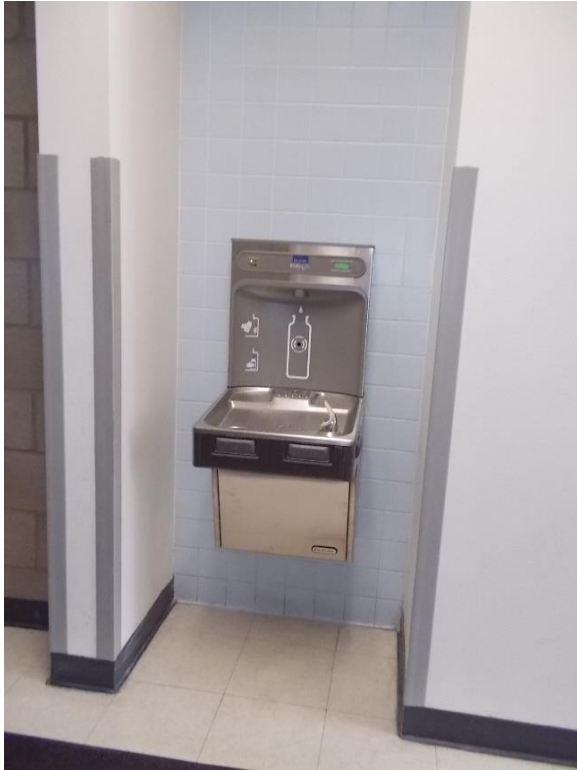
DF1. Bottle filling station/drinking fountain.  
Compliant maneuvering clearances are not provided.

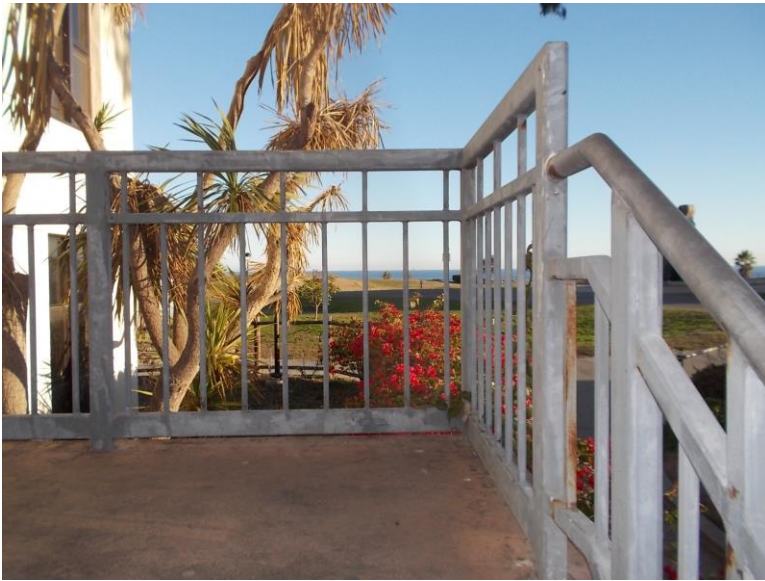
ST1. South exterior stairs with non-compliant and corroded handrails.

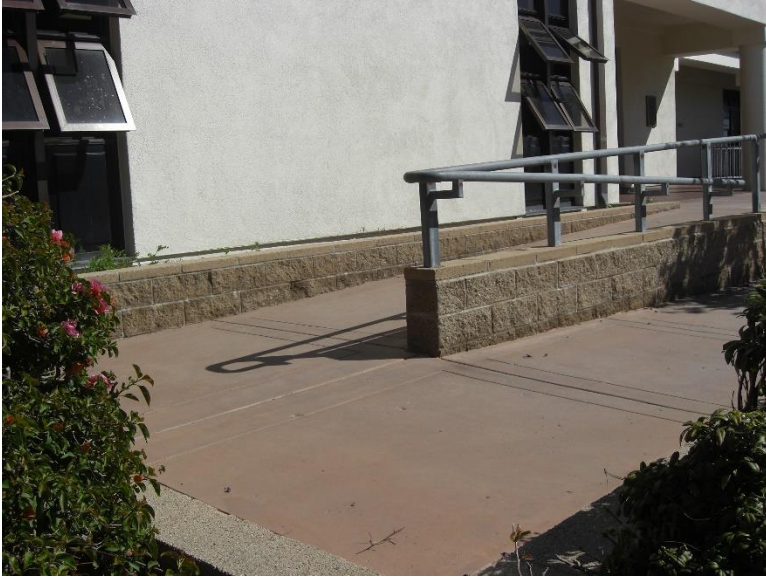
PT3. Non-compliant ramp at west main entry.

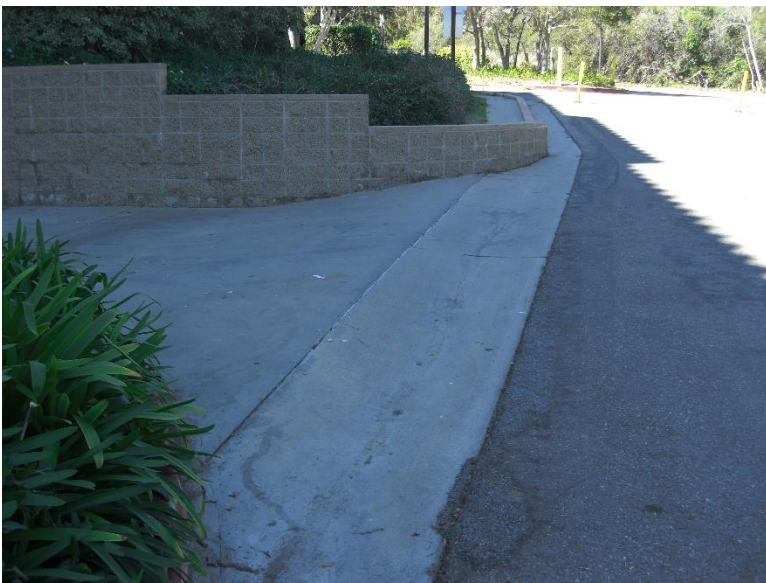
PT4. Non-compliant walkway at east main entry.

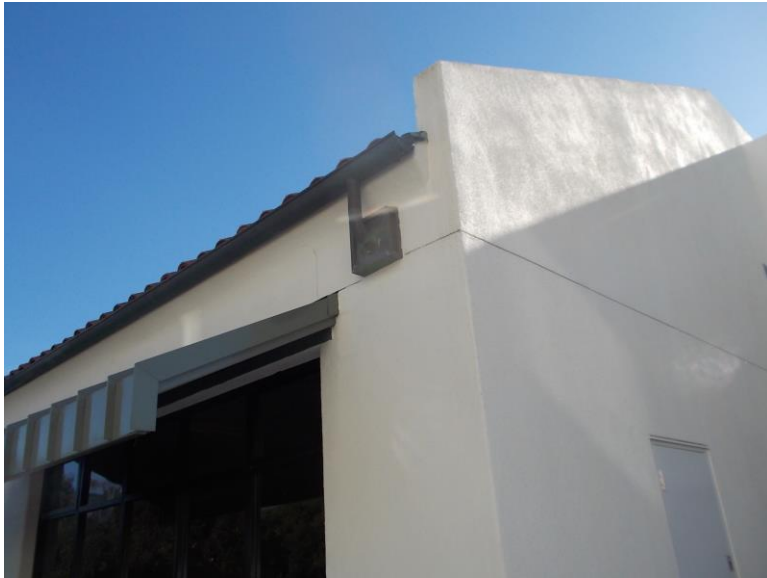
**WALLS:** The exterior wall finish is plaster over both concrete and steel stud construction. The plaster has minor hairline cracks, but otherwise appears to be in good condition and has been recently painted. The interior walls are painted gypsum board over metal stud framing, painted concrete, and fabric covered. The wall finishes on the west side of the building are in good condition, while all finishes on the east side are in very poor condition. Multiple locations have damaged drywall, marred and chipped paint, and badly stained wall coverings.

AE1. Exterior walls, minor plaster cracking.

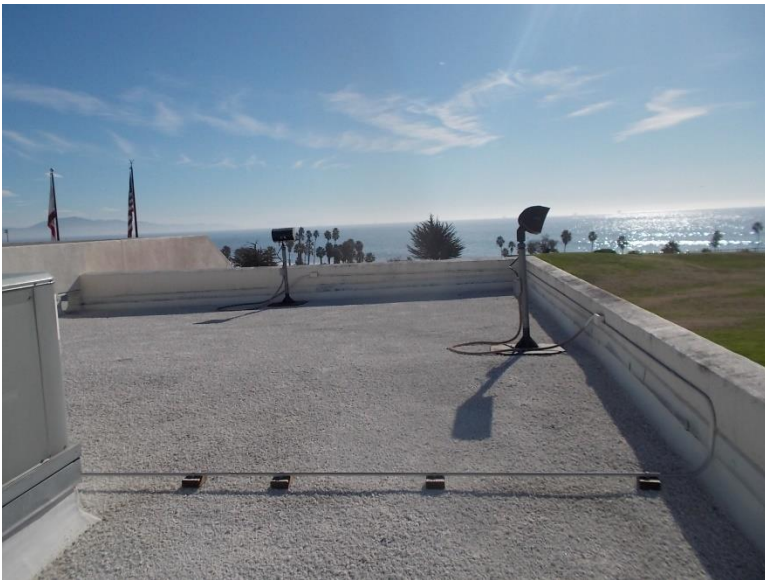
R4. Built-up roof system in good to excellent condition. Flood lights serve to light the walkways and plazas below.

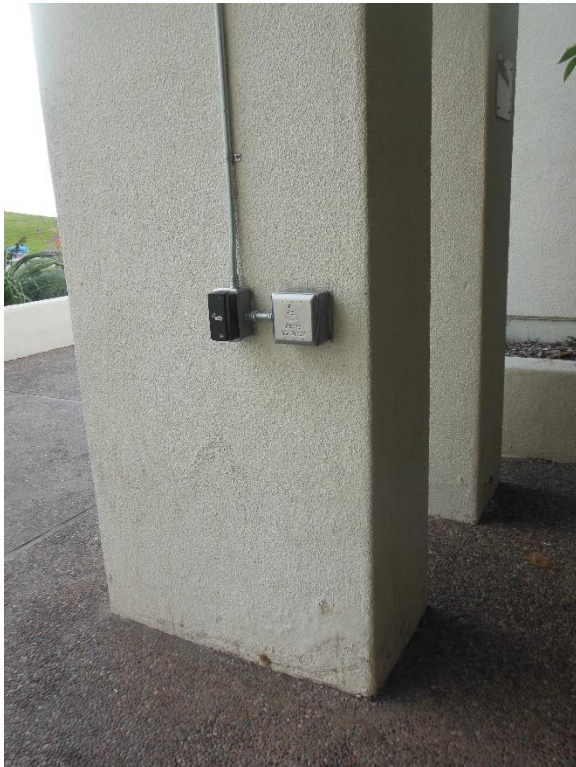
D2. Main Entrance; low level access button for electronic door operator not provided.

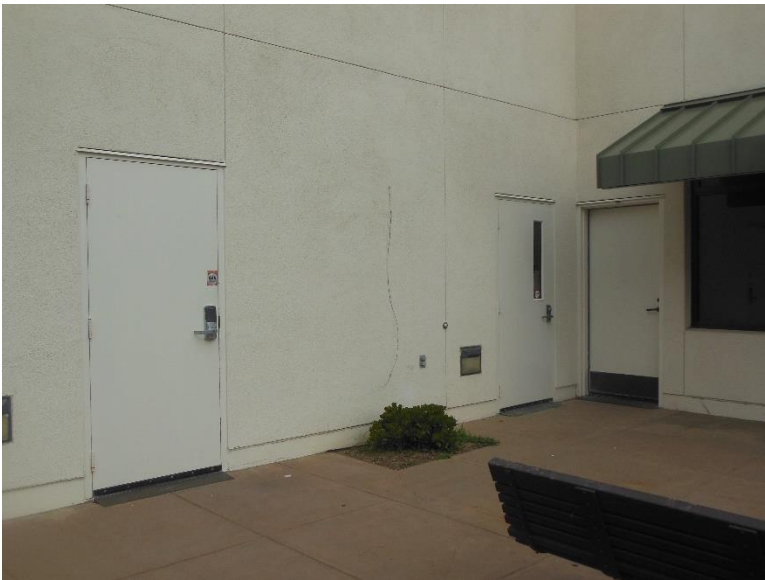
D4. Doors on east side of building; lacking code required wall mounted door identification signage.

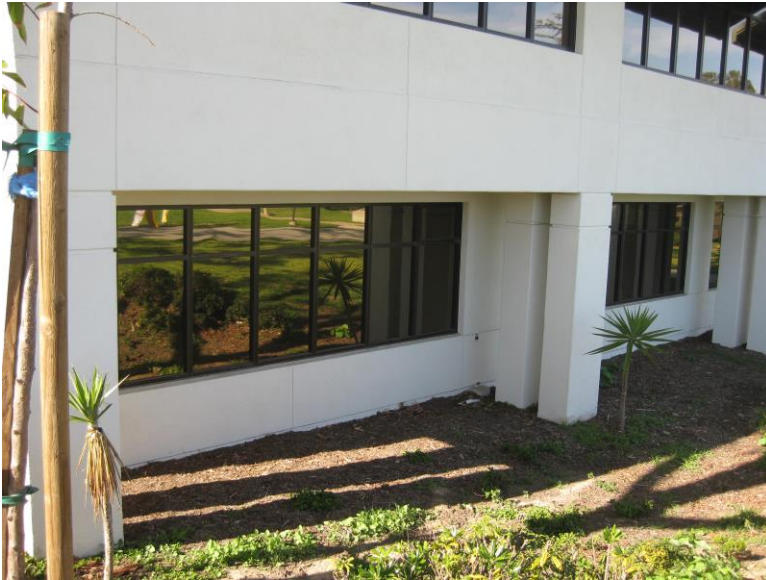
EW1. Exterior windows first level, in good condition.

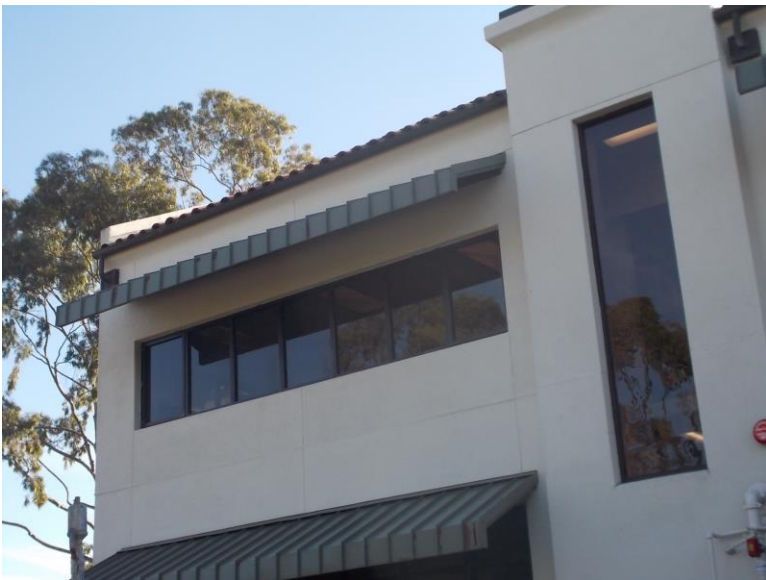
EW2. Exterior upper level windows, in good condition.

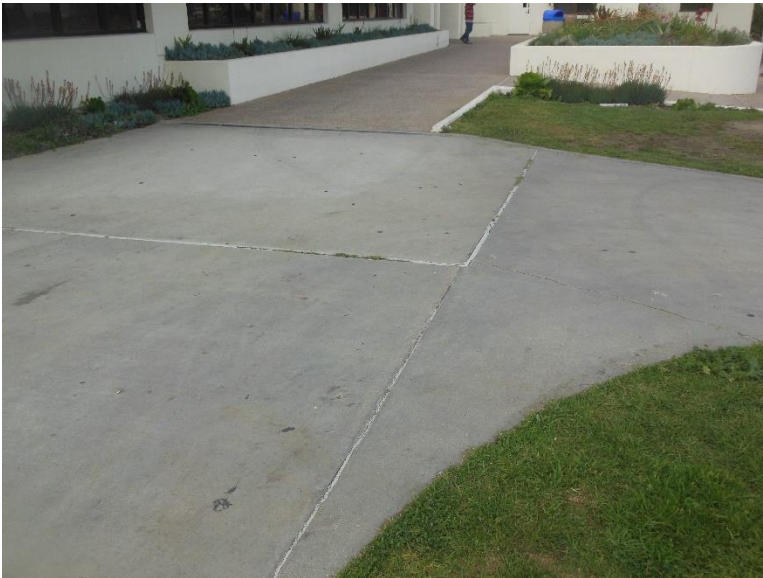
Exterior circulation walkways around the building are both concrete paving and epoxy pebbled surfaces. At multiple locations along the south and east sides of the building, the longitudinal slopes exceed the maximum allowed 5% and are without handrails. There are various points along these walkways that have abrupt changes in level and hazardous surface features. The expansion joints between pavement panels are degraded, and require replacement. The immediate surrounding site is severely lacking exterior path-of-travel and wayfinding signage as required by code.

EF2. South side concrete walkway, with excessive longitudinal slope and deteriorated expansion joints.

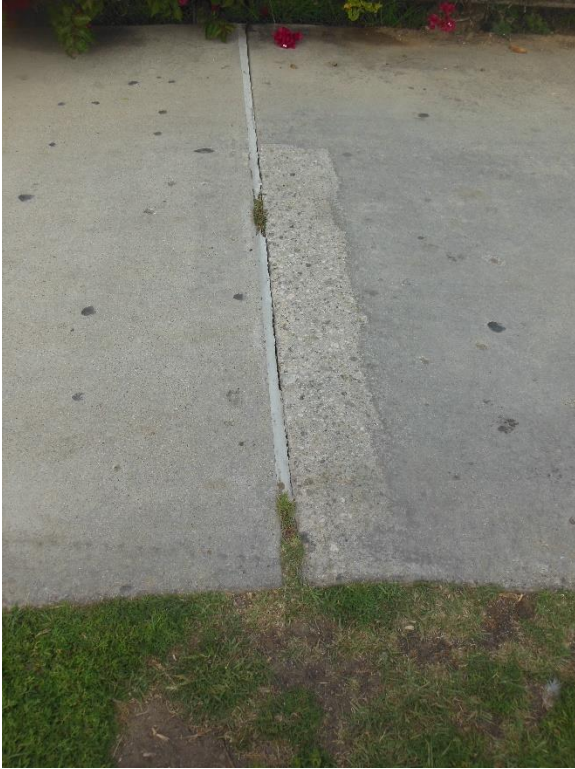
EF3. Concrete walkway, with tripping hazard ground down.

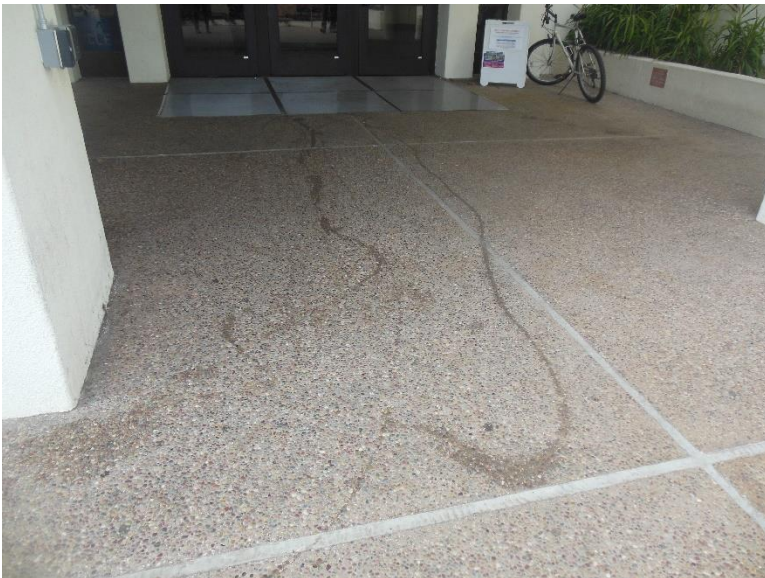
EF4. Main south entrance walkway; stained pebbled finish surface.

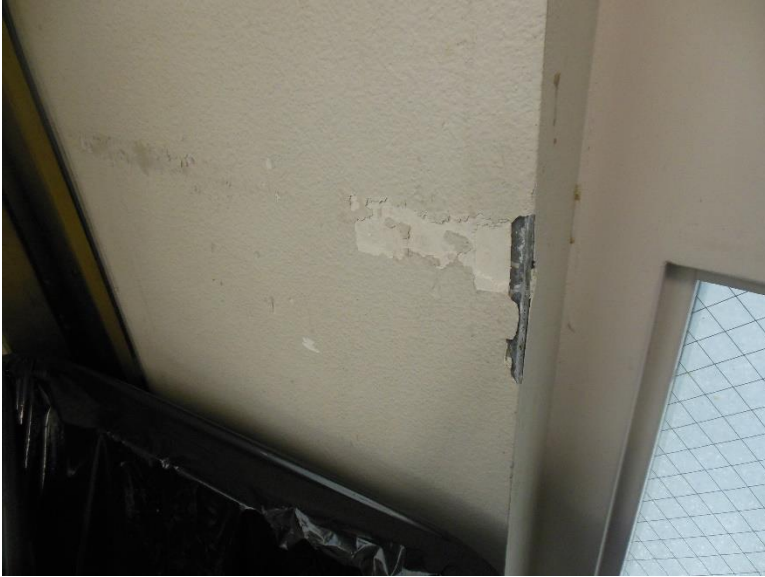
A3. Library vestibule; wall damage.

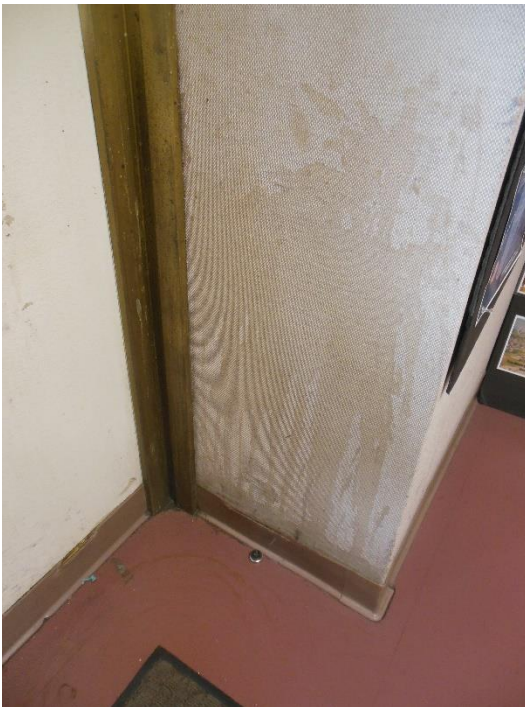
A4. Library vestibule;  
fabric wallcovering stained.

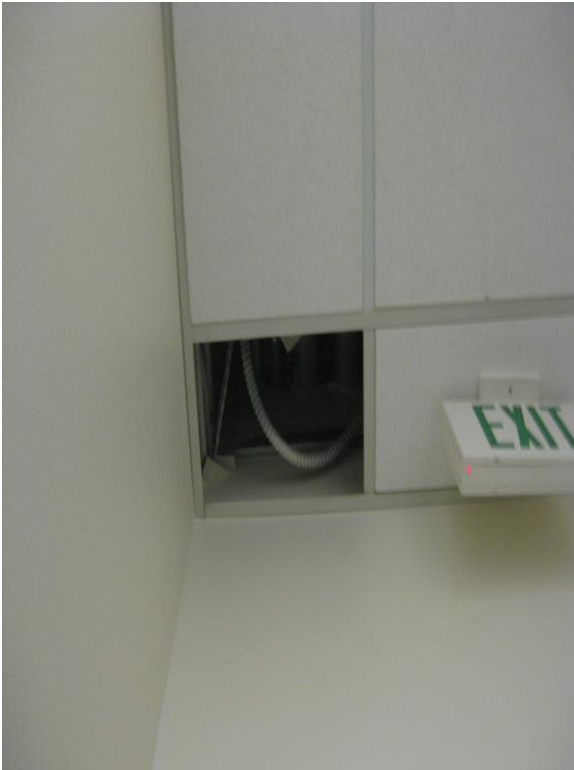
C1. Corridor 112B; missing ceiling tile.

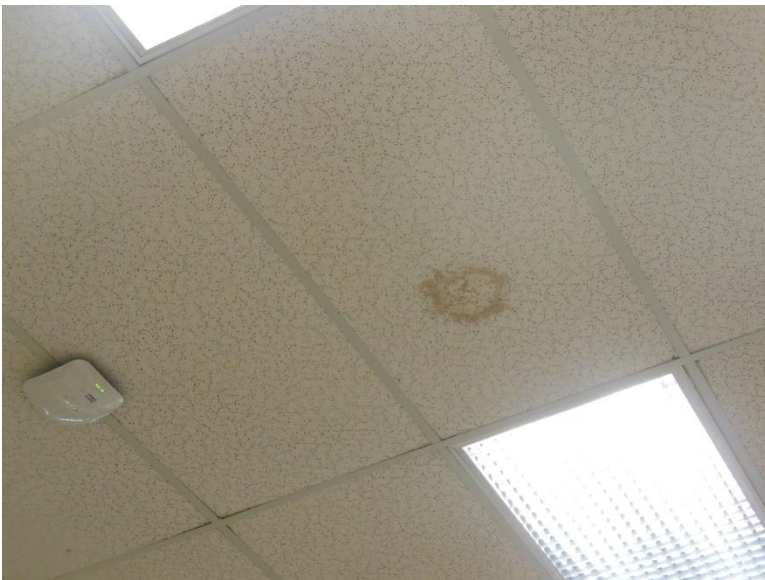
C2. Library second floor; stained ceiling tile.

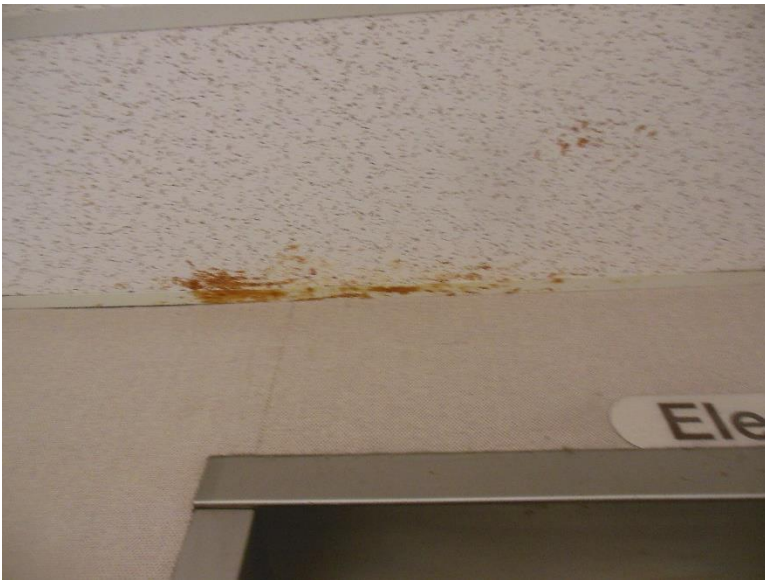
C4. Library upper floor; stained ceiling tiles at elevator.

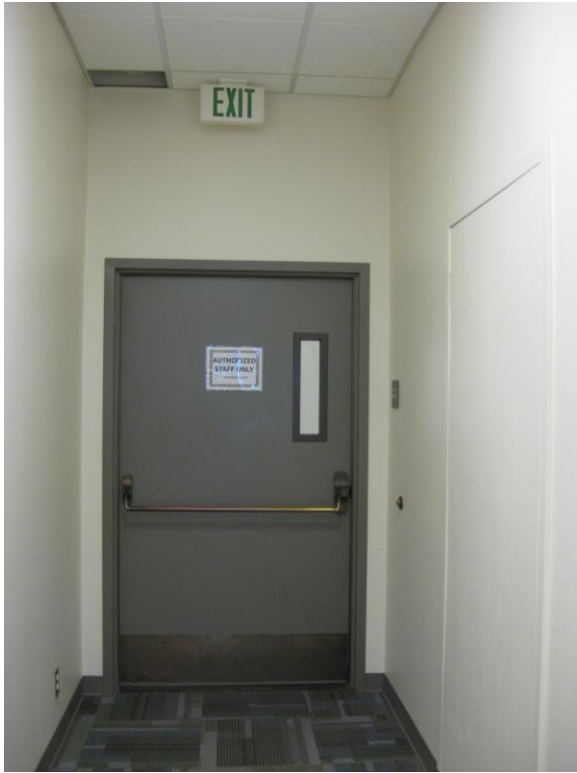
D1. Learning Center area non-compliant exit; side clearance not provided, vision light too high, and exit sign not illuminated.

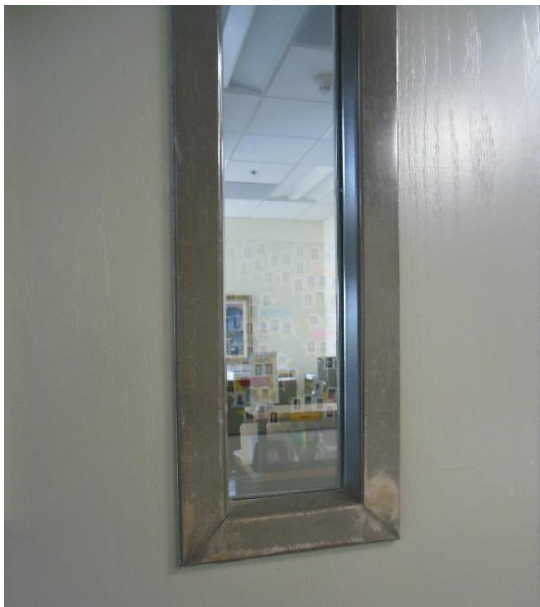
D3. Office 121; damaged frame at door lite.

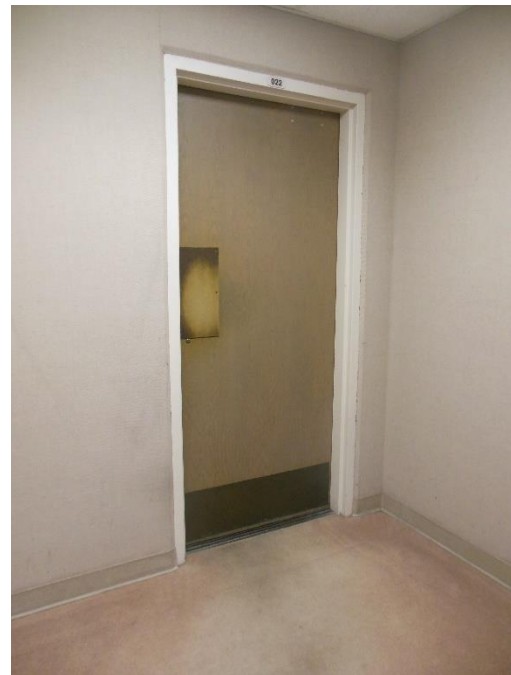
D4. Men's Restroom, 2nd floor; door and wall ADA signage not provided.

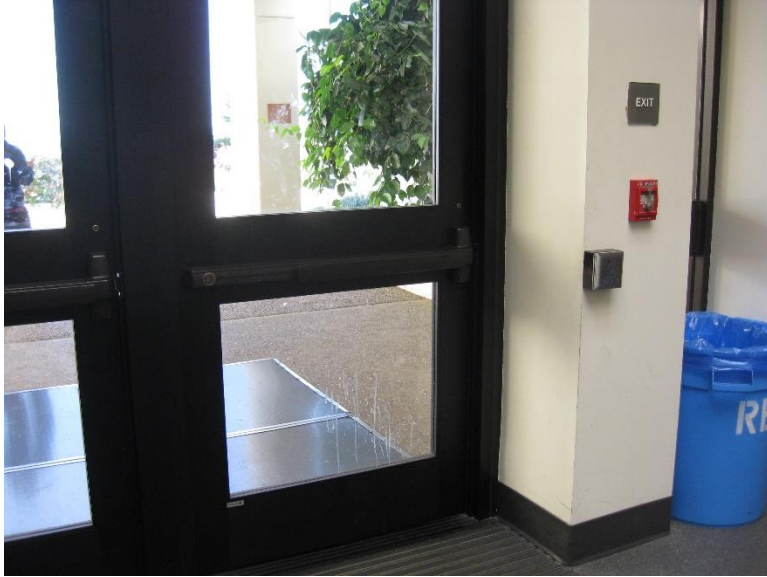
D5. Lobby main doors; non-compliant push-side clearance. Electronic door operator low level access button is required by code.

- Doors - The wood door stain and lacquer finishes show wear and should be refinished. The exterior pair of doors leading into the Disabled Student Programs and Services testing lab, does not have a compliant threshold. Doors with electronic door openers do not provide the code required lower-level push plates.

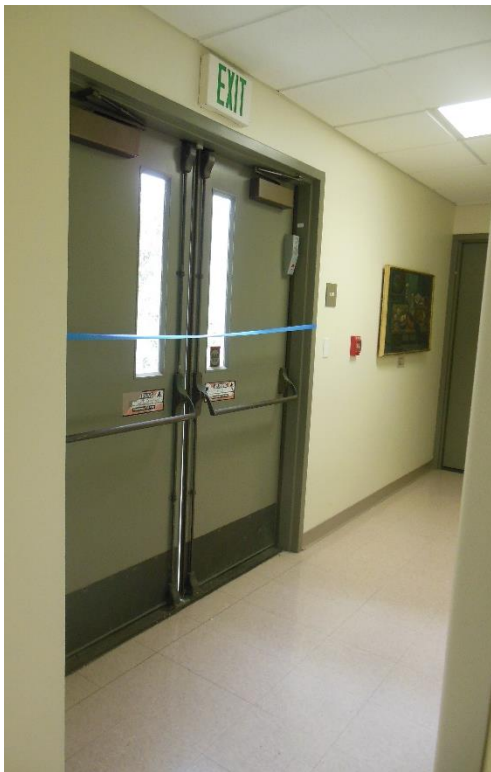
D6. Exit doors, Corridor 112A; exit access blocked with tape.

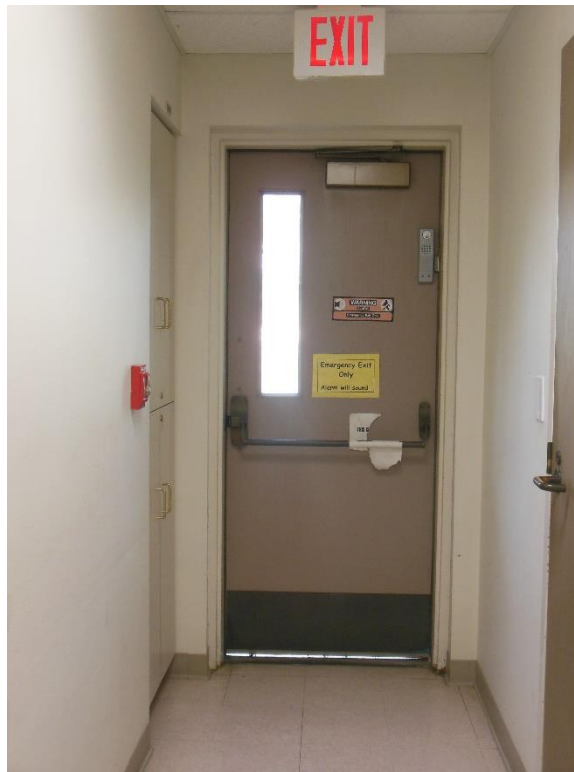
D7. Exit door, Corridor 008, push-side clearance not provided.

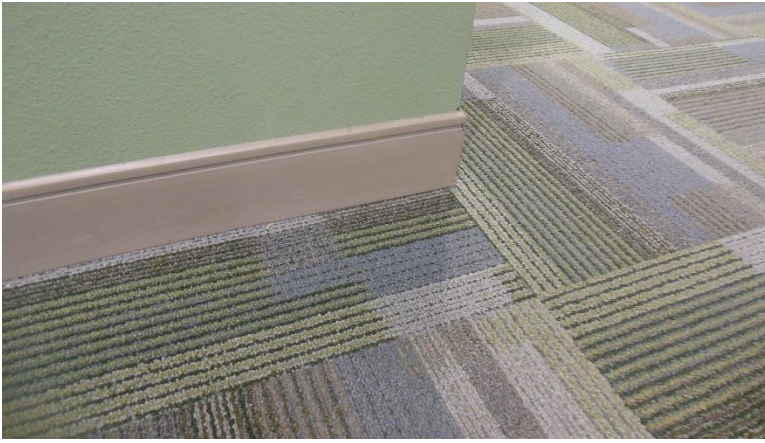
IF1. Learning Center carpet tile and wood base in excellent condition.

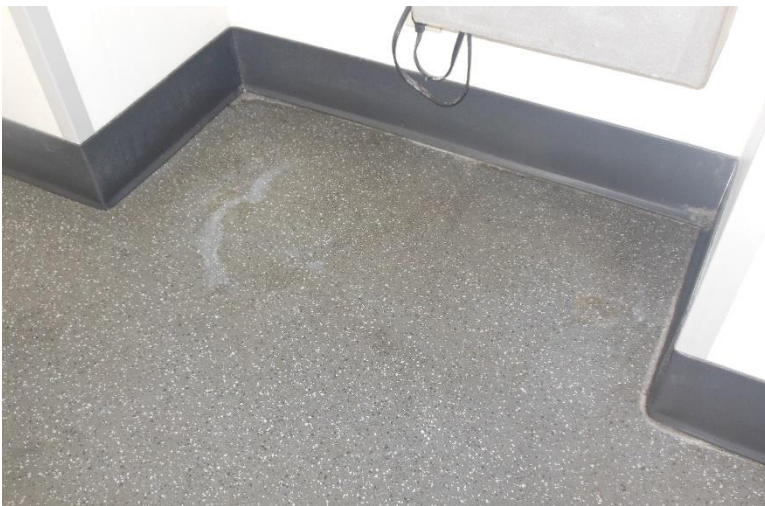
IF3. Lobby rubber tile and rubber base with water damage at drinking fountains.

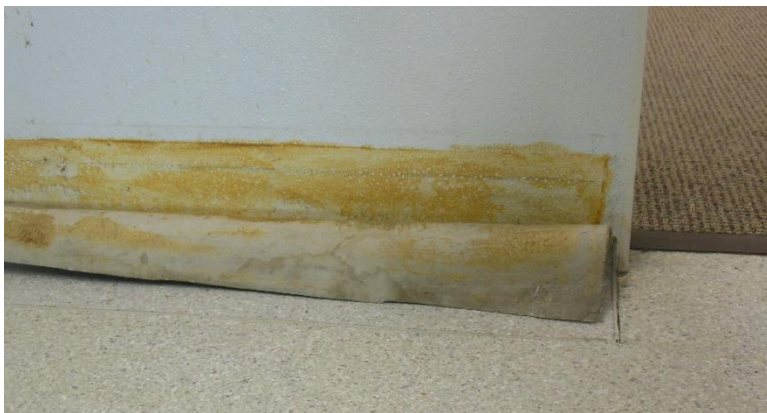
IF8. Library Café, upper floor; resilient cove base in very poor and unsanitary condition.

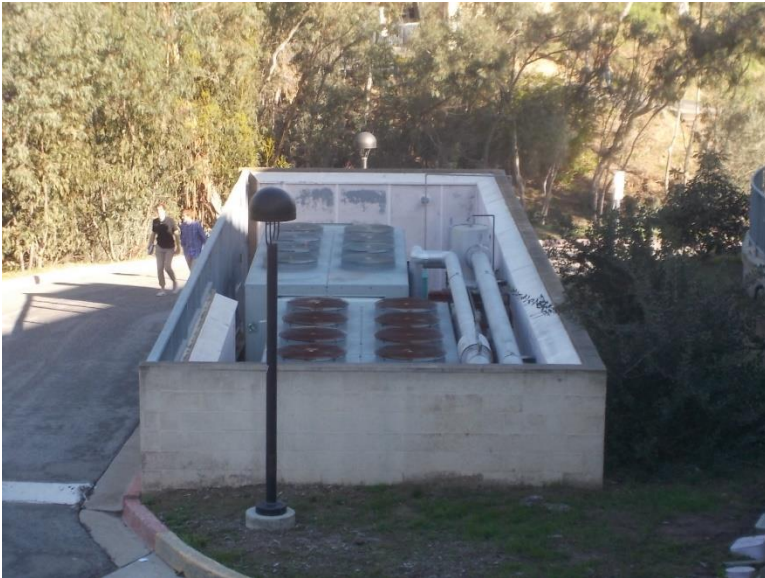
M1. Chiller enclosure. One unit is in use and in good condition.

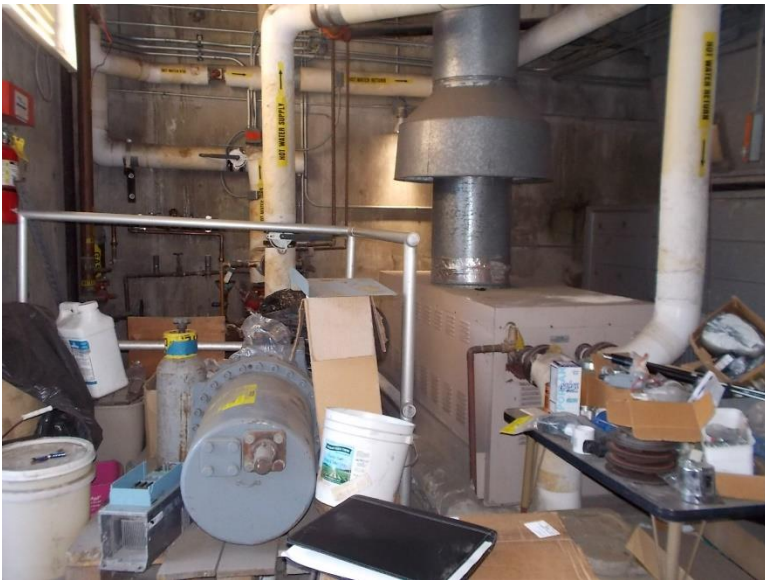
M2. Mechanical equipment blocked by debris.

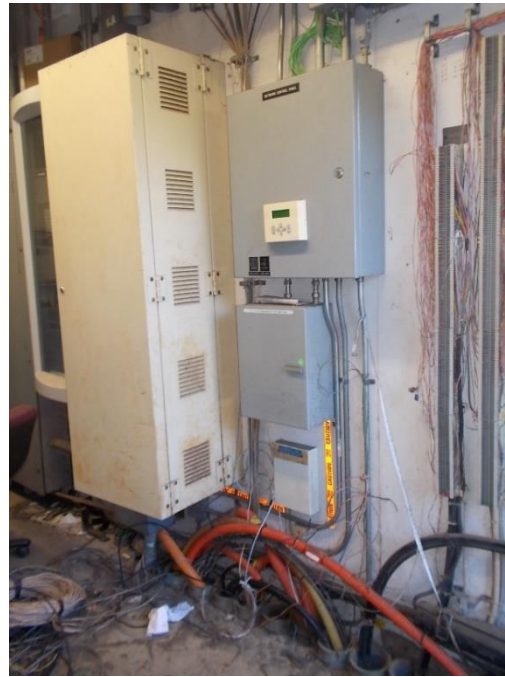
E2. IT and Fire Alarm equipment.

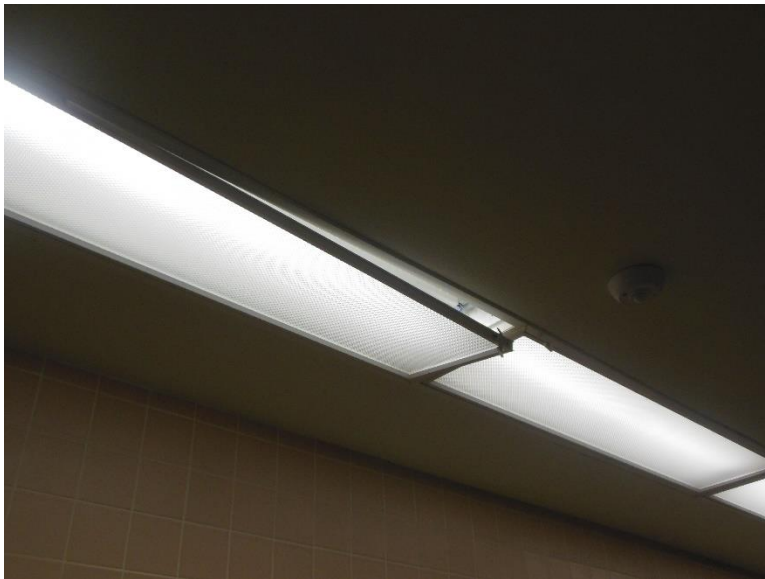
E3. Women's Rstroom 126; lighting fixture lens.

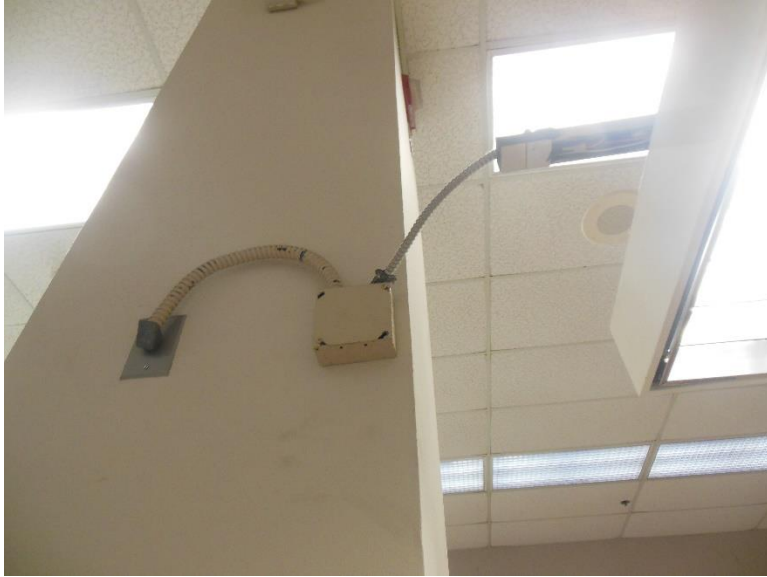
E4. Library, first floor; electrical light fixture connection.

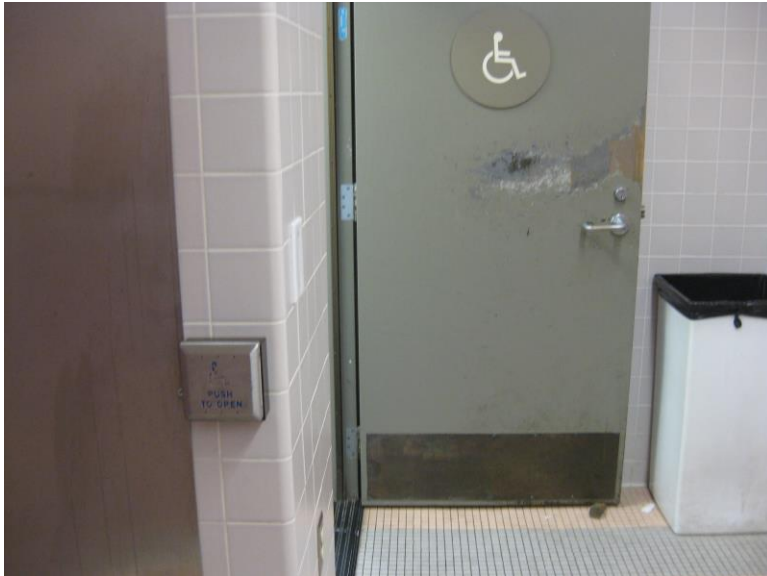
RR1. Women's Lobby restroom. Door finish repair required. Low level access button for electronic door operator is required by code, and ADA door signage is non-compliant.

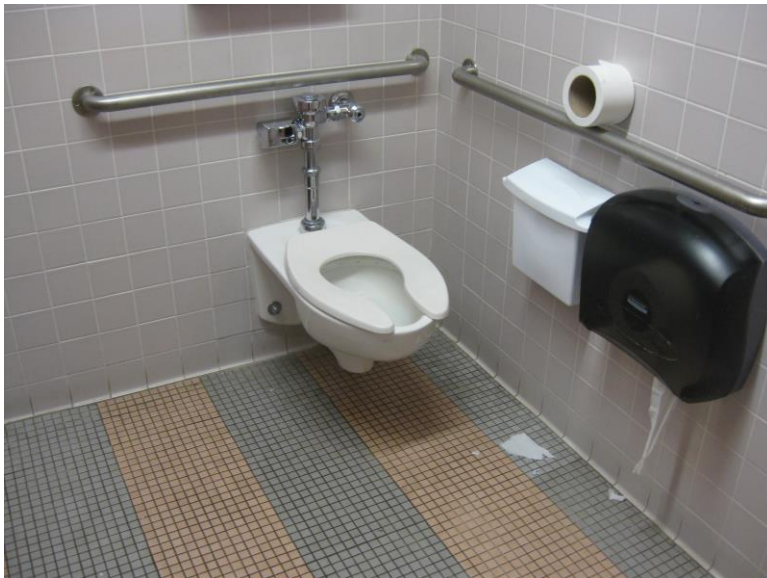
RR2. Women's Lobby Restroom. Dispenser and disposal units protrude into required clear space below handrail.

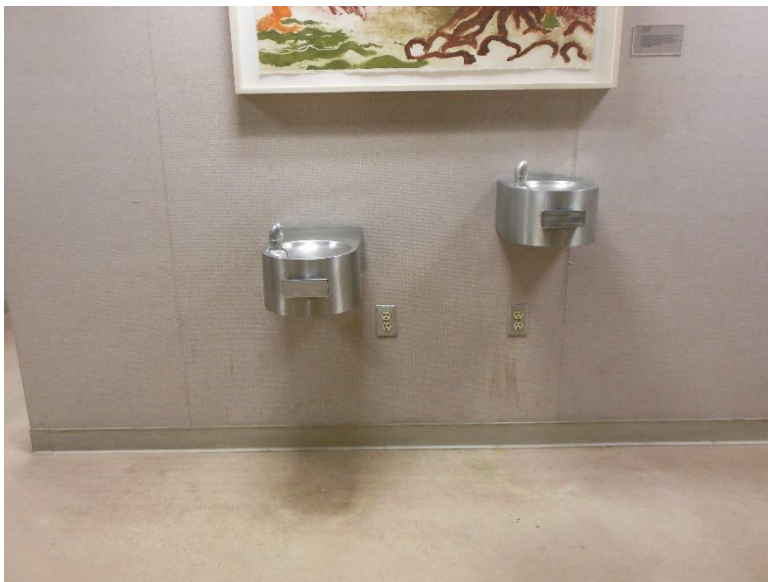
DF2. Second floor restrooms; non-compliant hi-low drinking fountains.

- Drinking Fountains - The building has drinking fountains on both floors, but building does not meet 50% ratio code requirement of hi-low accessible drinking fountains. One fountain has been replaced by a bottle filling station, and the alcove does not provide adequate wheelchair clearances. Fountains that splash and leak have caused water damage and staining on the flooring beneath.

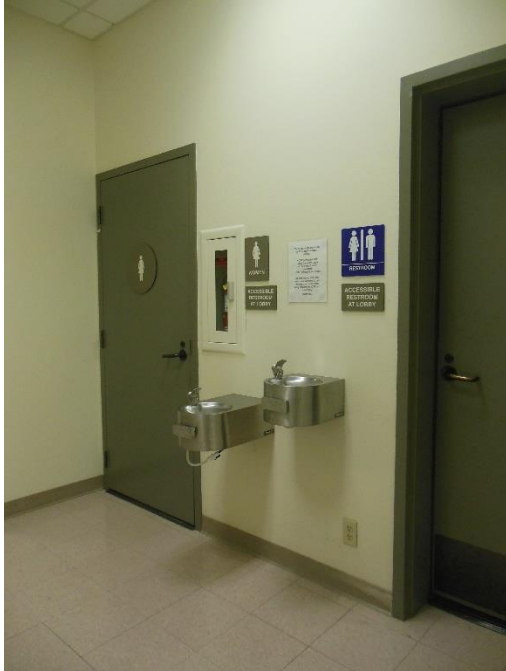
DF3. Corridor 112; non-compliant hi-low drinking fountains.

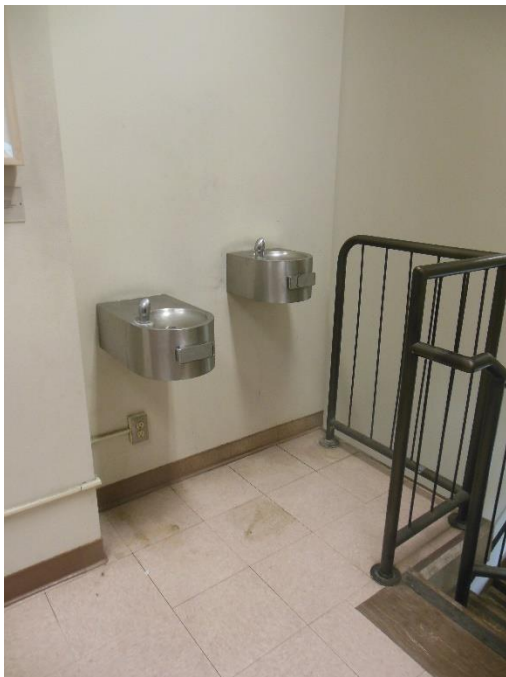
DF4. Top of Stairwell 147; non-compliant hi-low drinking fountains.

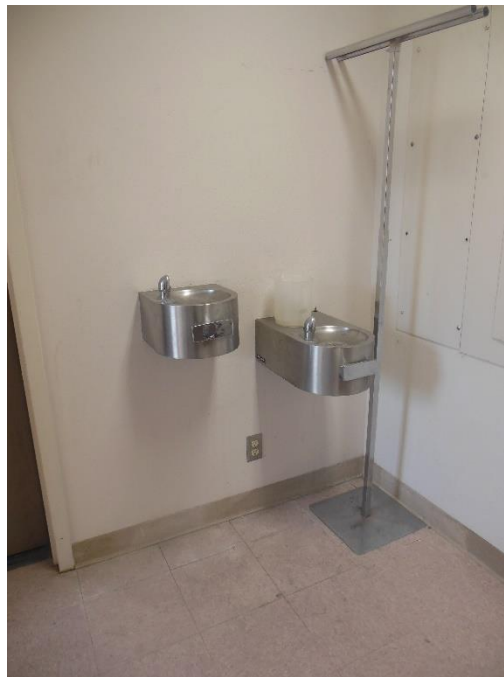
DF5. Top of Stairwell 136; non-compliant hi-low drinking fountains.
