# SANTA BARBARA CITY COLLEGE

## ADA PATH OF TRAVEL ASSESSMENT

# Facility Condition Assessment Report ADMINISTRATION BUILDING

**Facility Condition Assessment Report**  
**Santa Barbara City College – Main Campus**  
**Administration Building**  
**721 Cliff Drive**  
**Santa Barbara, CA 93109**

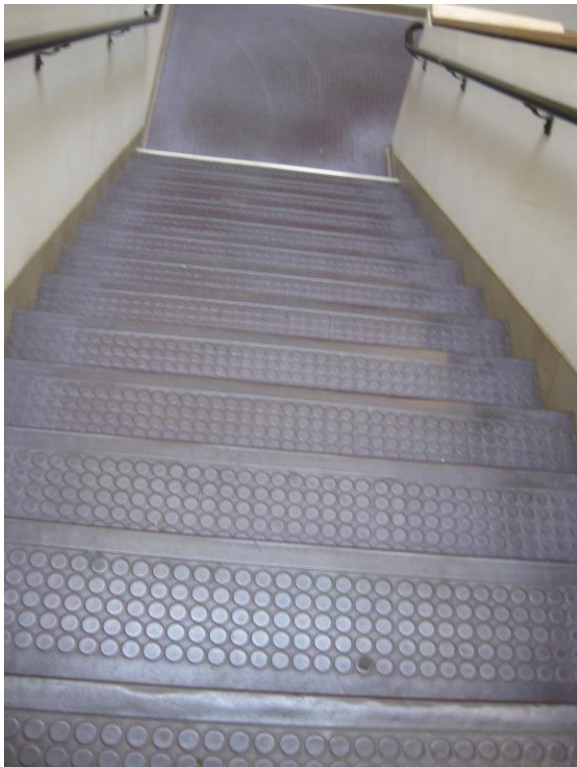
ST2. Library interior stairs; upper and lower visual warning stripes missing at stair nosings. Rubber treads worn and damaged.

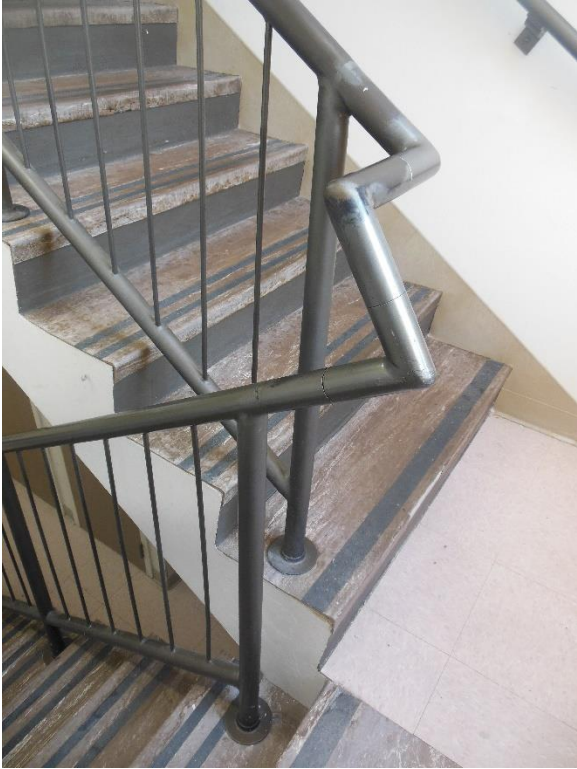
ST3. Stairwell 136; non-compliant handrail heights and returns.

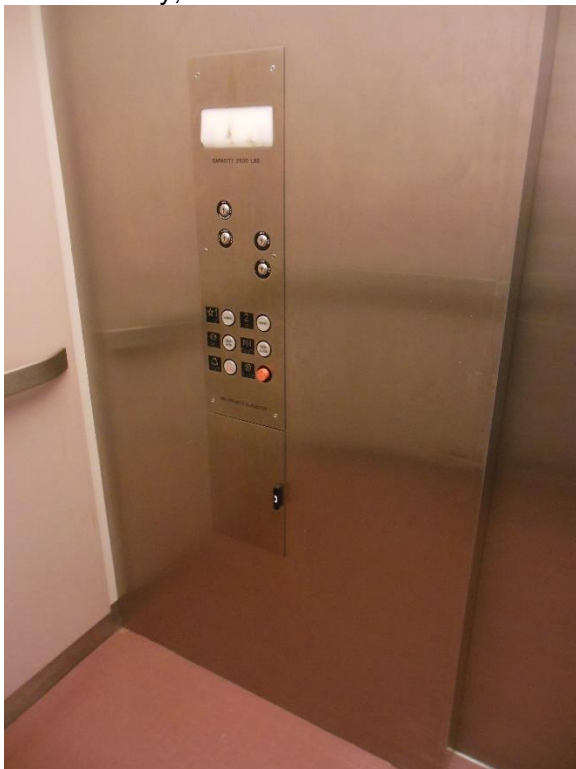
EV2. Elevator interior cab controls.

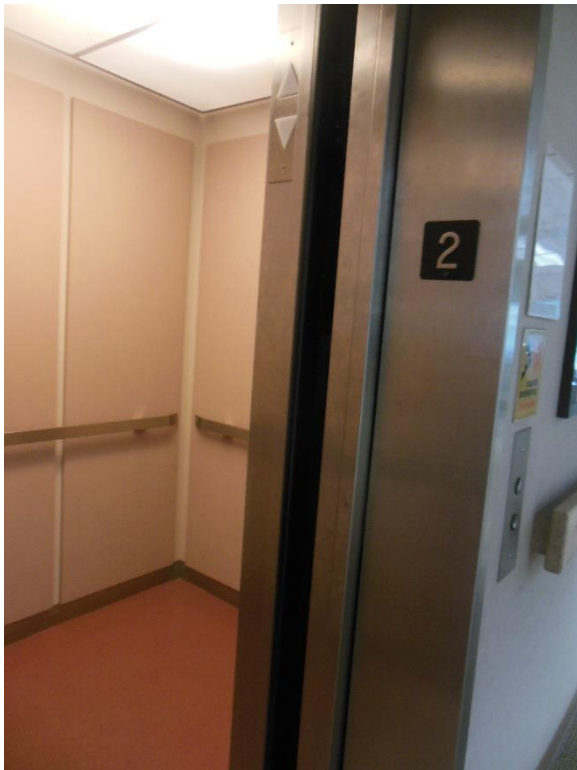
EV4. Elevator floor Braille sign at jamb.

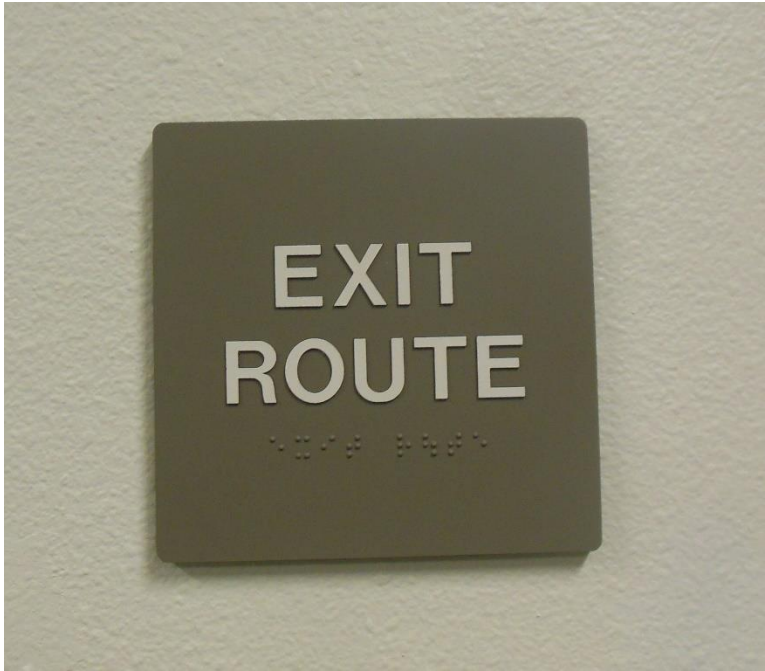
S1. Learning Center; ADA compliant exiting signage.

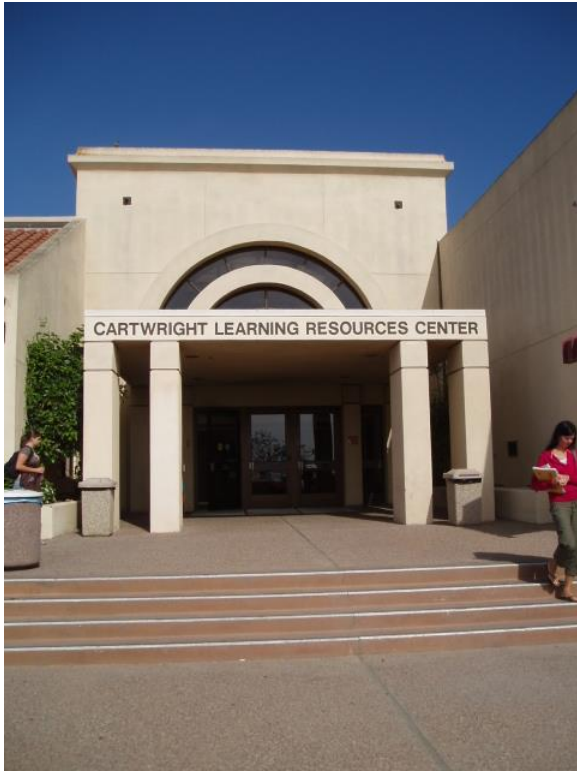
PT3. Main entrance, south side.  
Intermediate handrail at stairs required.

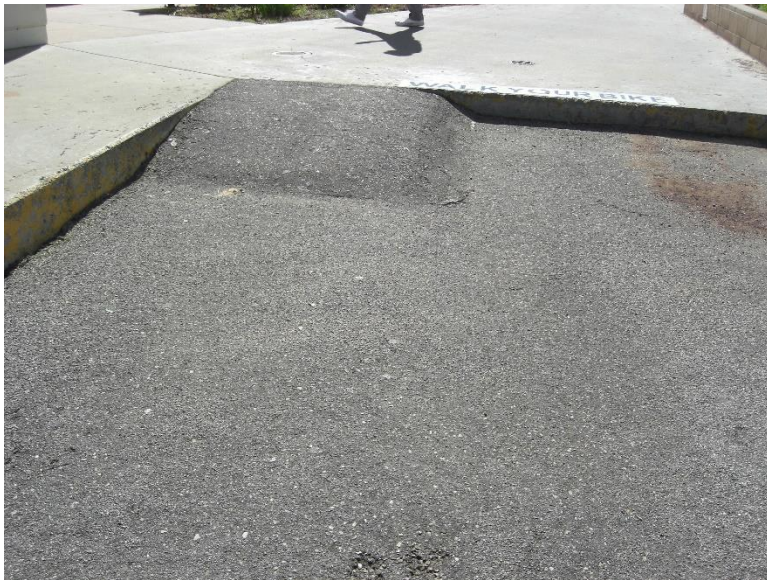
PT4. North side of building; non-compliant asphalt ramp.

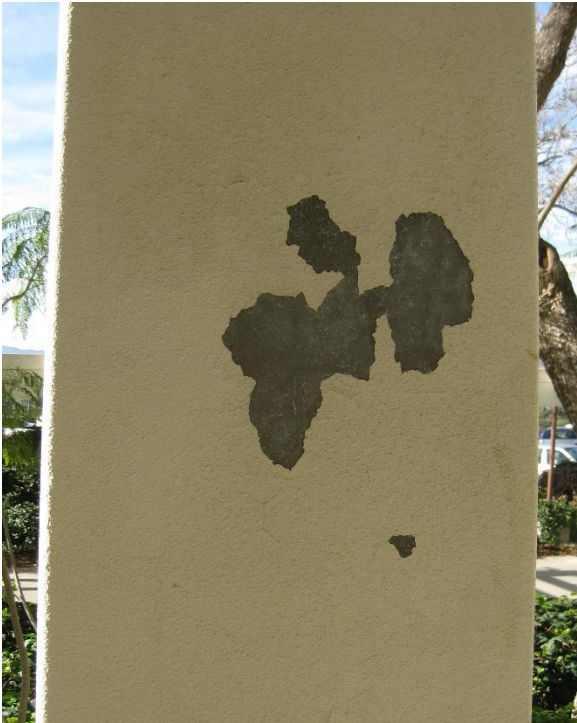
AE1. Exterior columns; peeling plaster paint.

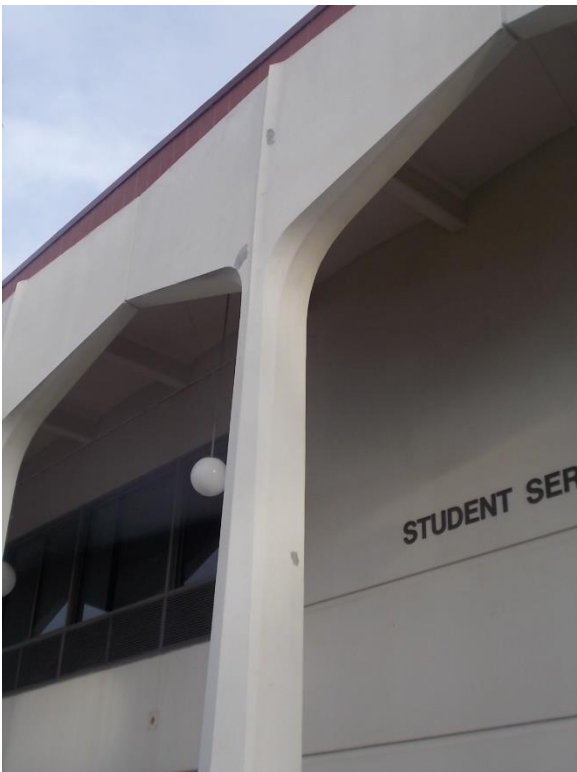
AE2. Exterior walls; peeling plaster paint.

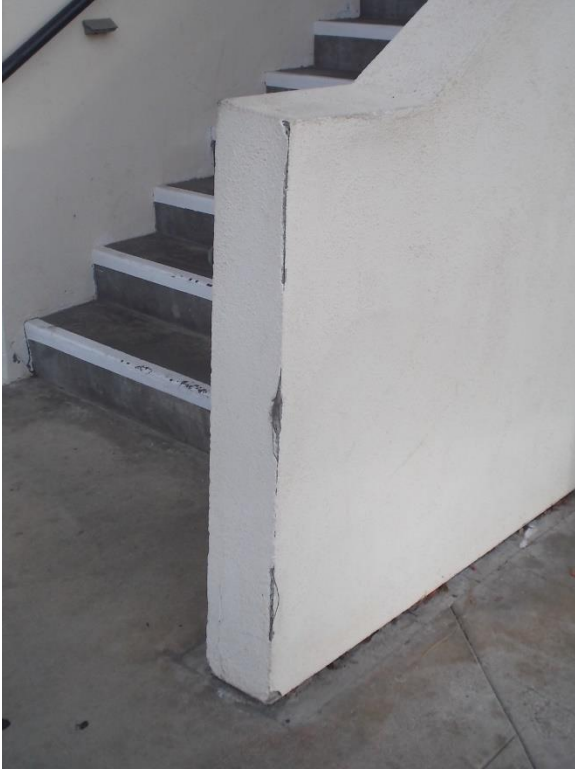
AE3. Exterior half wall; damaged plaster and paint.at corner condition.

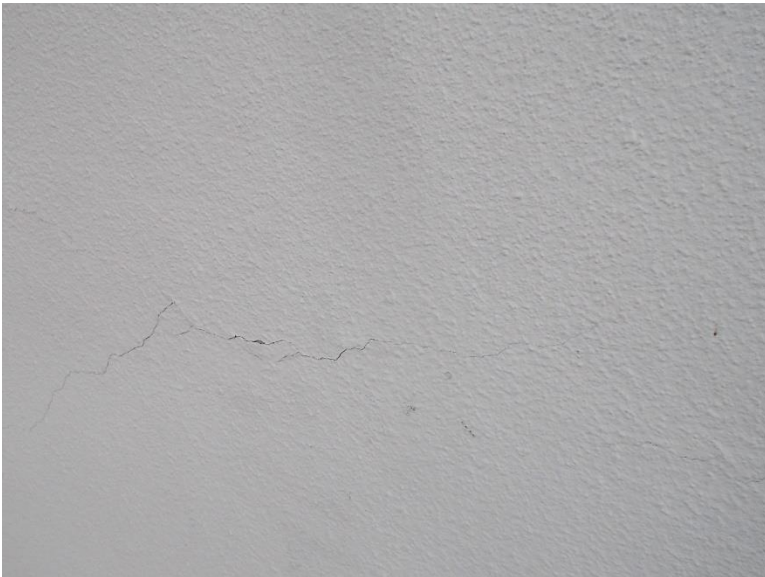
**WALLS:** The exterior painted plaster wall finish is in overall fair condition, with various locations of peeling paint and hairline cracks that require repair and repainting.

AE4. Exterior wall; cracked plaster finish.

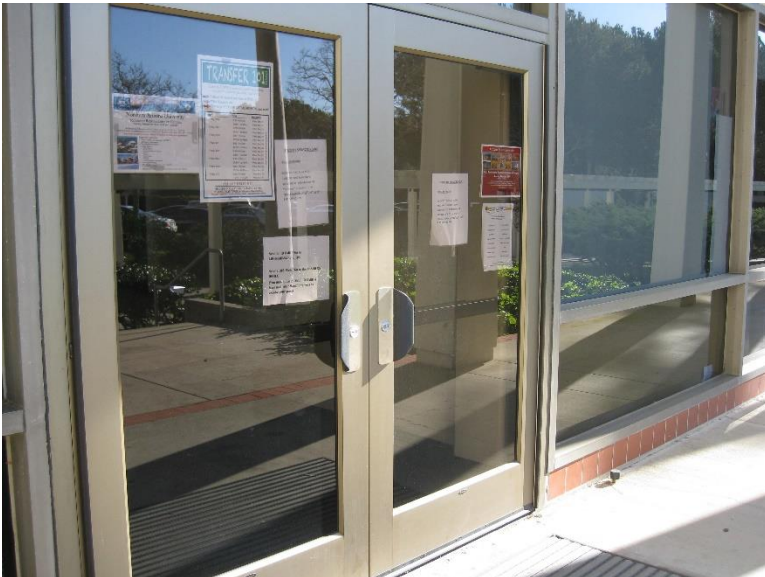
D2. North side entrance; ISA sign not installed.

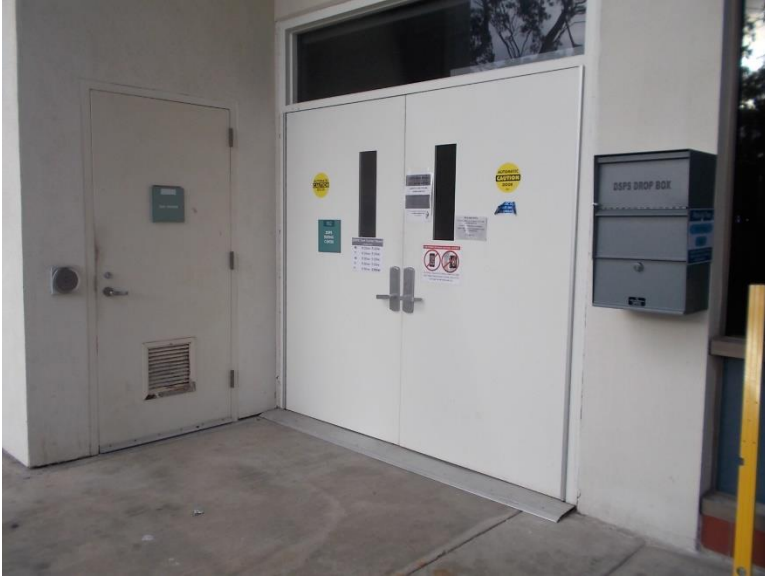
- Doors - The wood door stain and lacquer finishes show wear and should be refinished. The exterior pair of doors leading into the Disabled Student Programs and Services testing lab, does not have a compliant threshold. Doors with electronic door openers do not provide the code required lower-level push plates.

D3. DSPS Testing Lab; non-compliant threshold.

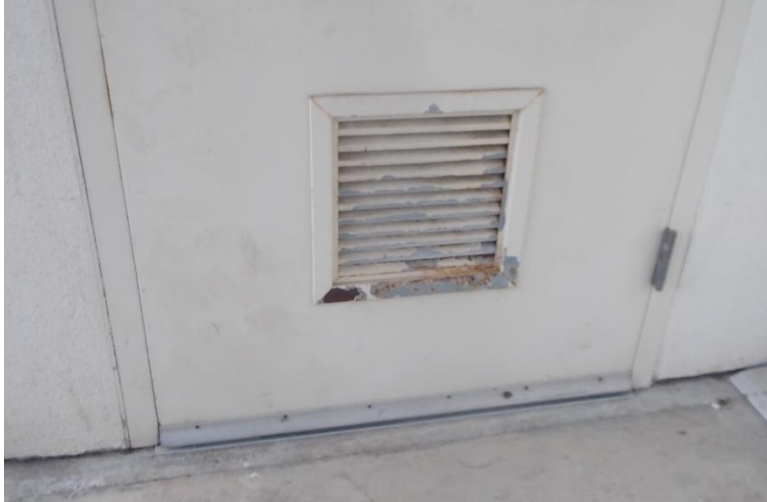
D5. Storage 164 door; damaged louver.

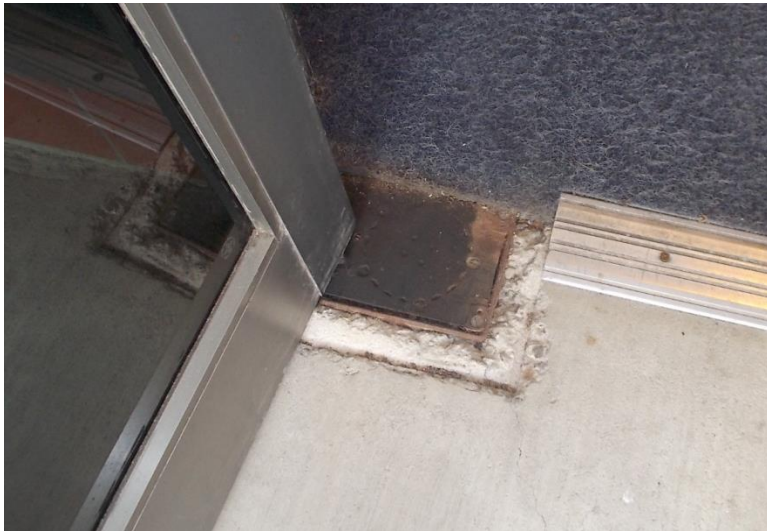
D6. West side entrance; door floor operator with exposed concrete.

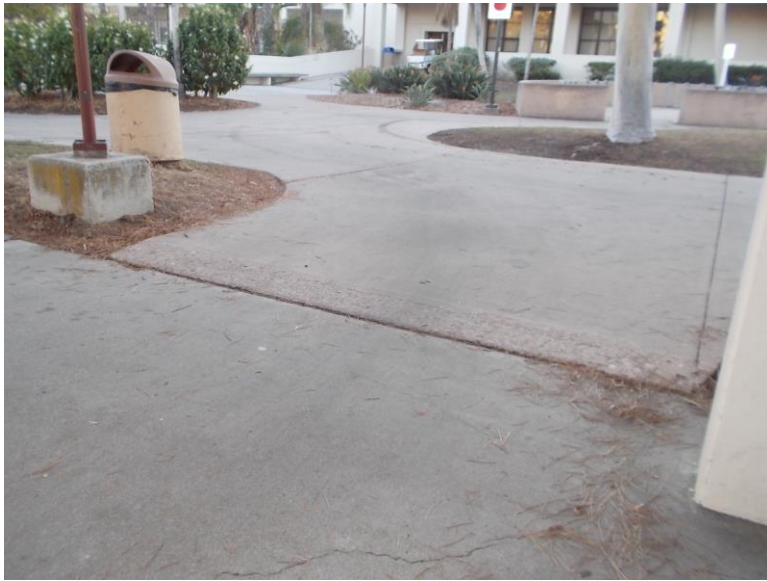
EF1. Exterior walkway; abrupt changes in level.

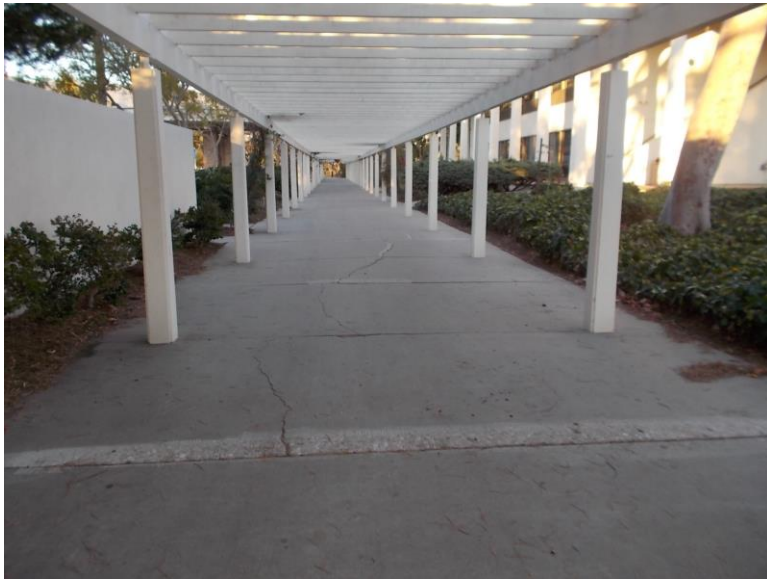
EF2. Exterior walkway; cracked concrete, excessive slopes, and abrupt changes in level. End of walkway terminates into fire truck lane.

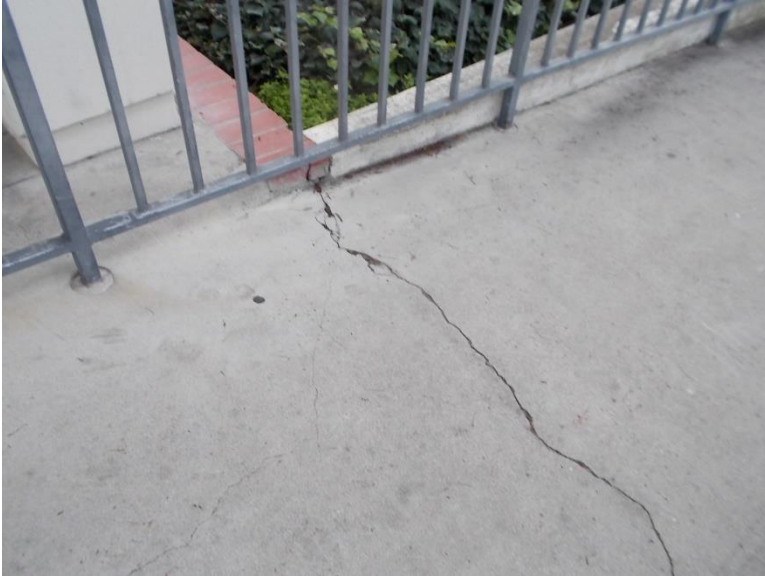
EF3. Northeast exterior walkway at top of ramp; cracked concrete.

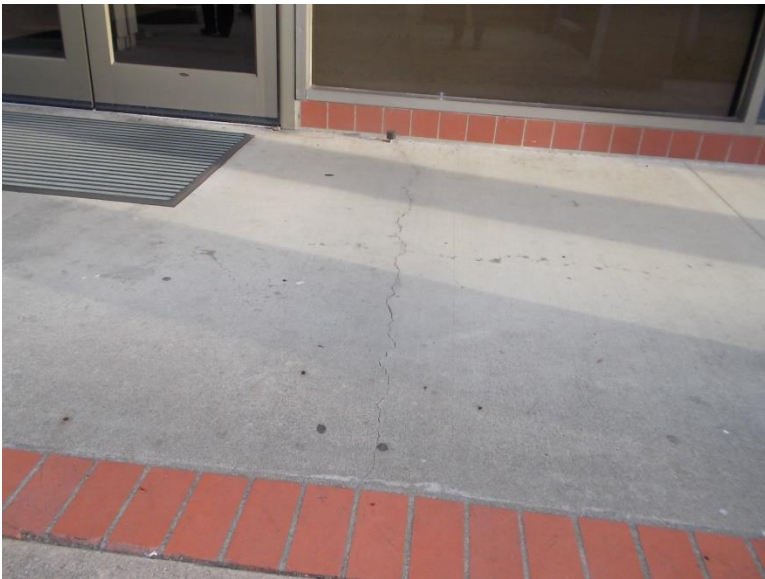
EF4. North side entrance; cracked concrete walkway.

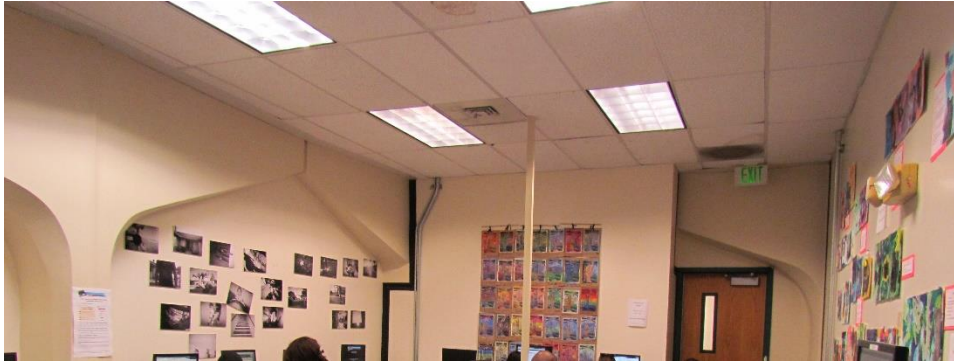
AI3. Second floor Atrium infill space; awkward wall transitions.

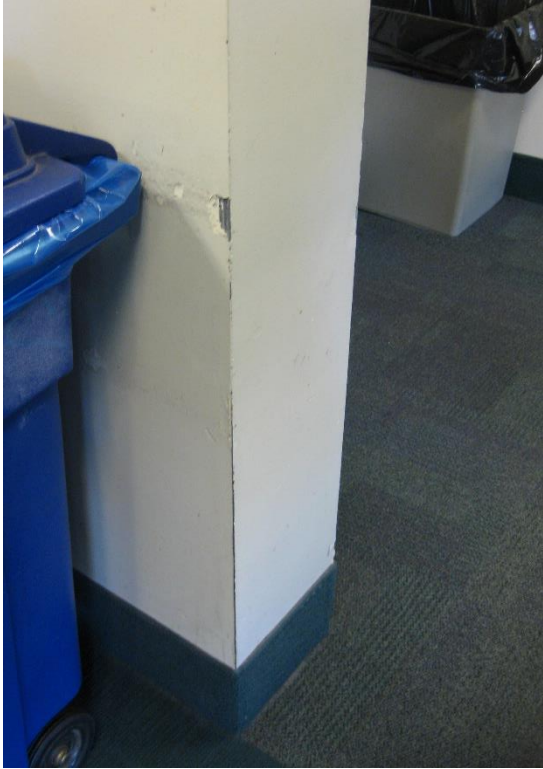
A15. Wing wall damaged corner.

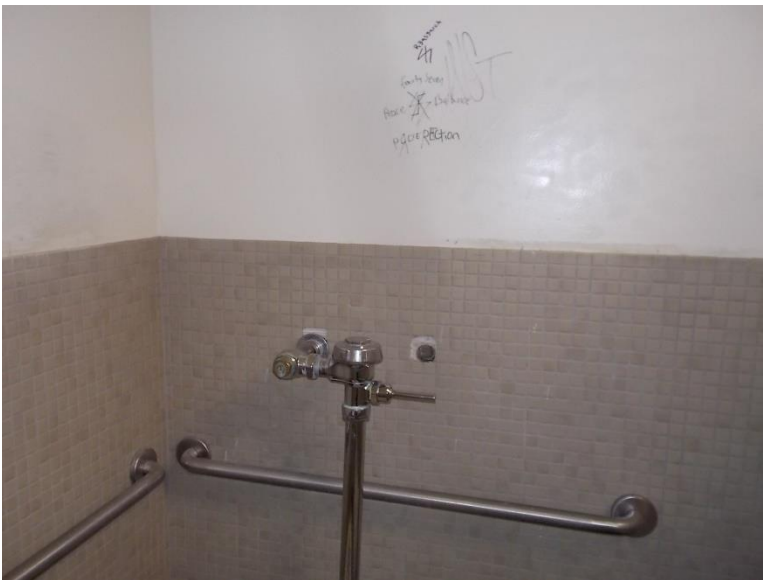
A17. Men's Restroom accessible stall; ceramic wall finishes have holes, and graffiti on wall finish.

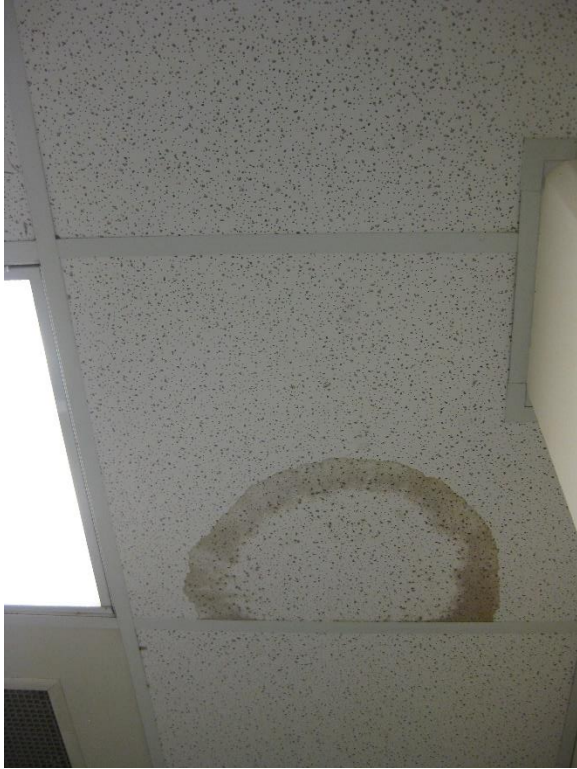
C4. Suspended ceiling tile; stained.

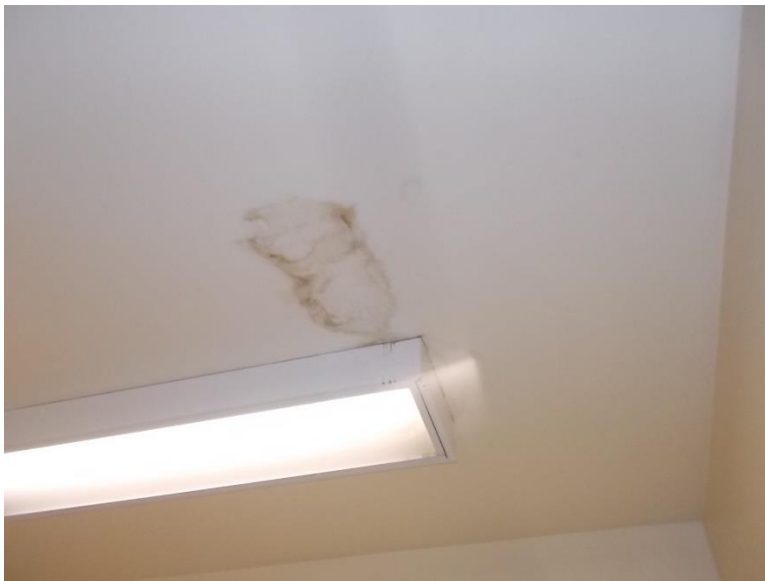
C5. Second floor Women's Restroom; gypsum board ceiling stained.

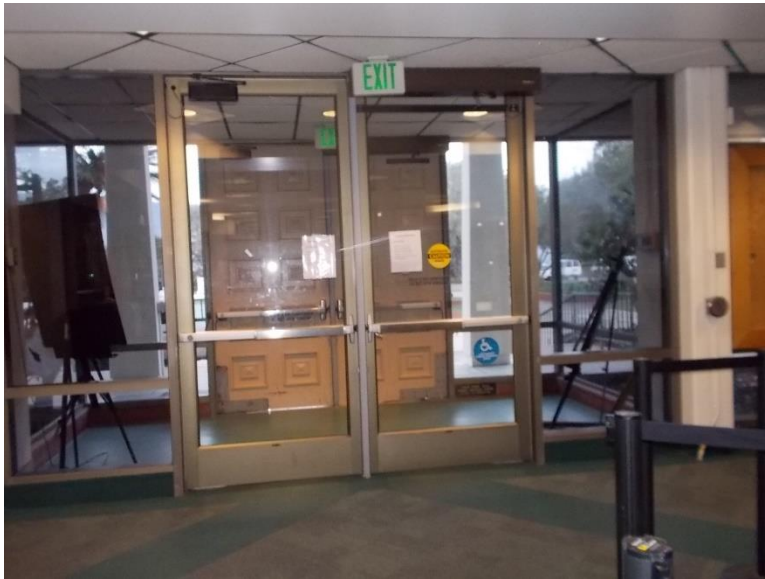
D1. First floor north east exit; electronic door operator low level access button required by code is not installed, and tactile exit signage not provided.

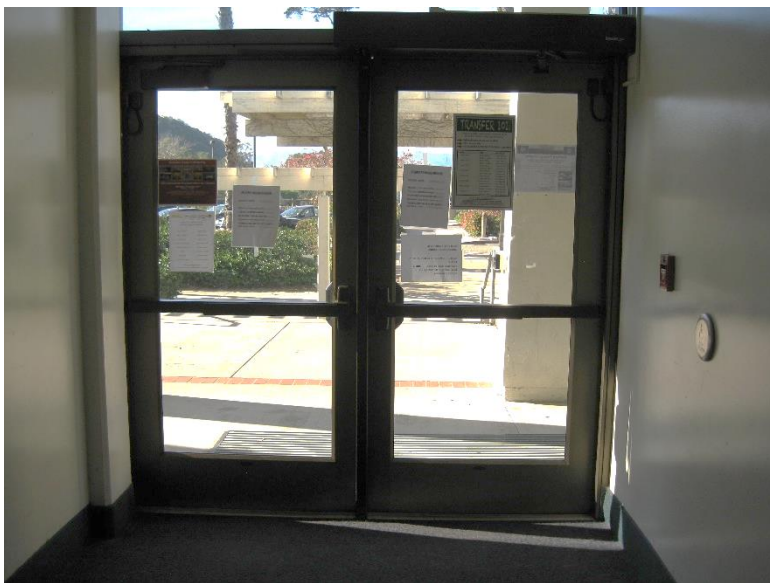
D2. First floor exit; electronic door operator low level access button required by code is not installed, and tactile exit signage not provided.

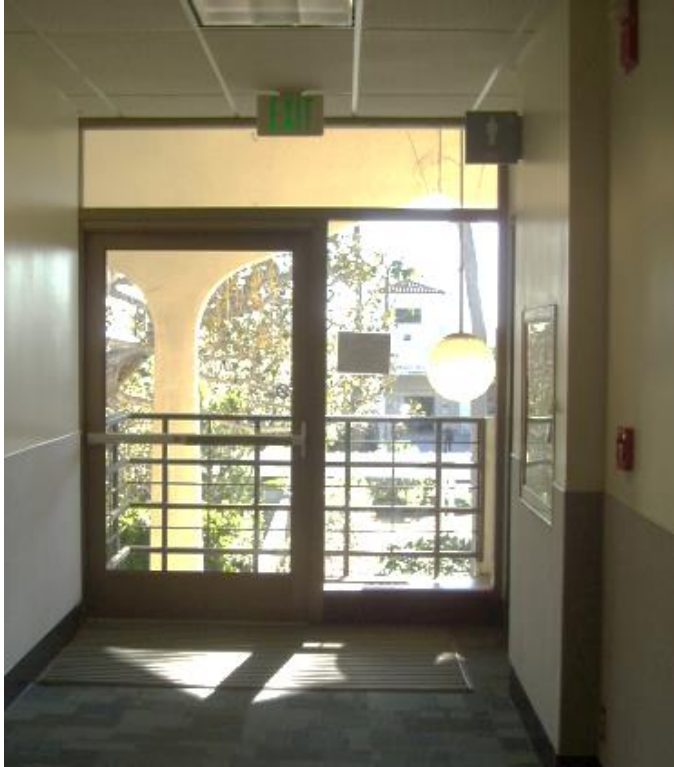
D3. Second floor exit to stairs; tactile exiting signage not provided.

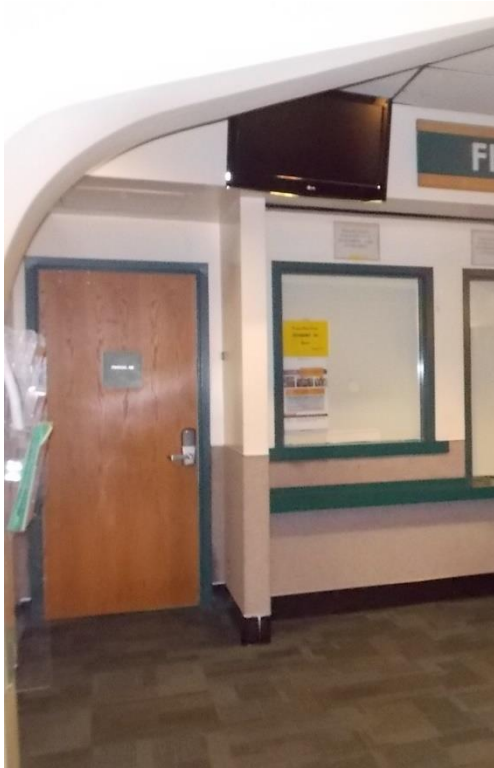
D4. Second floor office; pull-side clearance not met.

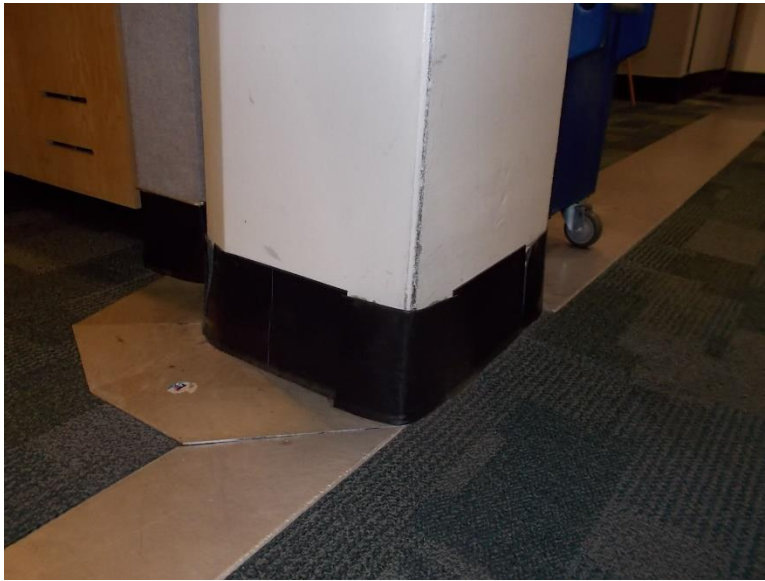
IF1. Second floor Atrium infill space; building expansion joint cover lifted, and rubber base damaged.

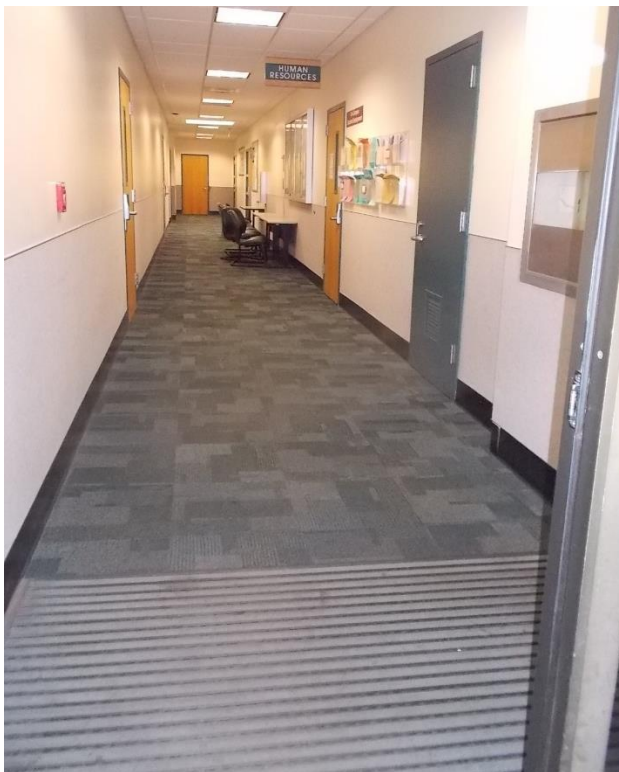
IF2. Second floor corridor; carpet tile, walk-off mat and rubber base in good condition.

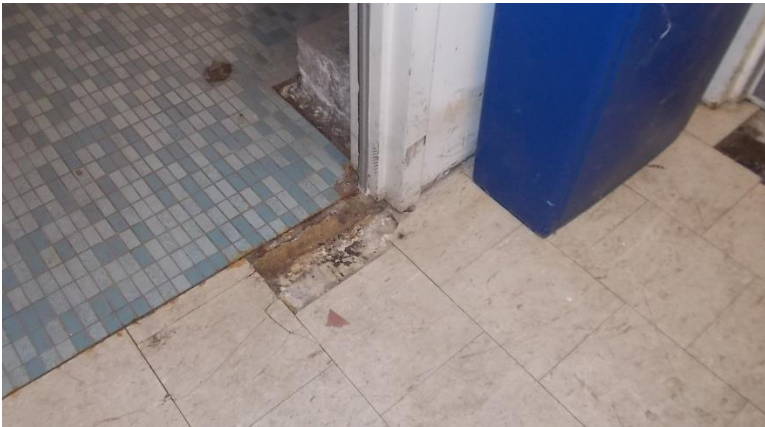
IF4. Basement; 9x9 VAT flooring damage.

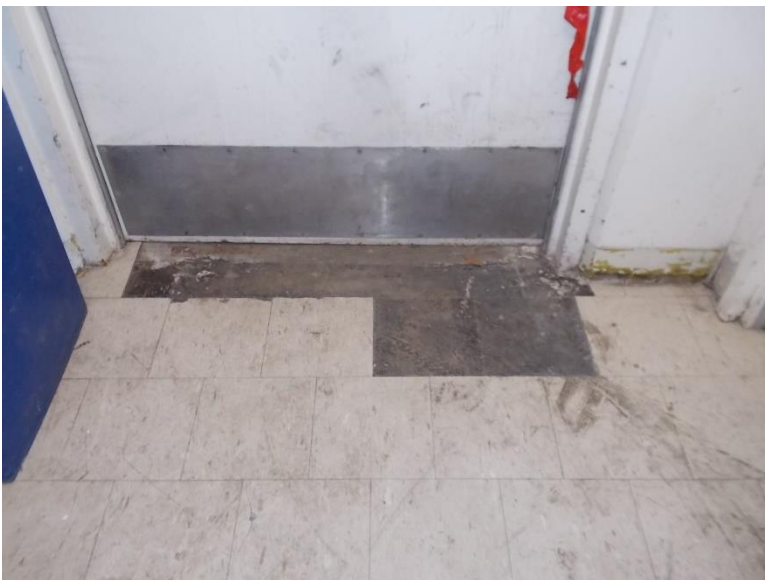
IF5. Basement; 9x9 VAT flooring damage.

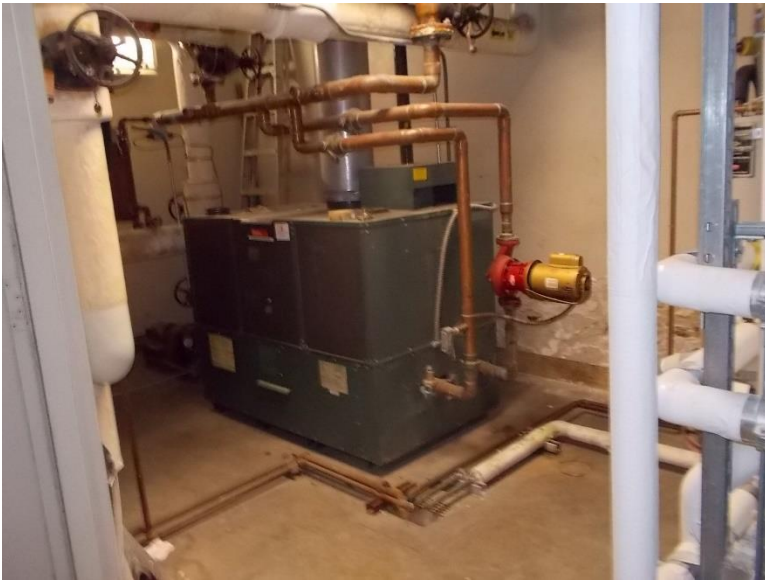
M1. Boiler in basement.

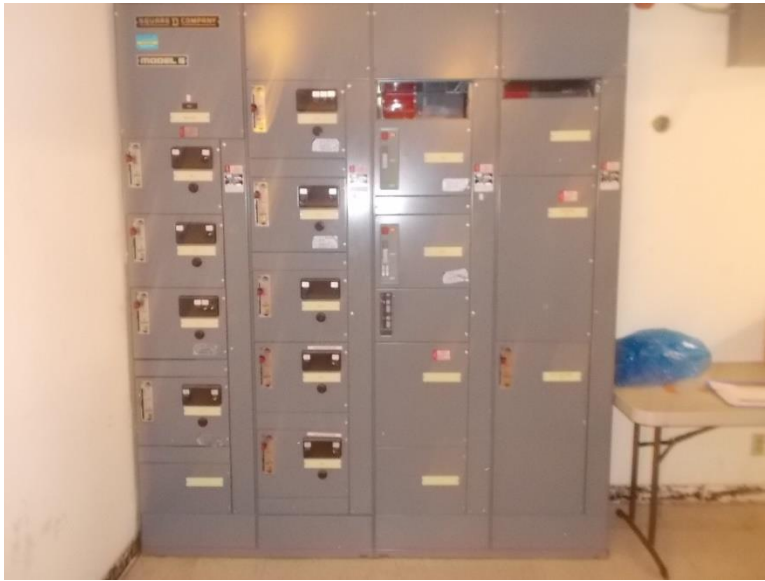
E1. Electrical equipment.

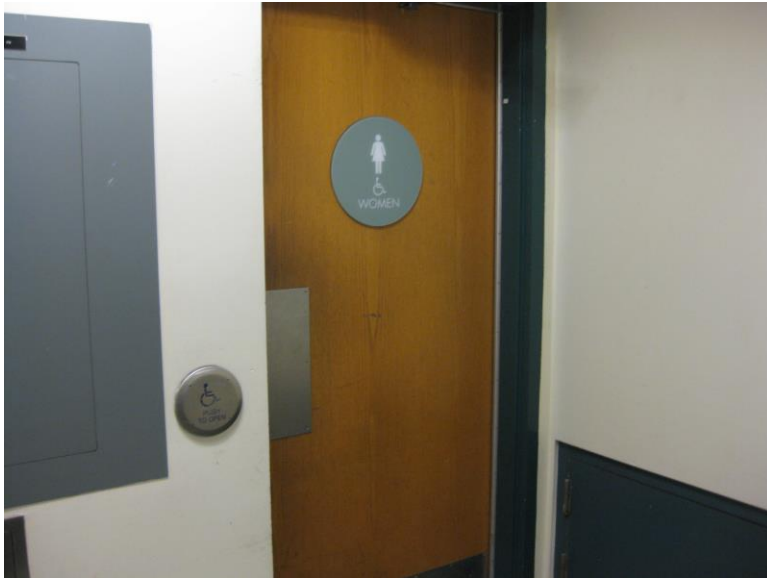
RR1. Women's Restroom; wall mounted ADA signage and electronic door opener lower-level push plate not provided.

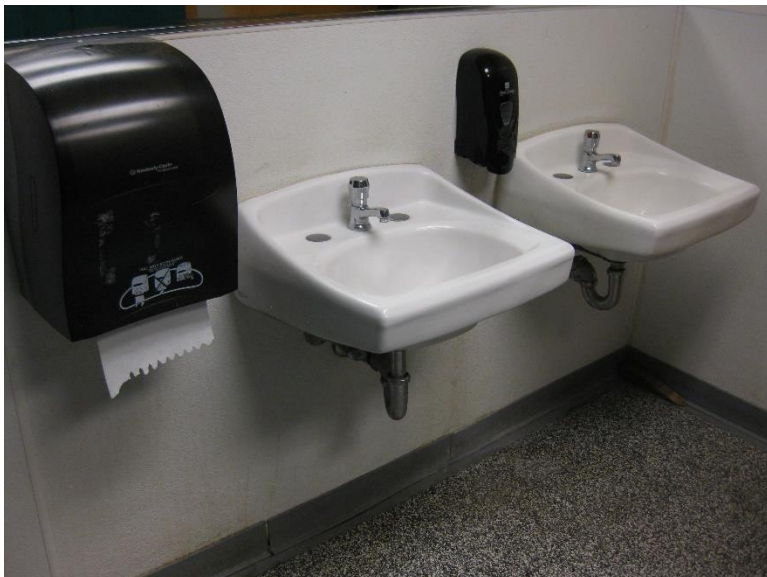
RR2. Sink does not provide paddle faucet fixture handles, knee protection is not provided at under sink plumbing traps.

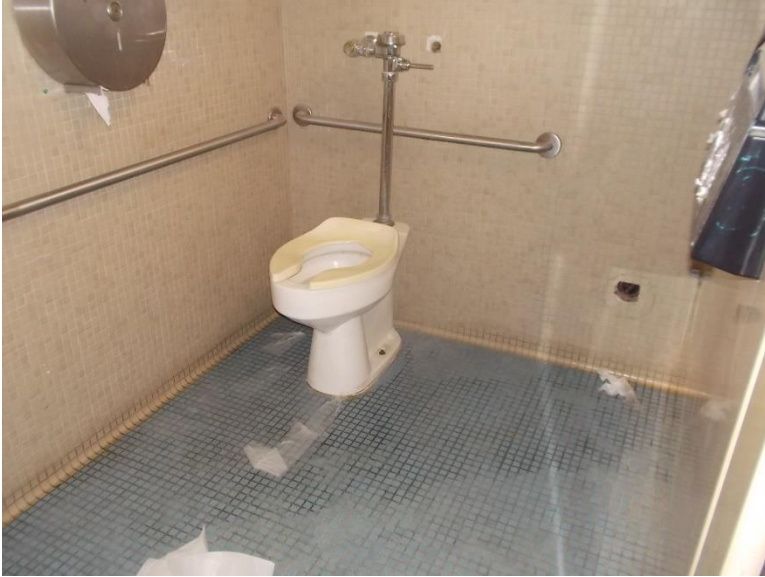
RR3. Men's Restroom accessible stall; ceramic wall finishes have holes and dispenser mounting location interferes with the required clear space above side handrail.

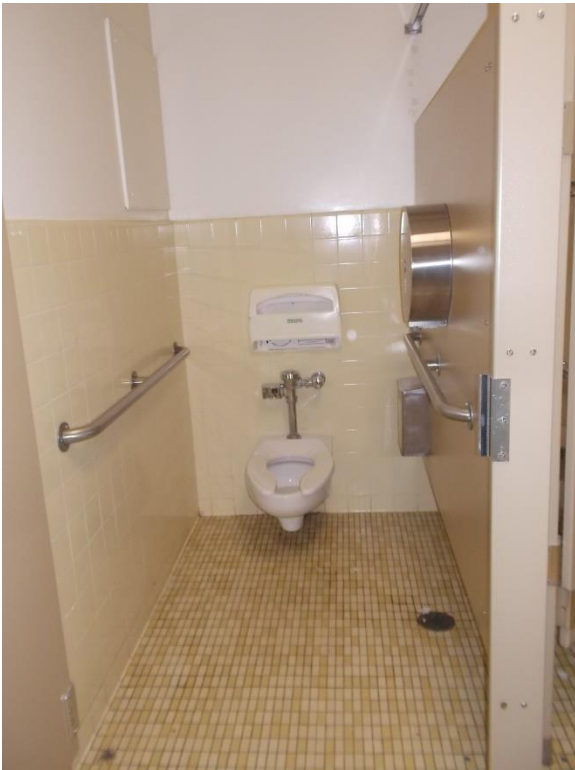
RR4. Women's Restroom ambulatory stall; wall finishes have holes and dispenser mounting location interferes with the required clear space above side handrail.

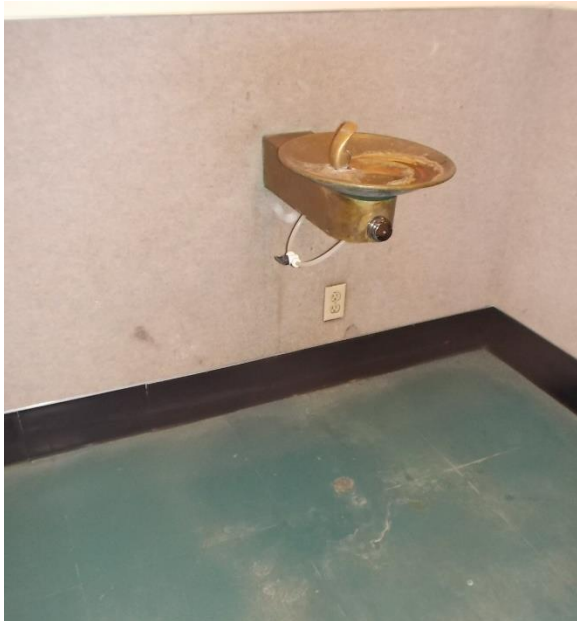
DF1. First floor single drinking fountain; hi-low drinking fountain not provided and flooring damaged.

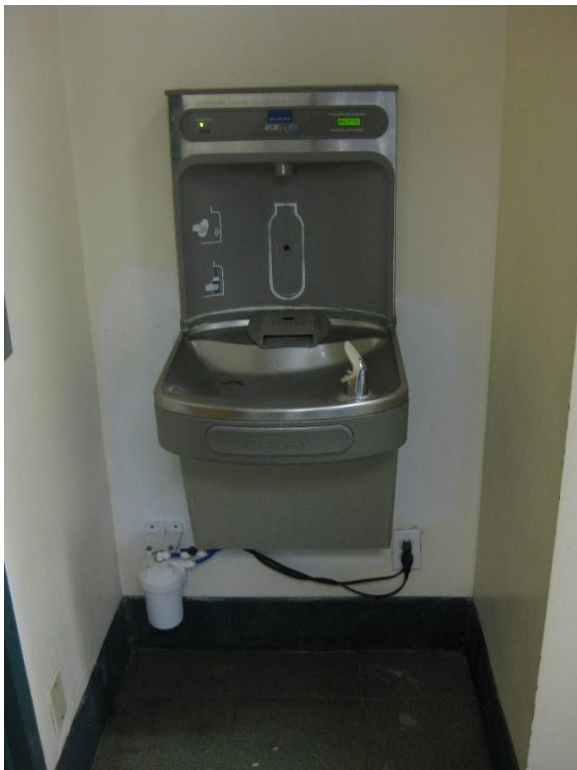
DF2. Bottle filling station/drinking fountain. Compliant maneuvering clearances not provided.

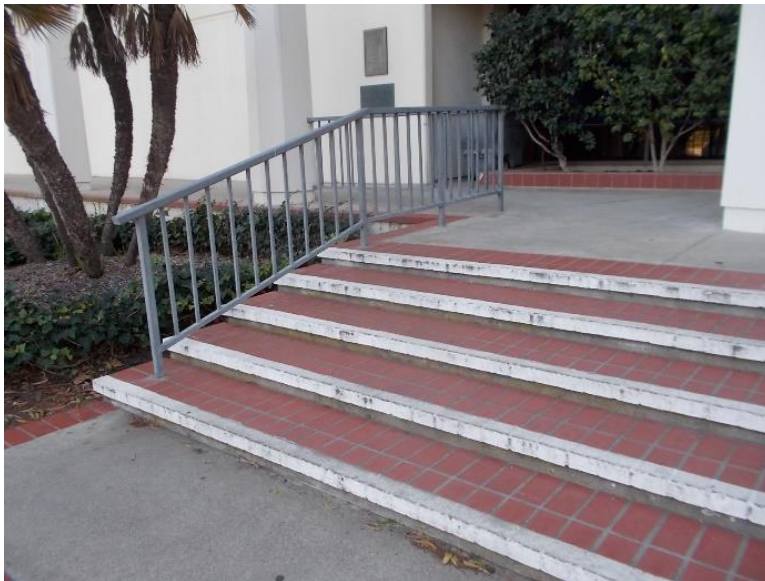
S2. Exterior east stairs; lower handrail extensions are non-existent, gripping surface is too wide, the top and bottom landings have excessive slope and are not level.

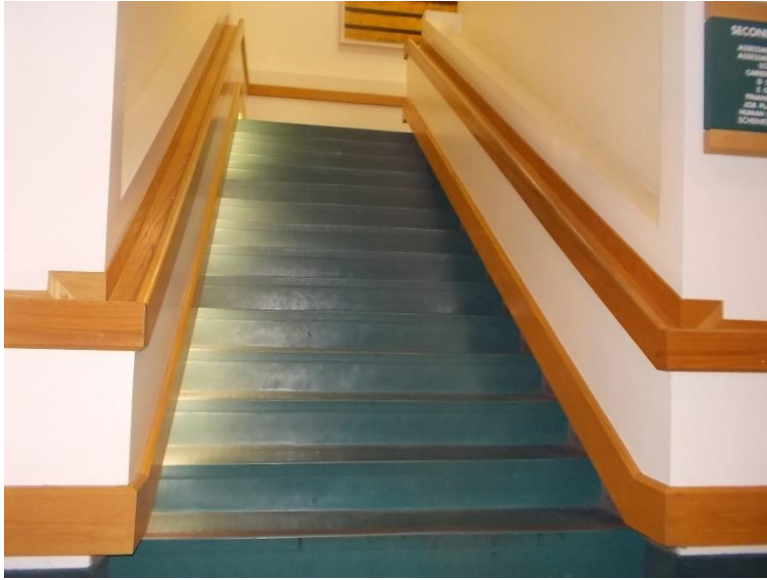
S3. Interior staircase; stair nosings not contrasting, handrails not compliant, and stair signage not provided.

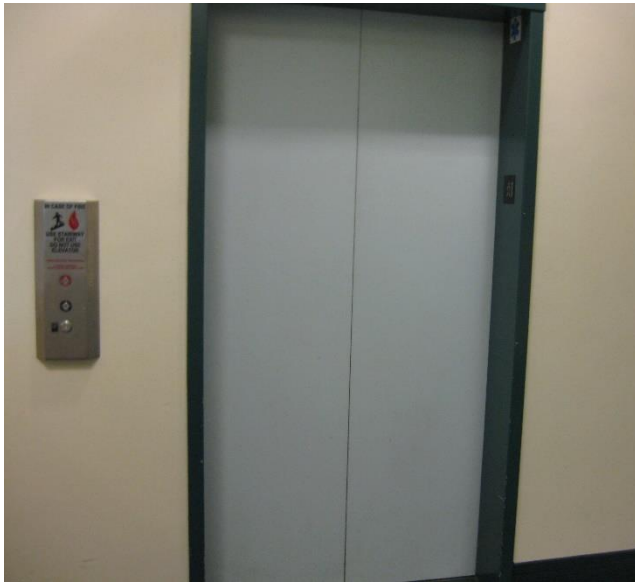
EV1. Elevator access to all floors.

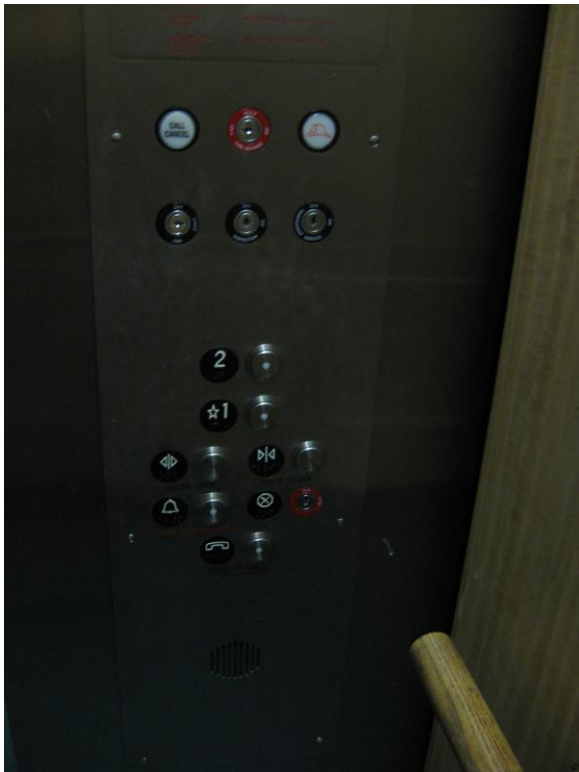
EV2. Elevator car interior.

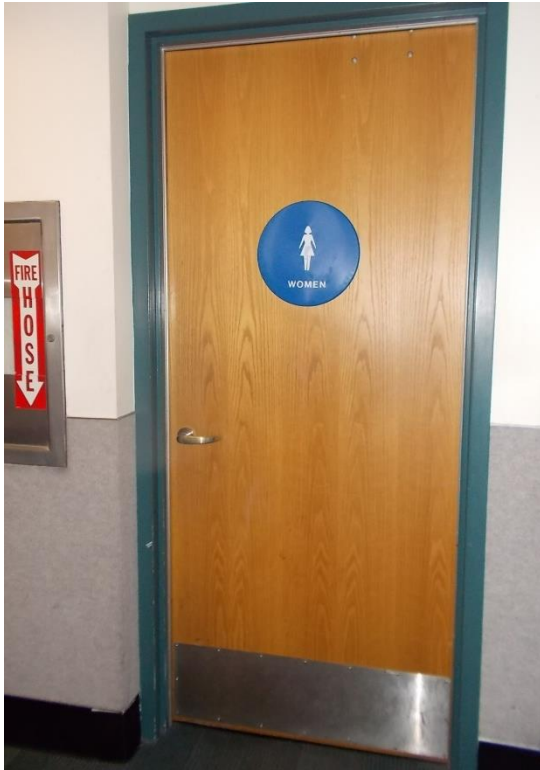
S1. Women's Restroom entrance; wall mounted room ID sign missing.

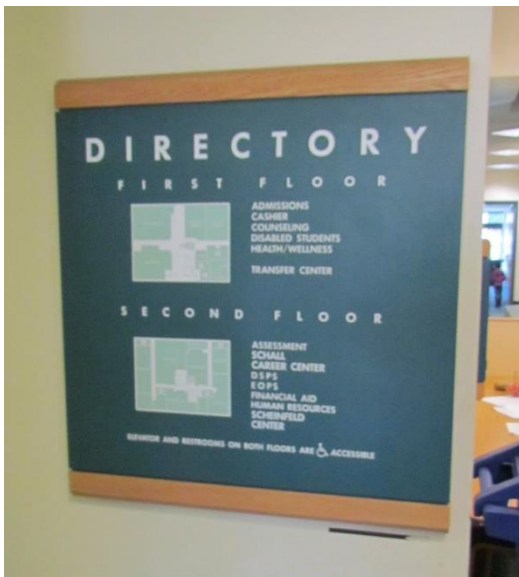
S2. Directory sign; no evacuation or other way finding signs are in the facility.

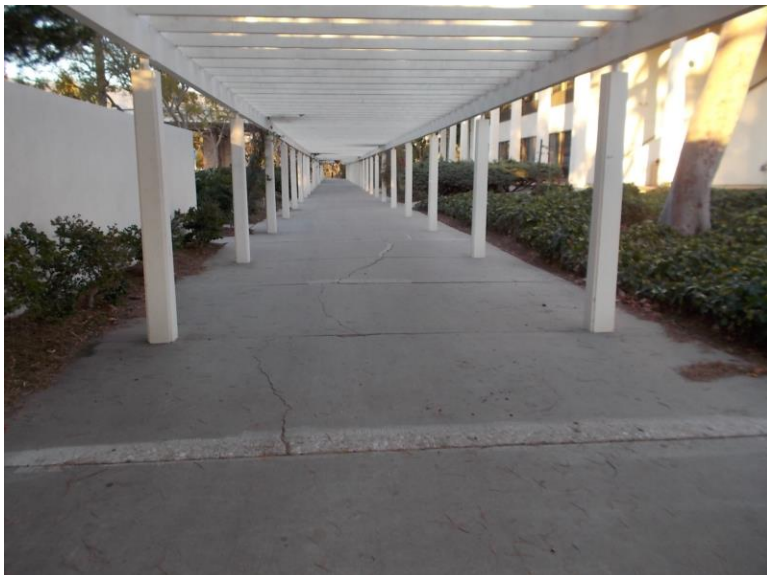
PT2. Exterior walkway Pergola; non-compliant path of travel. Concrete surface is cracked, uneven and has excessive cross slopes. ADA directional signage is not provided.

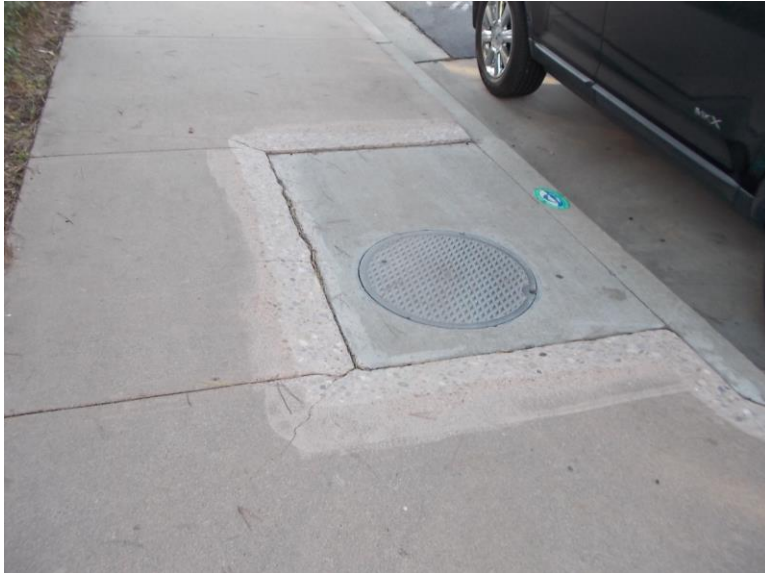
PT3. Exterior sidewalk; non-compliant path of travel. Abrupt changes in level.

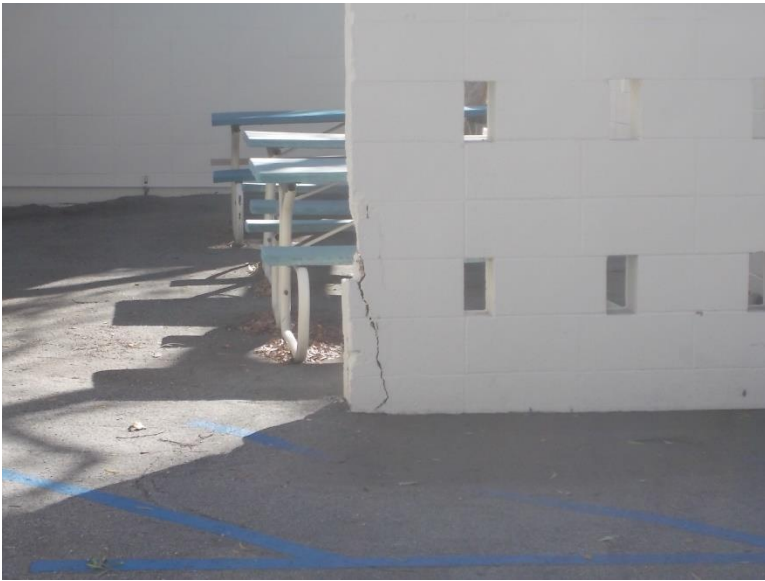
AE1. Exterior patio CMU wall; damaged.

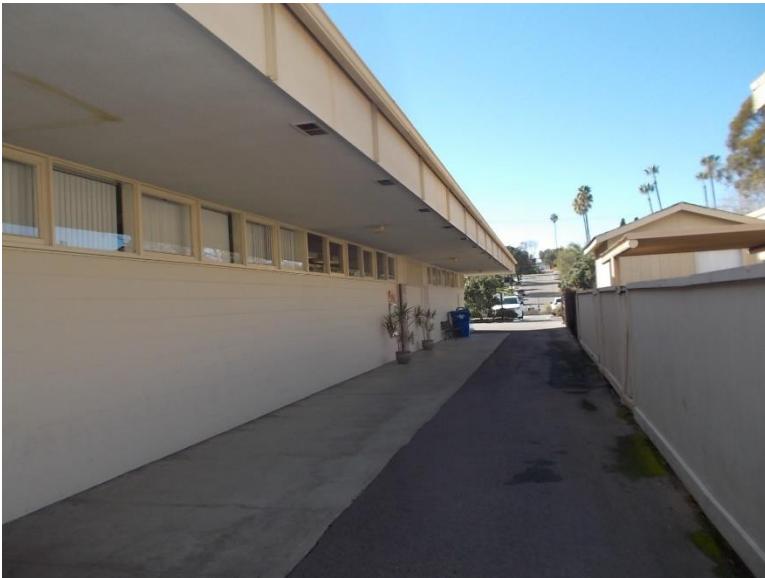
AE2. Exterior wall; painted CMU and wood, good condition.
