# SANTA BARBARA CITY COLLEGE

## ADA PATH OF TRAVEL ASSESSMENT

# Facility Condition Assessment Report ADMINISTRATION BUILDING

**Facility Condition Assessment Report**  
**Santa Barbara City College – Main Campus**  
**Administration Building**  
**721 Cliff Drive**  
**Santa Barbara, CA 93109**

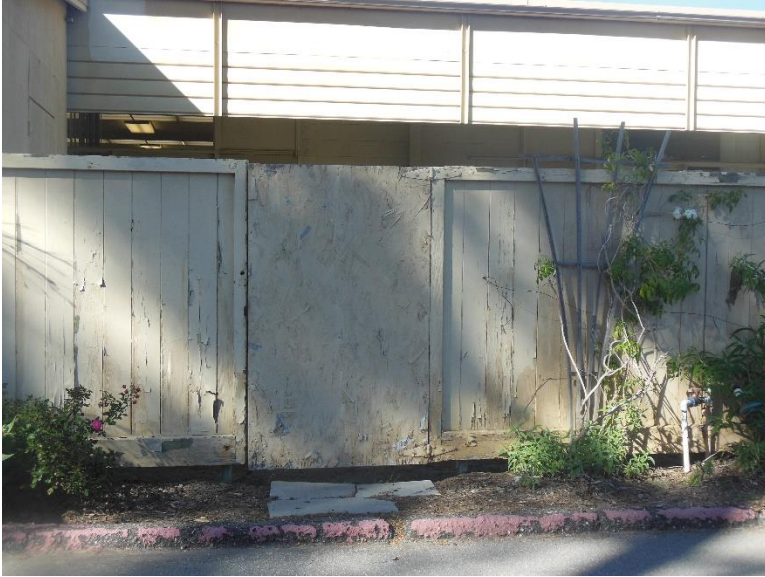
AE3. Exterior wood patio fence; damaged paint.

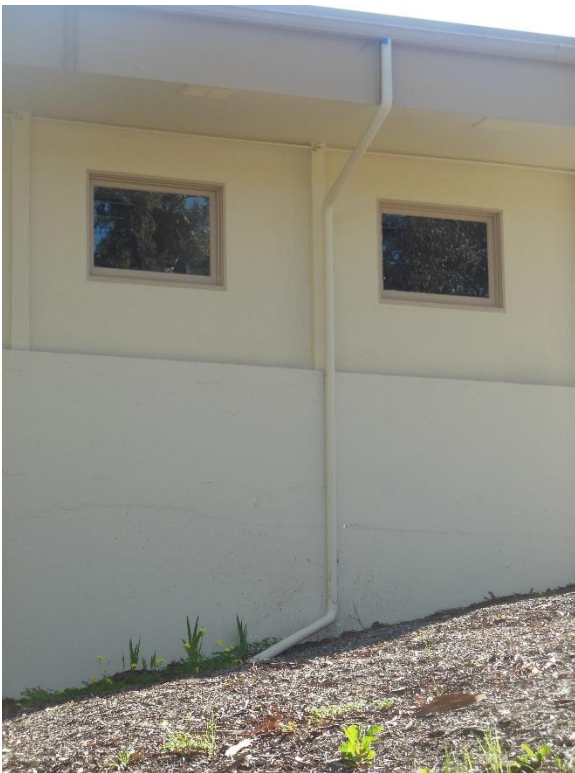
AE4. Exterior painted concrete and plaster.

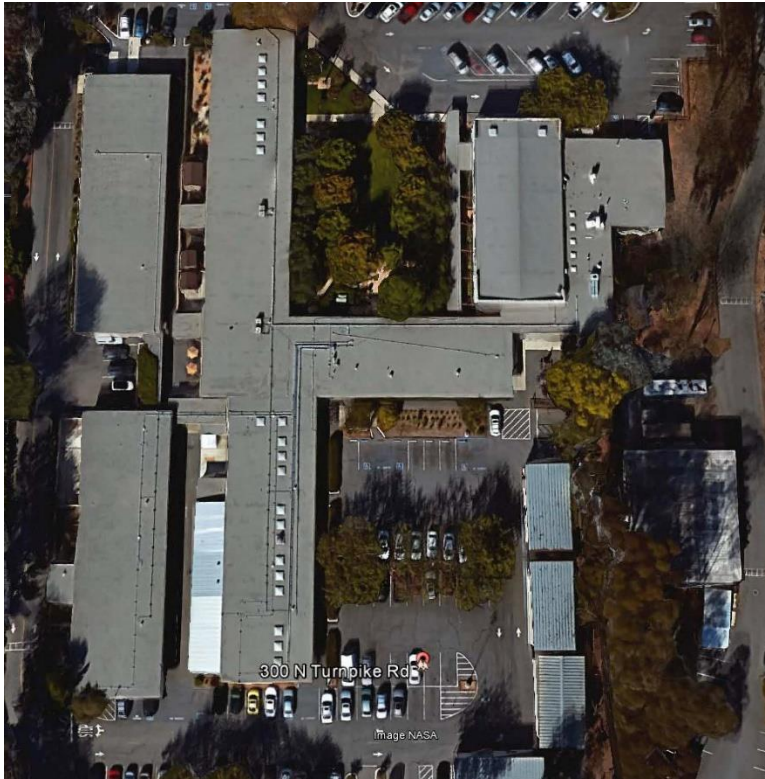
R1. Overall site; roofs.

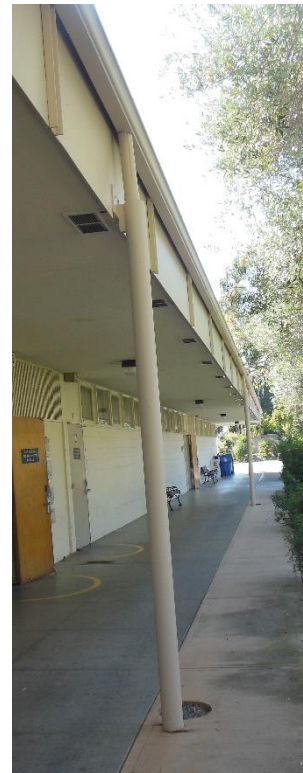
R2. Gutter and downspout.

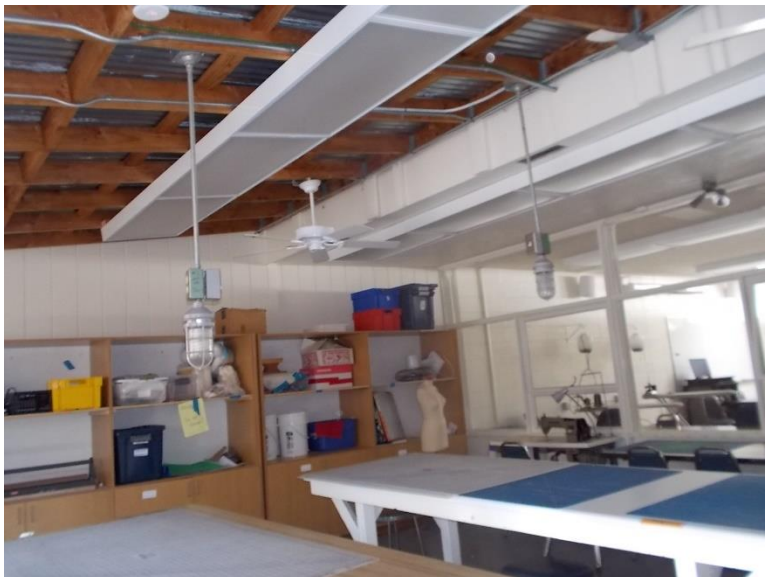
R3. Enclosed patio; underside of exposed roof structure.

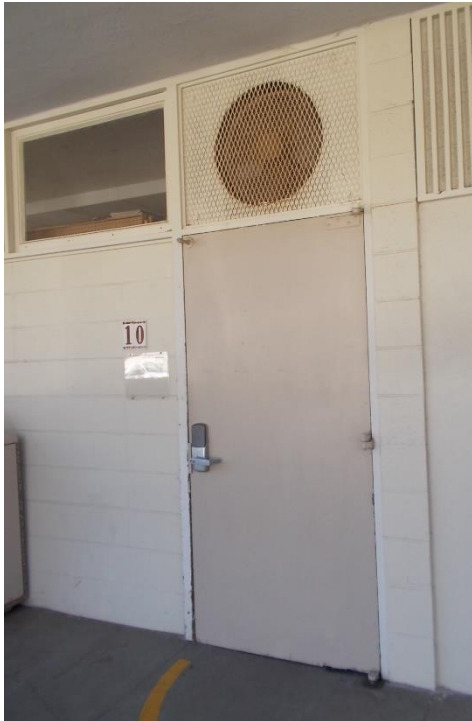
D1. Classroom 16; exterior door; fan in transom.

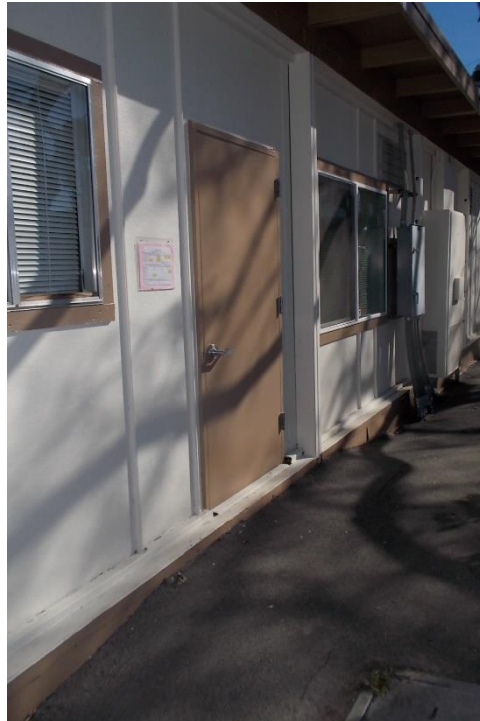
D2. Portable 22, excessive threshold height.

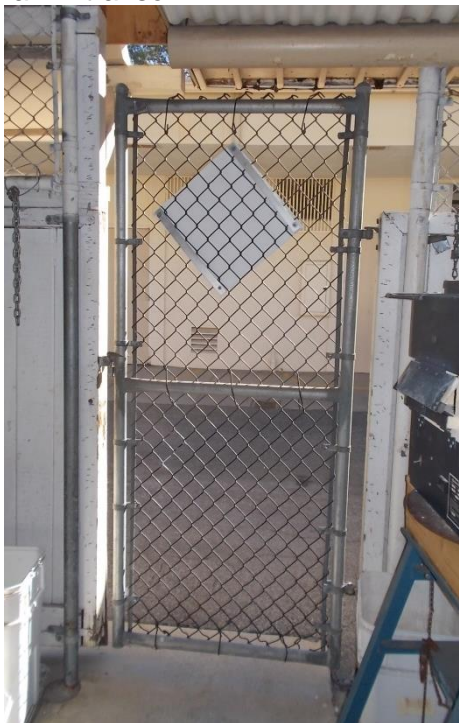
D3. Classroom patio; locked gate to exterior.

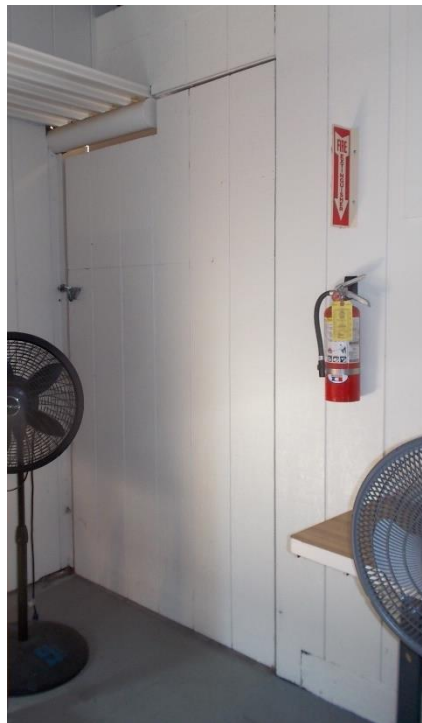
D4. Classroom patio; locked gate to exterior.

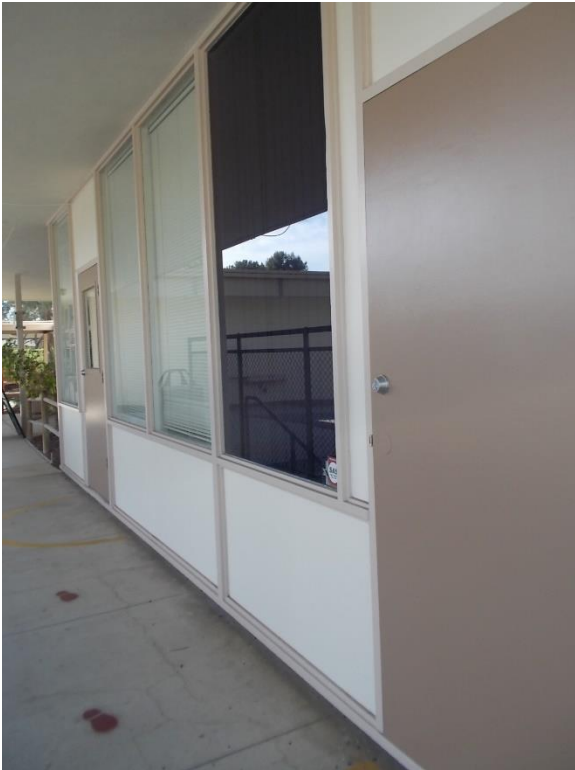
EW1. Exterior fixed wood windows; new paint.

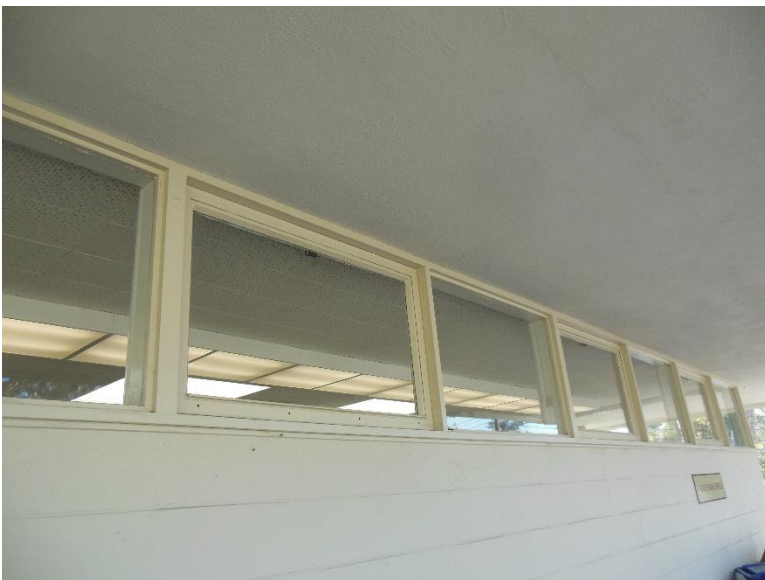
EW2. Exterior fixed wood windows; new paint.

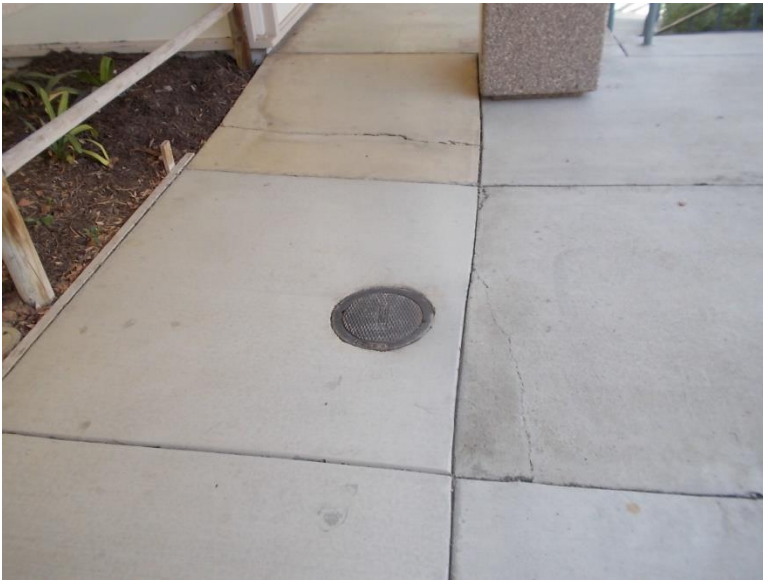
EF1. Exterior corridor walkway; cracked and degraded concrete.

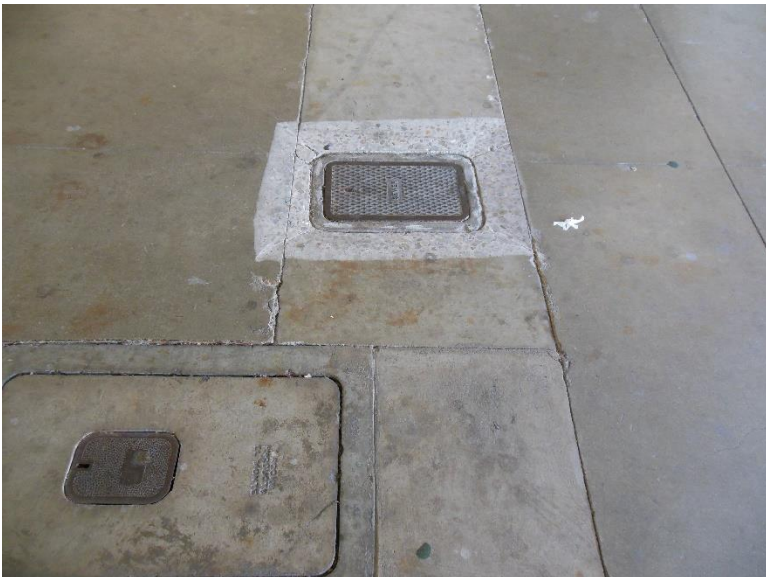
EF4. Exterior corridor walkway; abrupt changes in level.

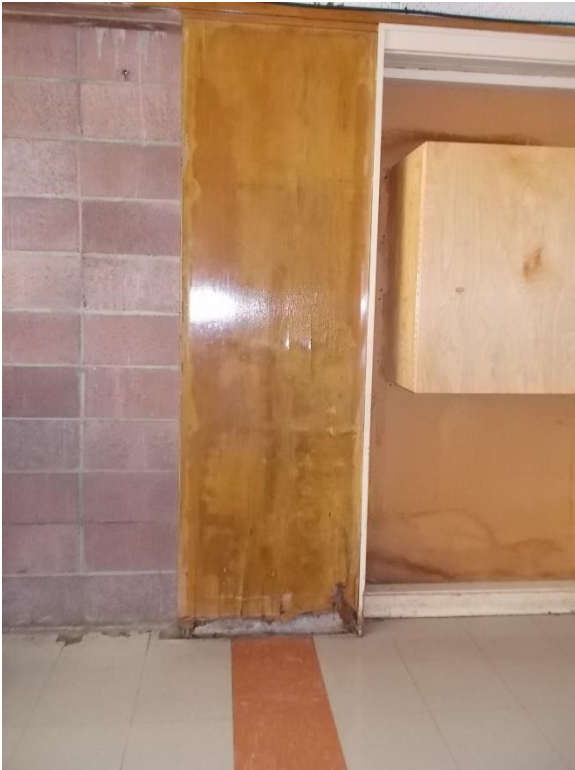
AI1. Auditorium; water damaged exposed CMU and wood finishes.

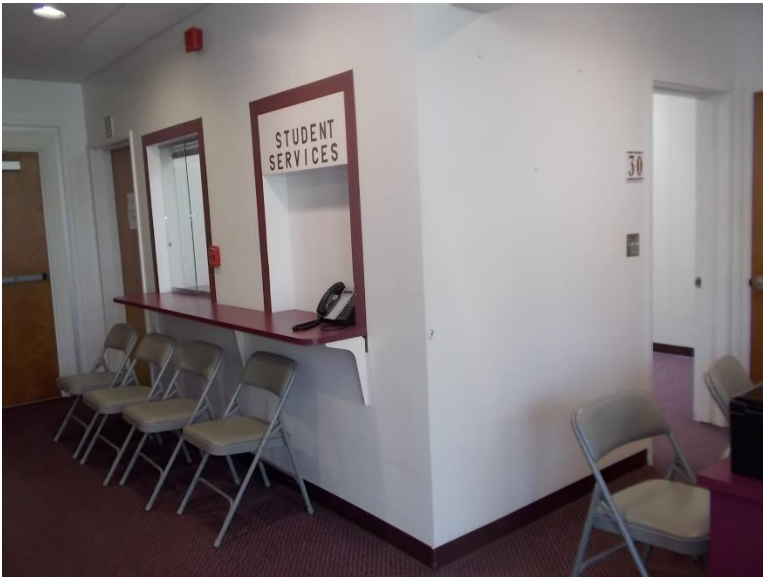
AI2. Office 29; painted drywall.

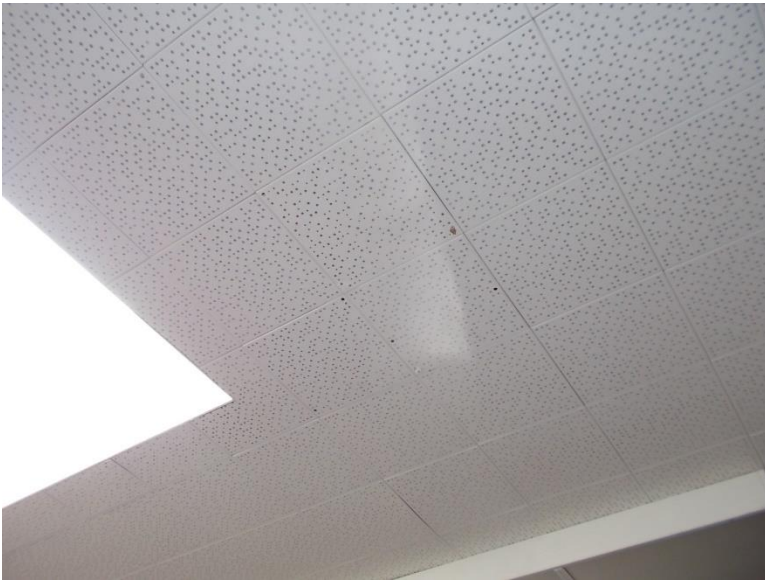
C1. Classroom; glue on ceiling tiles, typical.

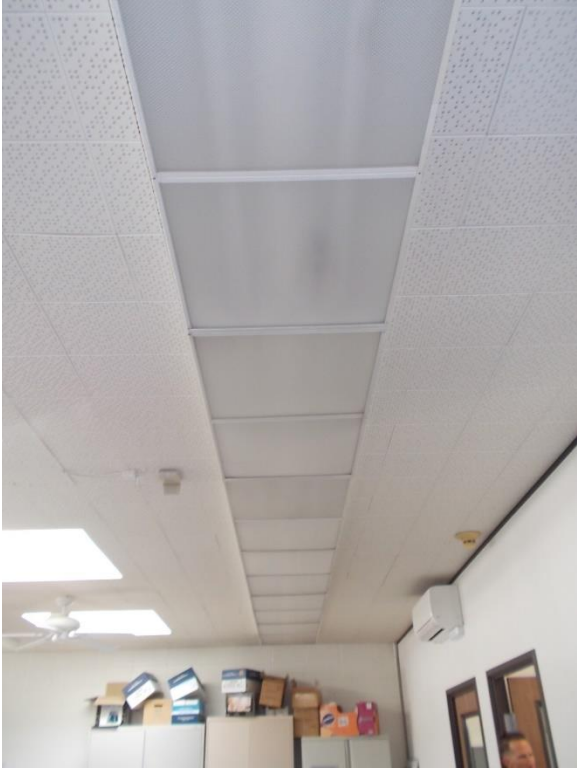
C3. Office 2; glue on ceiling tiles with surface mounted lights.

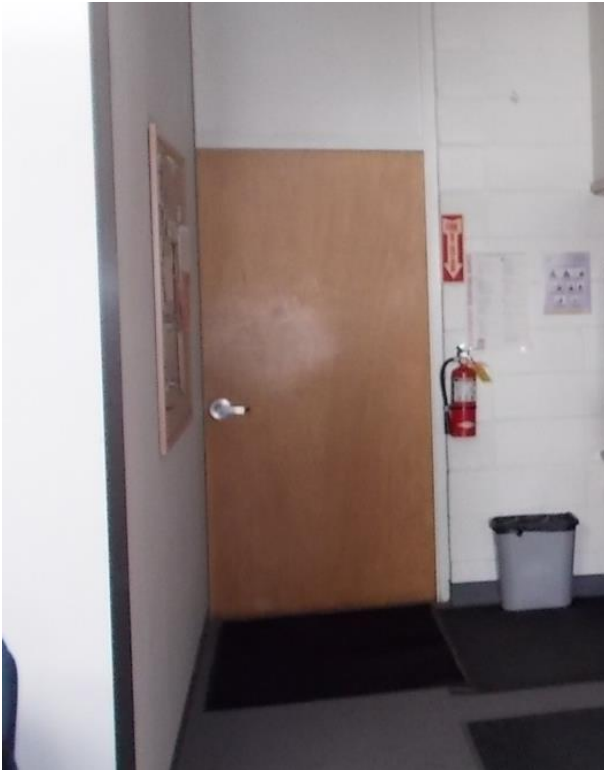
D1. Office 2; interior door.

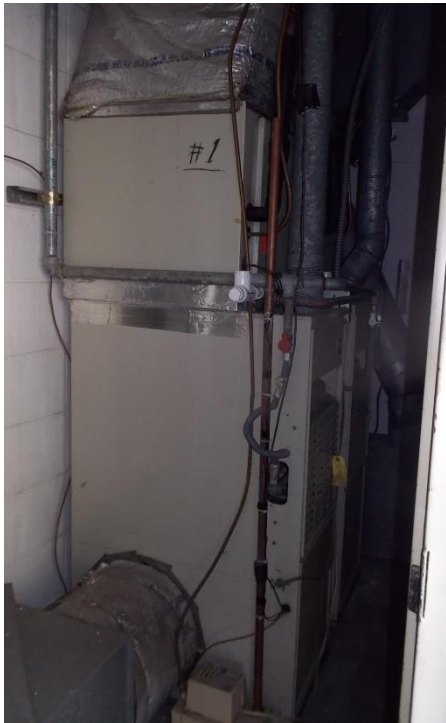
M1. Gas fired forced air heating units in mechanical closet, typical.

Forced air units, cooling coils, condensing units and controls are at the end of their useful life and should be replaced with high efficiency units with cooling coils and high efficiency condensers.

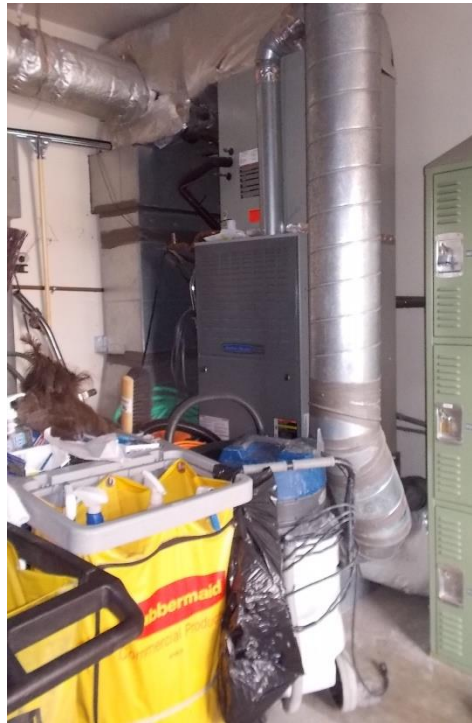
M2. Gas fired forced air heating units; clear floor space not provided.

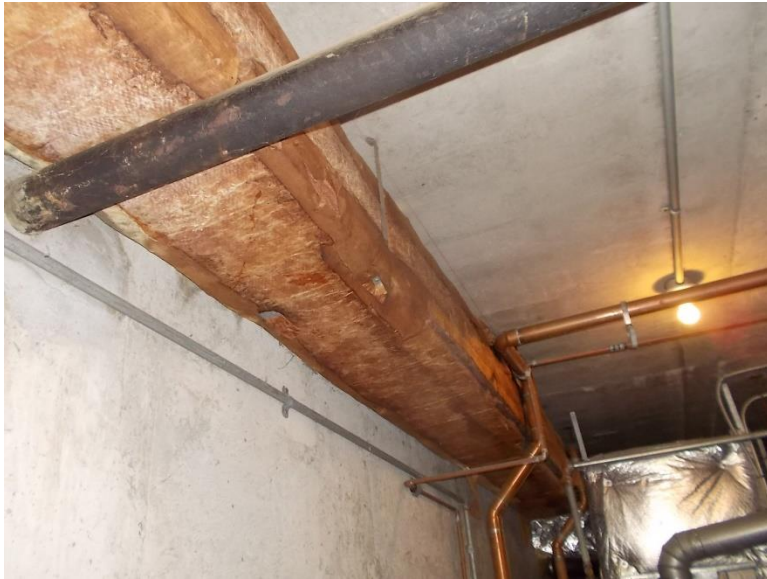
M4. Mechanical space under Kitchen; exposed insulation.

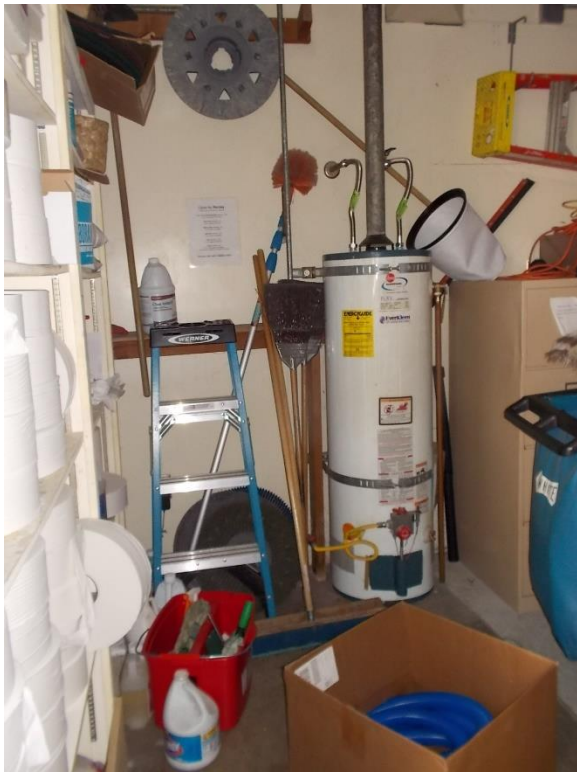
M5. Hot water heater, clear floor space not provided.

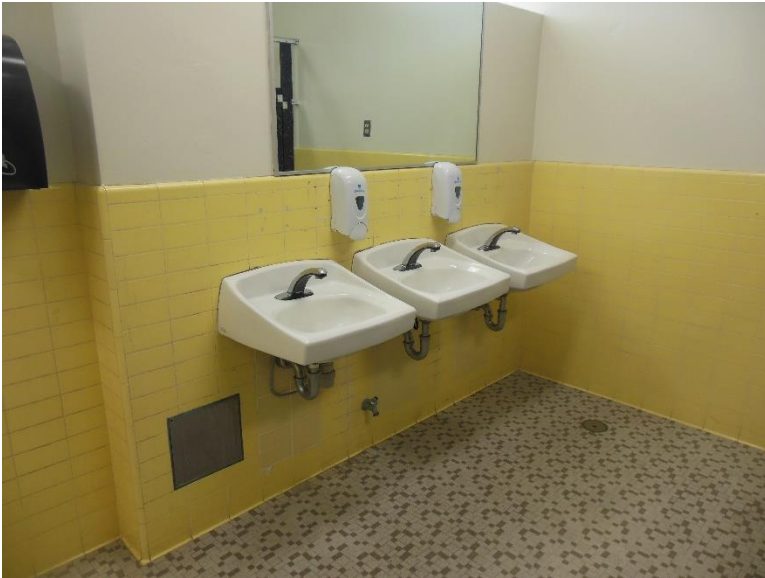
RR1. Women's Restroom; laboratories.

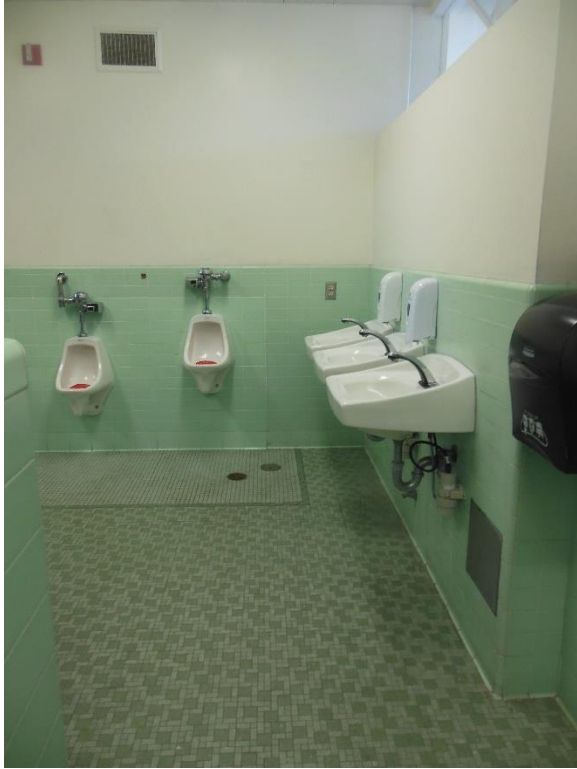
RR3. Men's Restroom; lavatories and urinals.

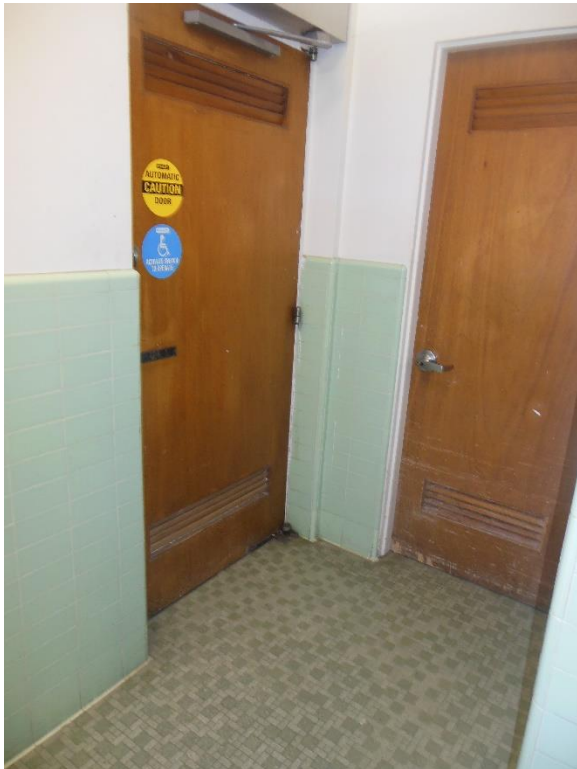
RR5. Mens foyer; door clearances not provided.

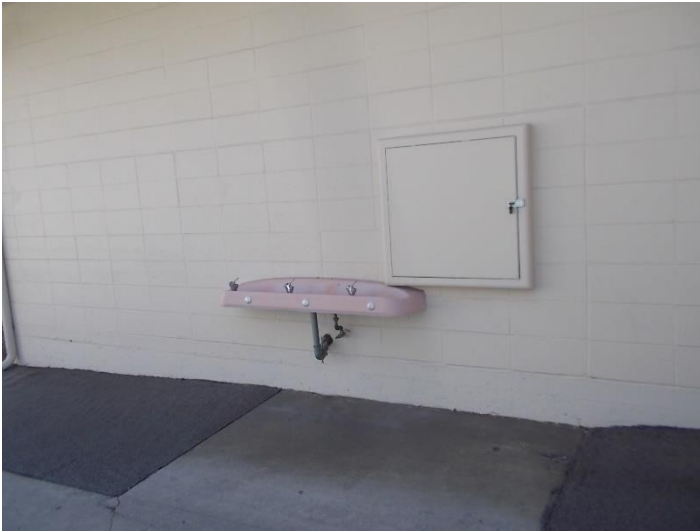
DF1. Drinking fountain in exterior walkway; hi-low fountains are not provided.

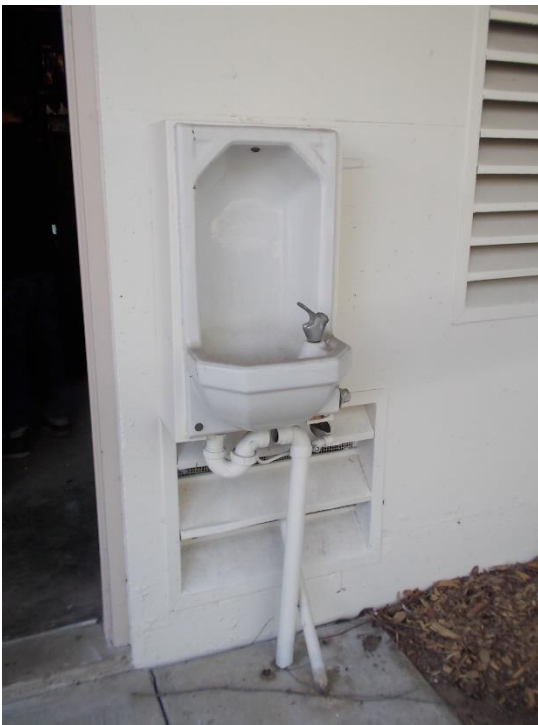
DF2. Drinking fountain in exterior walkway; hi-low fountains are not provided.

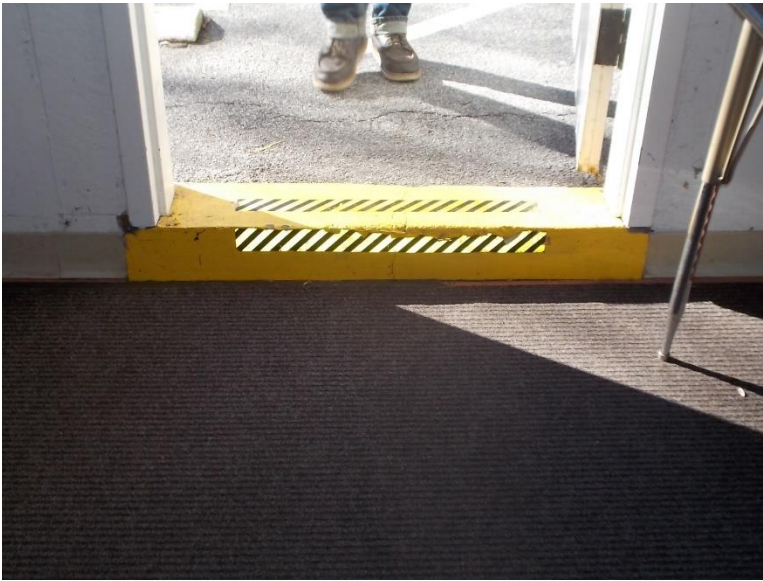
PT1. Room 32; door threshold exceeds 1/2" maximum.

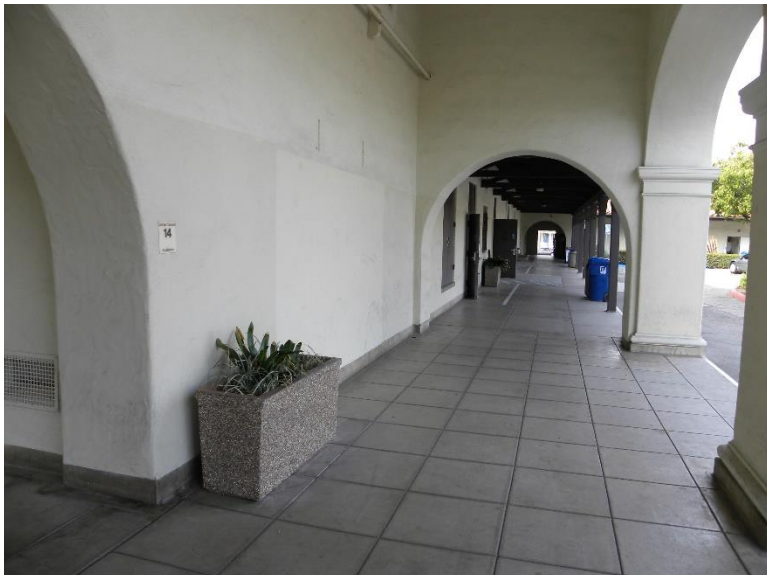
AE2. Permanent building exterior wall; painted plaster, non-matching colors.

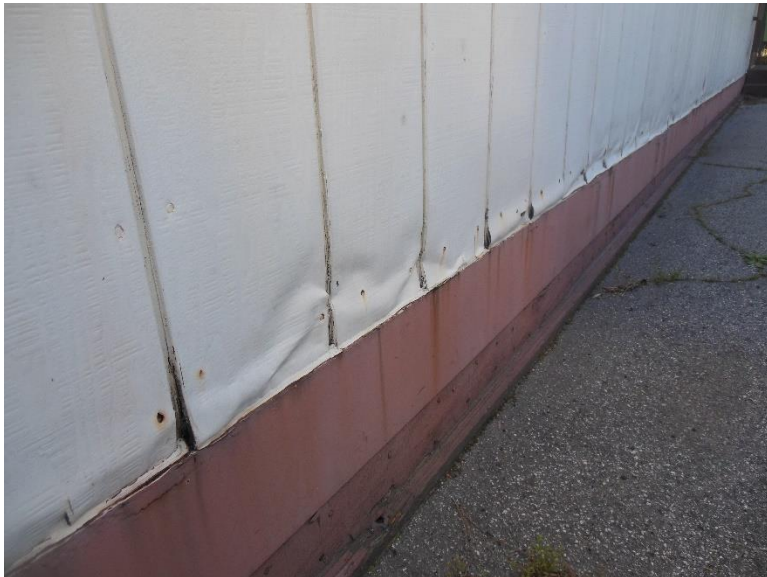
AE4. Portable building, exterior painted siding, damaged.

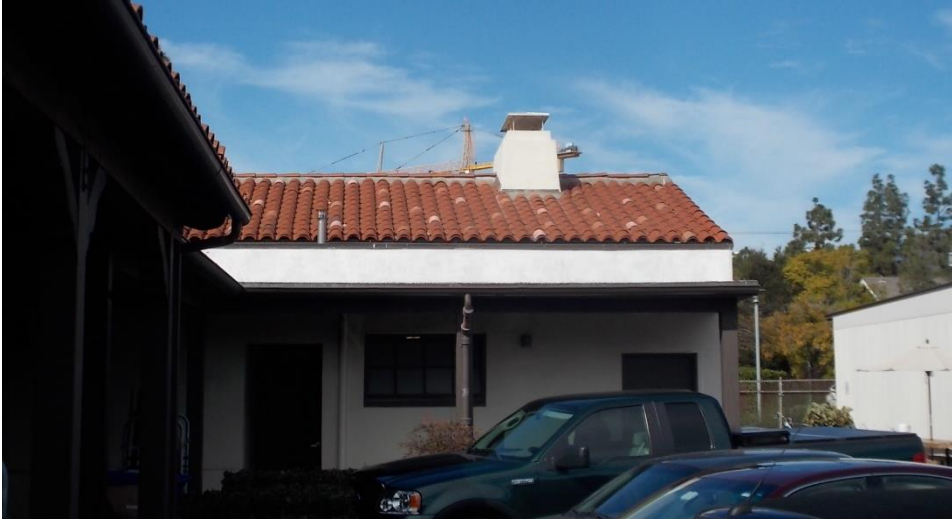
R3. Kitchen; clay tile and roof chimney/vent, and built-up roofing over walkway canopy.

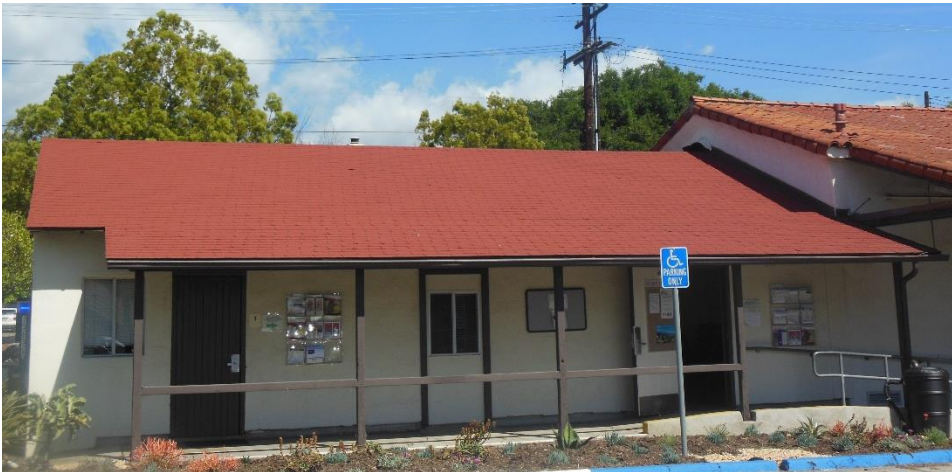
R4. Asphalt roofing over Offices 1, 2 and 3 in good condition.

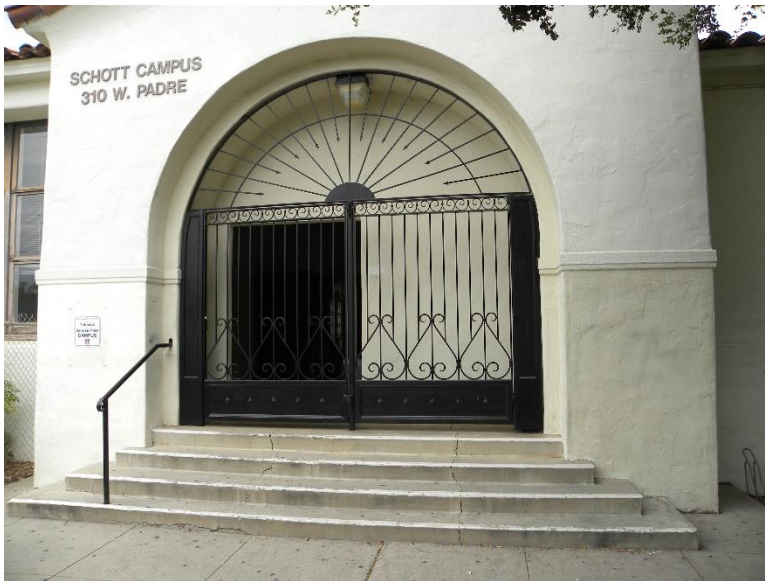
D1. Entrance from west side of site; missing handrails on right.

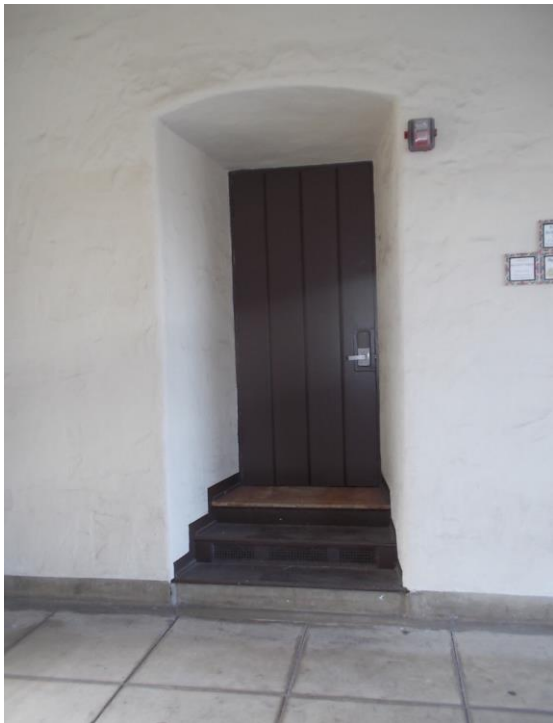
D4. Auditorium backstage door; pull-side clearances not met, stairs not accessible.

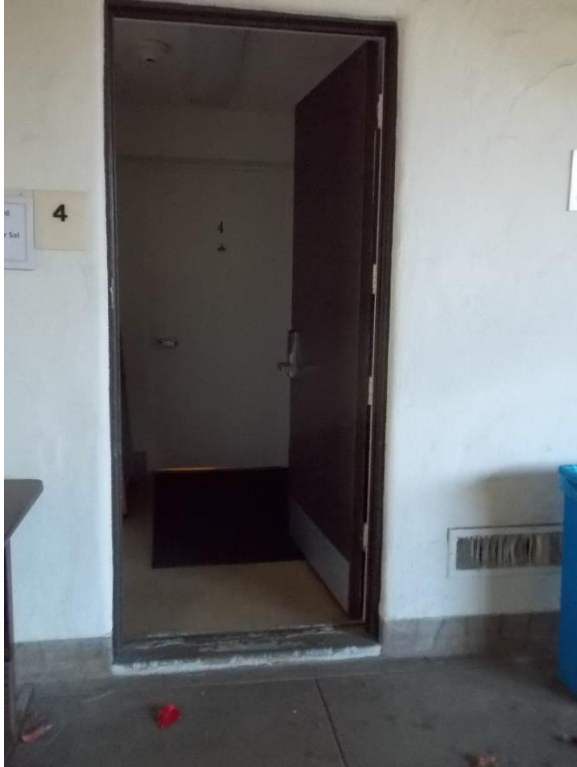
D6. Classroom 4, non-compliant threshold.

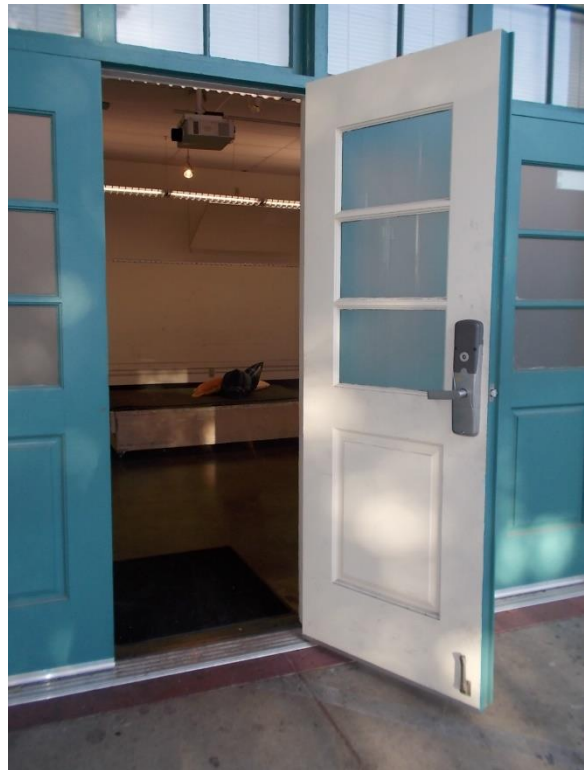
D9. Classroom 23; non-compliant thresholds and no level landing at exit.

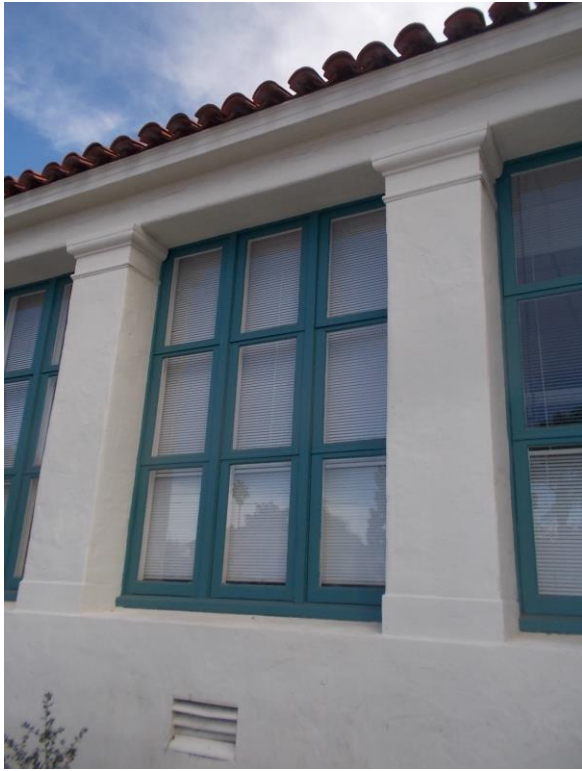
EW1. Exterior fixed wood windows; with new painted frames in excellent condition.

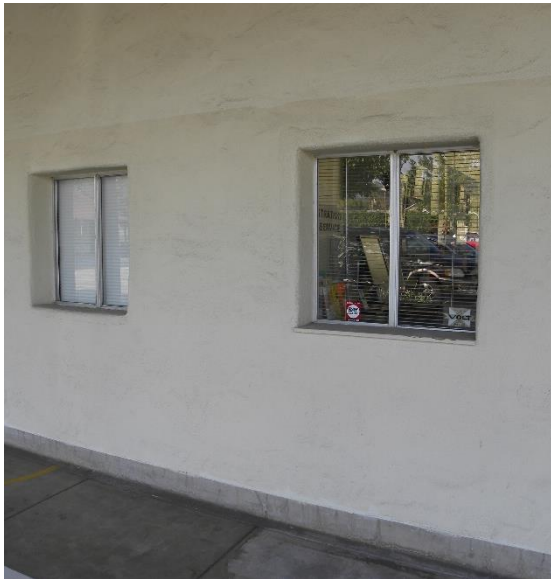
EW3. Exterior aluminum windows; frames don't match other existing windows.

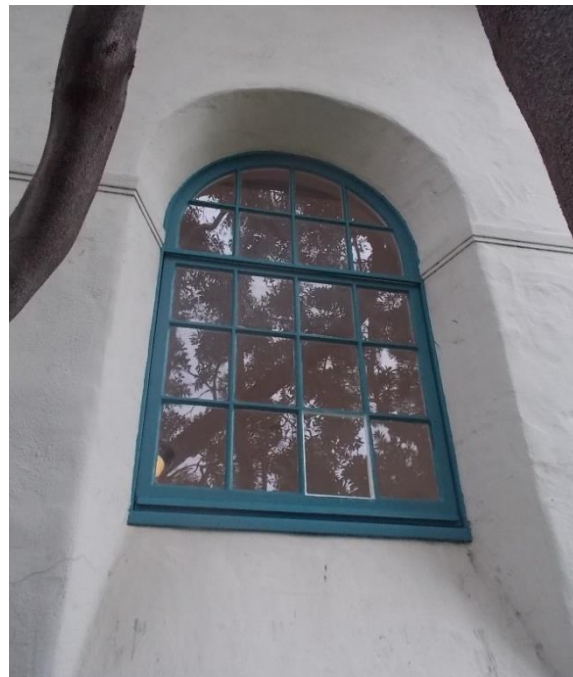
EW4. Exterior fixed wood windows; with newly painted frame in excellent condition.

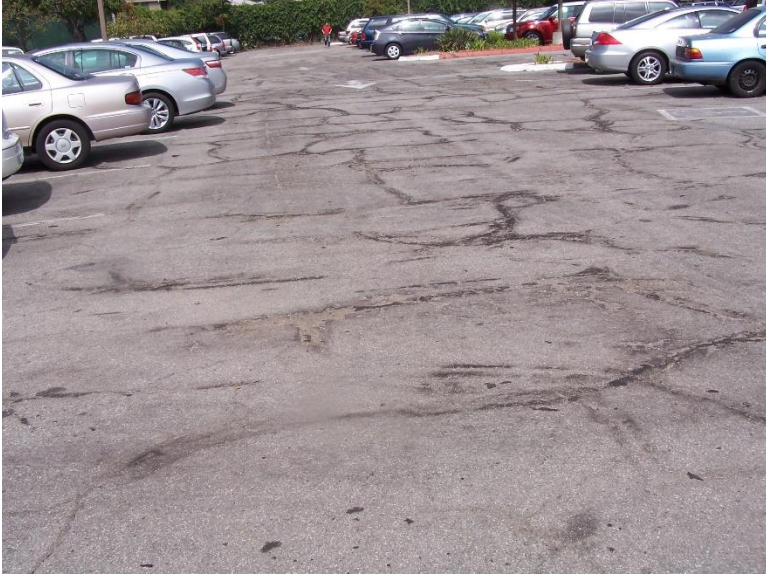
The asphalt surface at both parking lots is in very poor condition, and the stripping is faded. The asphalt surface has raveling, alligator cracks, upheaval, and depressions. Cracks have been filled with slurry, but the surfaces would benefit from a full restoration and restriping. Additionally, the main lot slopes toward a poor draining catch basin in the southwest corner by Rooms 17 and 20. During periods of heavy rain, this area floods up to the doors, due to excessive storm water retention.

EF3. Asphalt parking lot; degraded materials, poor condition.

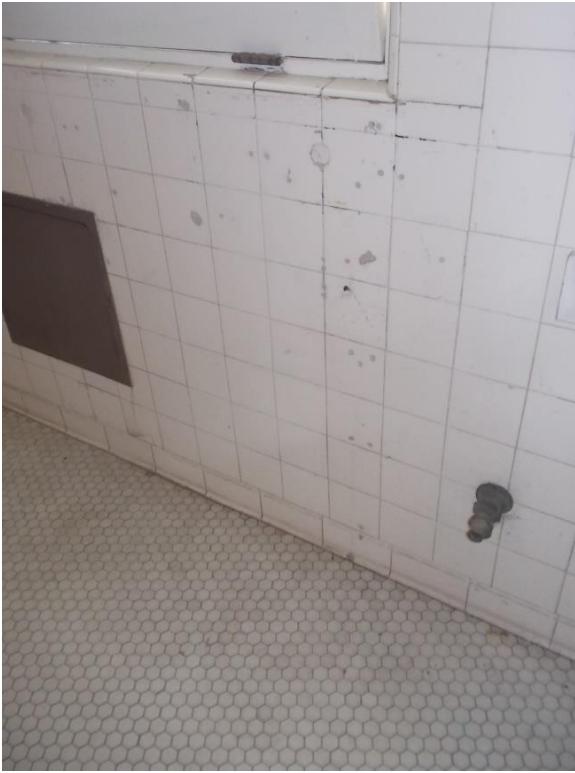
AI1. Women's Restroom, ceramic wall tile damaged.

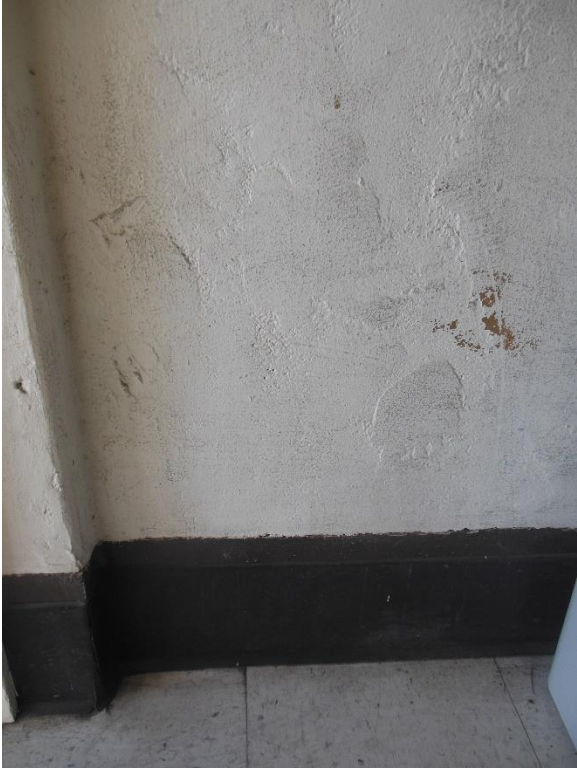
AI3. Office 11 foyer, plaster wall damage.

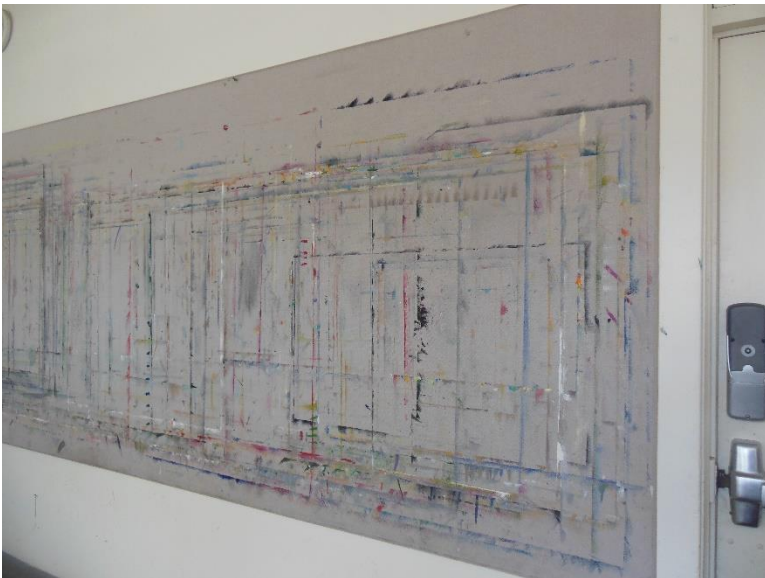
AI4. Classroom 22; fabric covered tackboard, paint damaged.

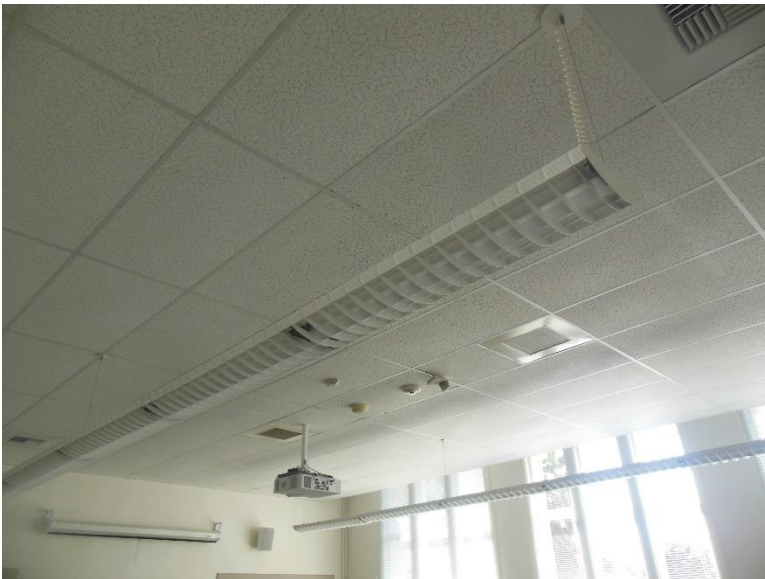
C2. Classroom; suspended ceiling system in good condition.

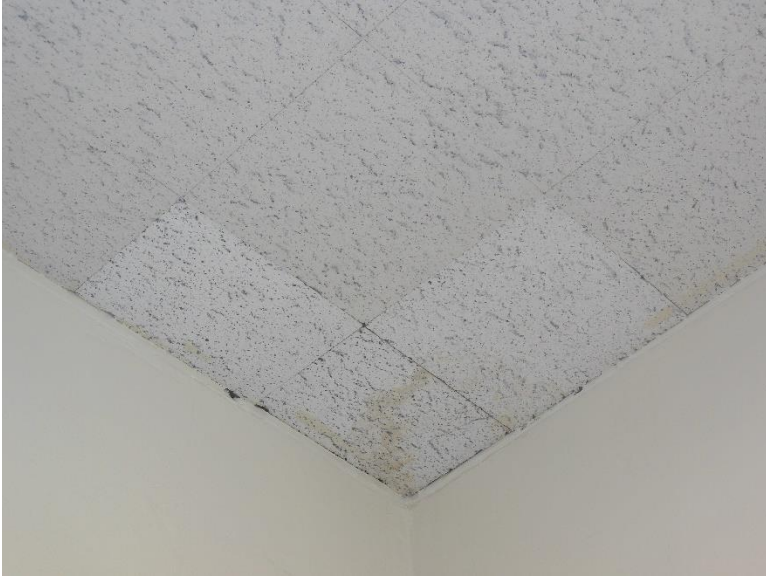
C3. Copy Room 10; glued on ceiling tile, damaged.

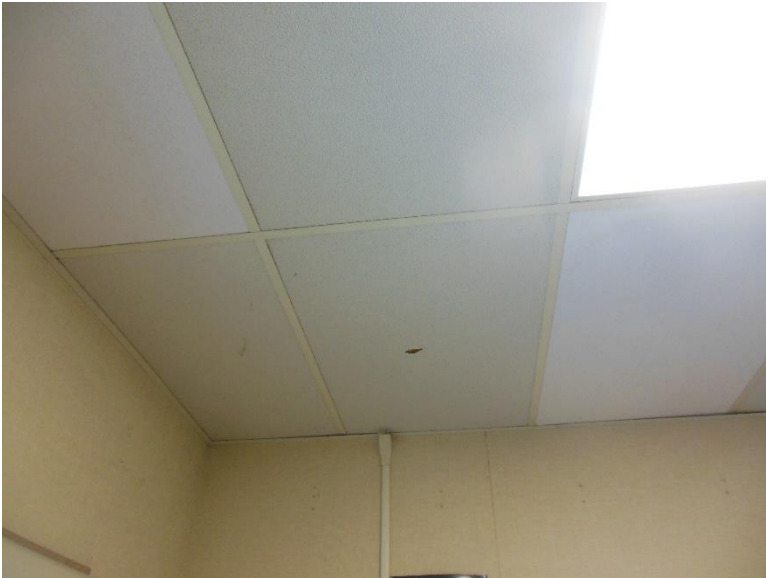
**CEILING:** Ceilings are original plaster and suspended acoustical ceiling systems. Plaster ceilings require repainting, and those suspended ceiling not recently renovated required replacement.

C4. Portable Classroom 29; damaged and miss-matched suspended ceiling tiles.

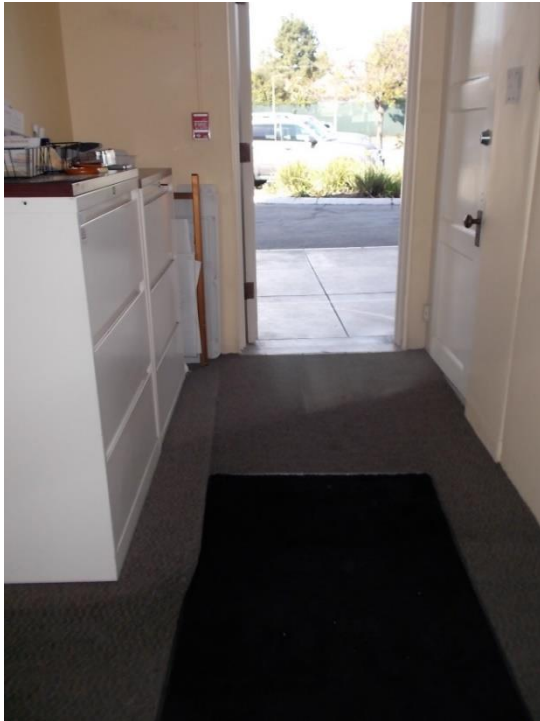
D1. Office 13; push-side clearance not provided, ramp is non-compliant, and adjacent door has non-compliant hardware and opens into the ramp.

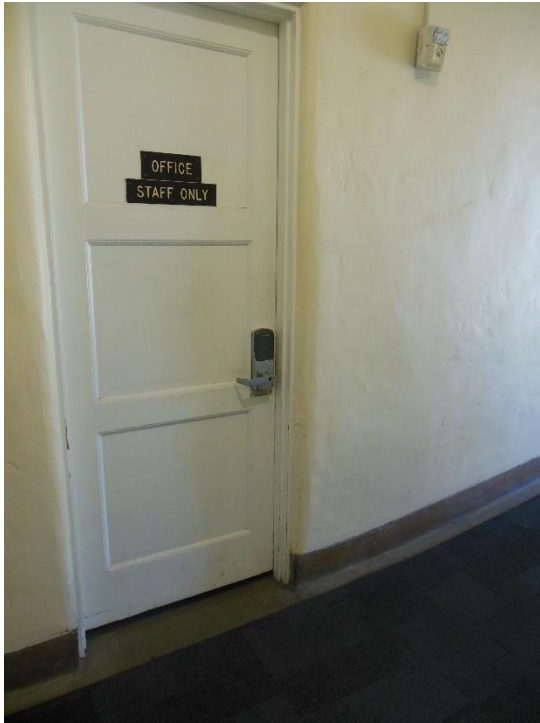
D3. Office 15; interior painted wood door, ADA room ID signage not provided.

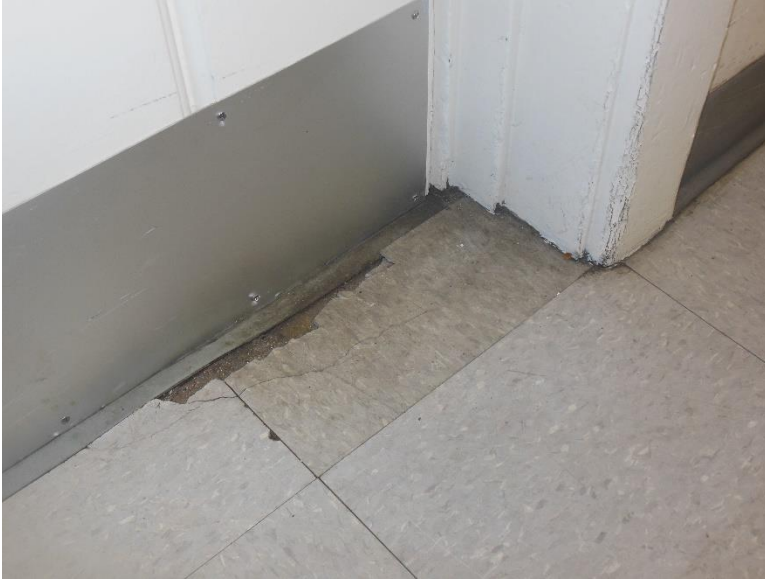
IF1. Main Office Room 8, damaged VCT at door.

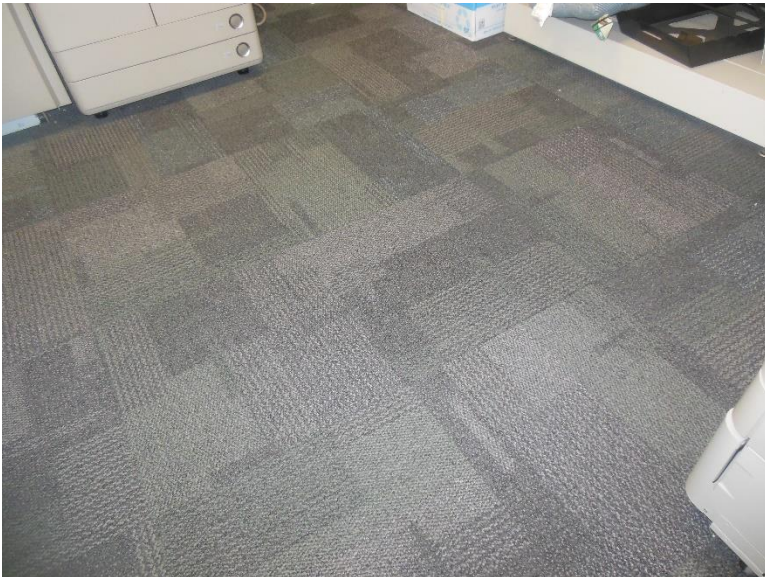
IF2. Copy room 10; carpet tile in good condition.

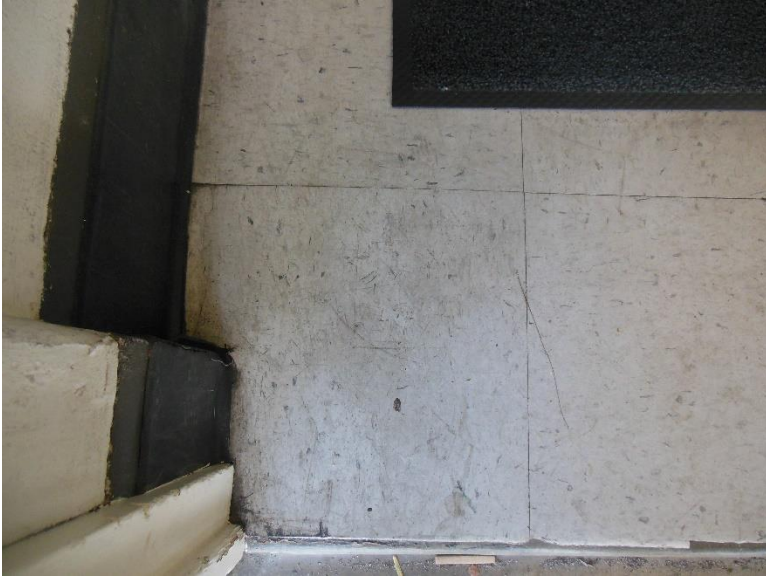
IF3. Office 11 foyer, VCT floor damage.

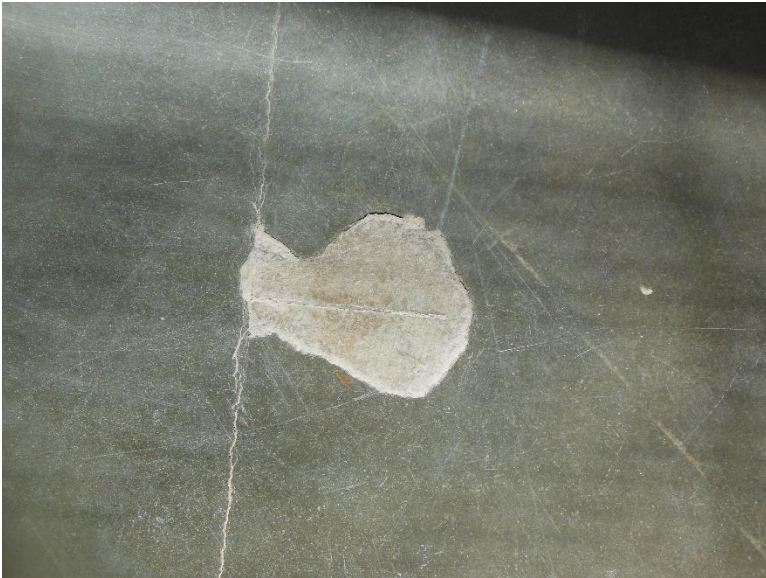
IF4. Classroom 22; concrete topping material damage.

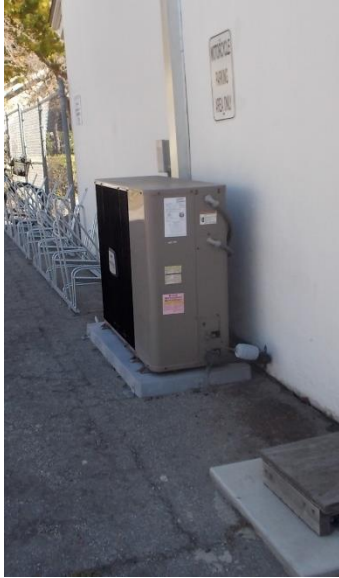
M1. Outside Room 1; mini-split heat pump system.
