# SANTA BARBARA CITY COLLEGE

## ADA PATH OF TRAVEL ASSESSMENT

# Facility Condition Assessment Report ADMINISTRATION BUILDING

**Facility Condition Assessment Report**  
**Santa Barbara City College – Main Campus**  
**Administration Building**  
**721 Cliff Drive**  
**Santa Barbara, CA 93109**

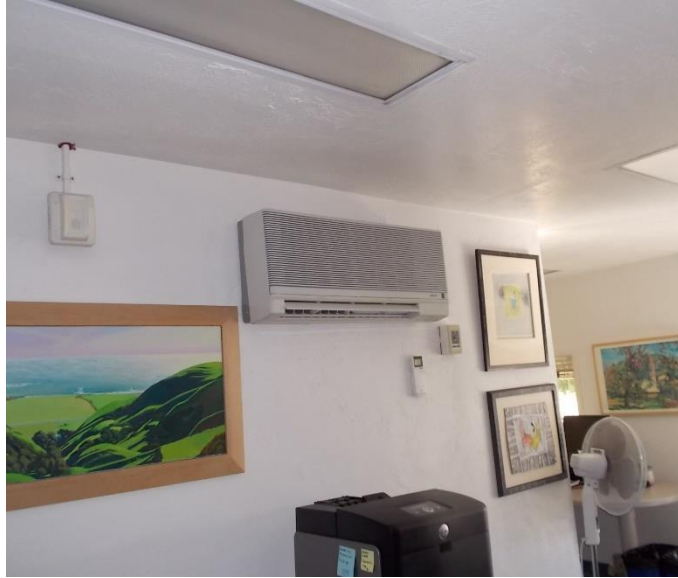
M2. Office 12; wall mounted AC unit.

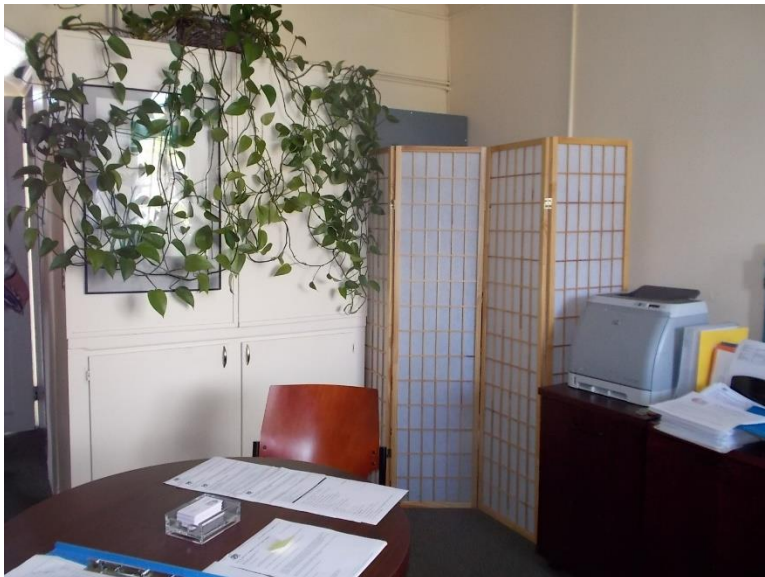
E2. Office 13 interior; main distribution panel, service meter, distribution panel and transformer, behind screen.

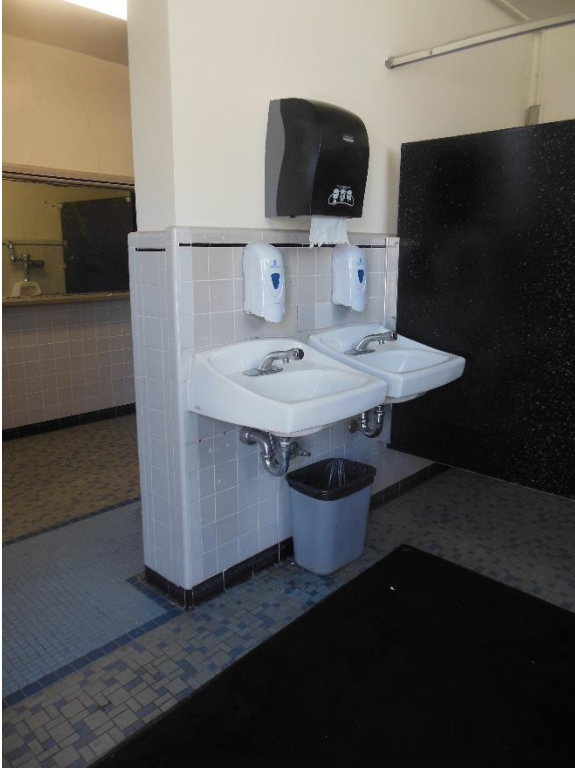
RR3. Men's Restroom; lavatories and fixtures.

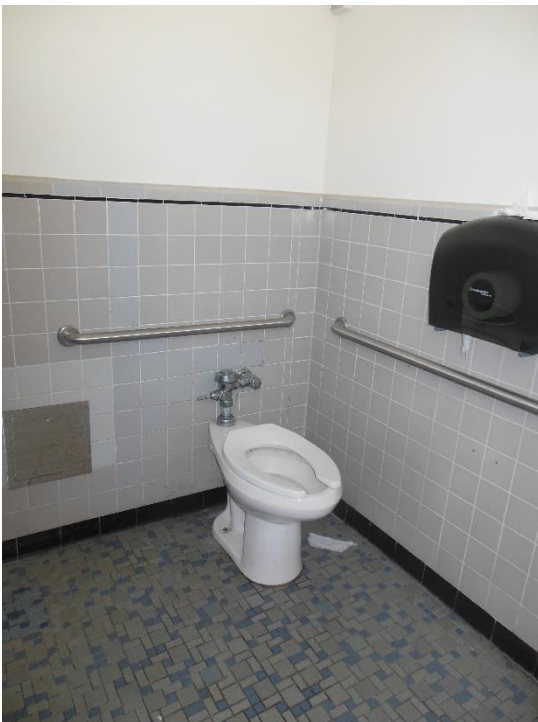
RR4. Men's Restroom; toilet paper dispenser located too high above toilet, and protrudes into clear space above grab bar.

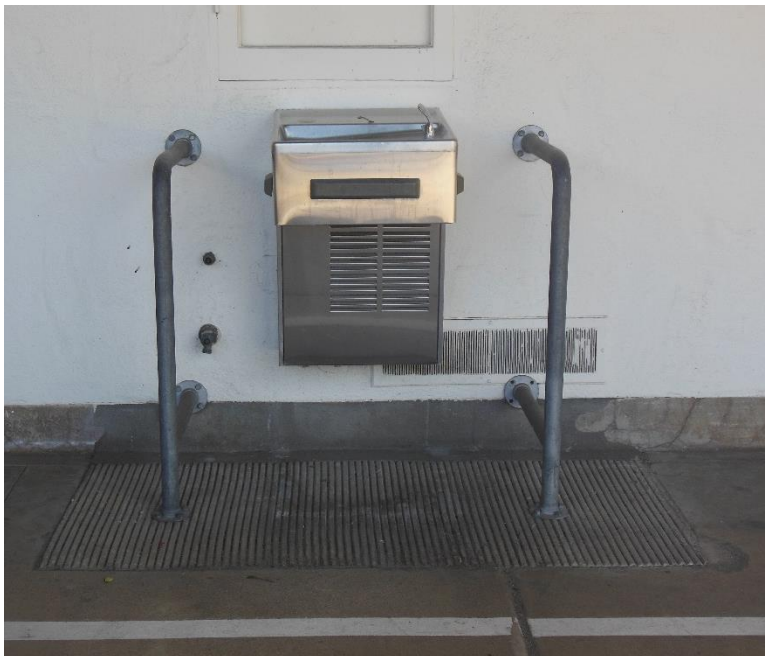
DF3. Drinking fountain in exterior walkway; hi-low fountains not provided

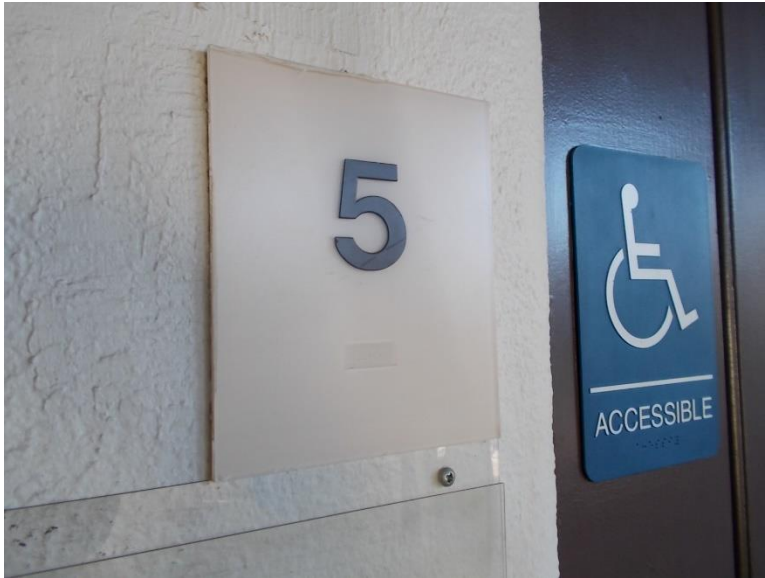
S1. Classroom 5; typical room ID wall signage.

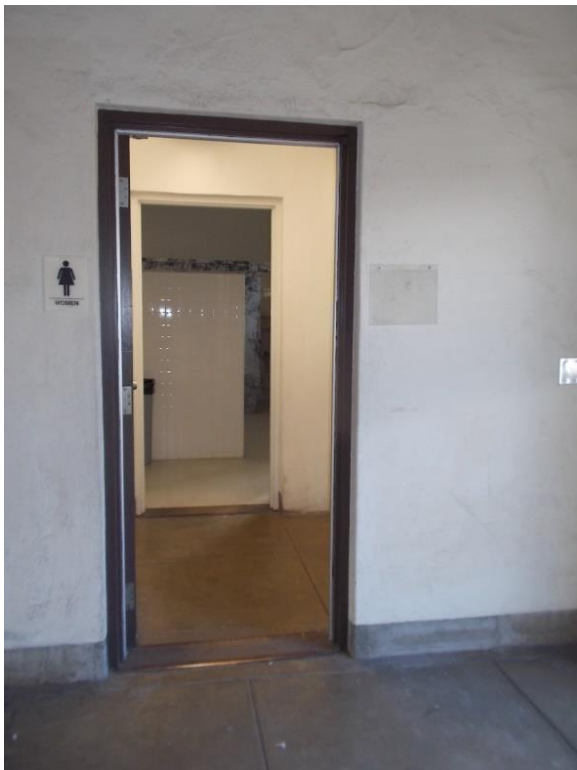
S2. Women's Restroom entrance; room ID signage mounted on wrong side of door

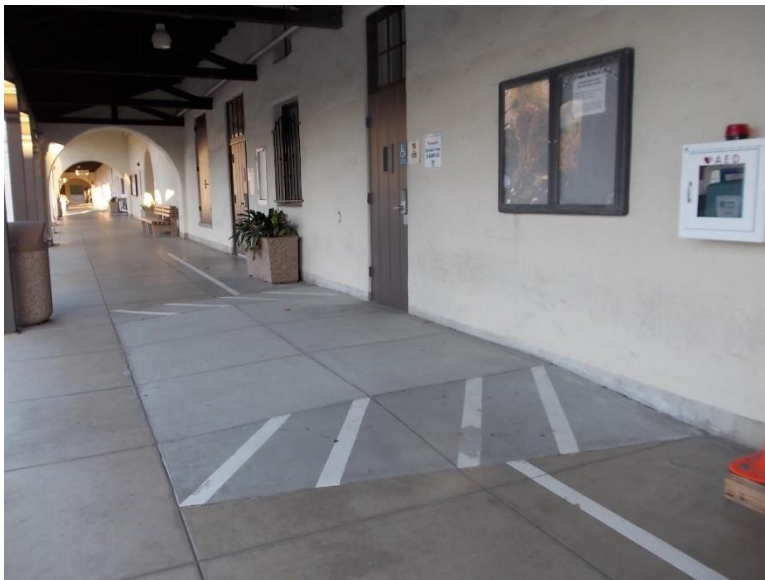
PT2. Exterior walkway; path of travel interrupted by ramp.

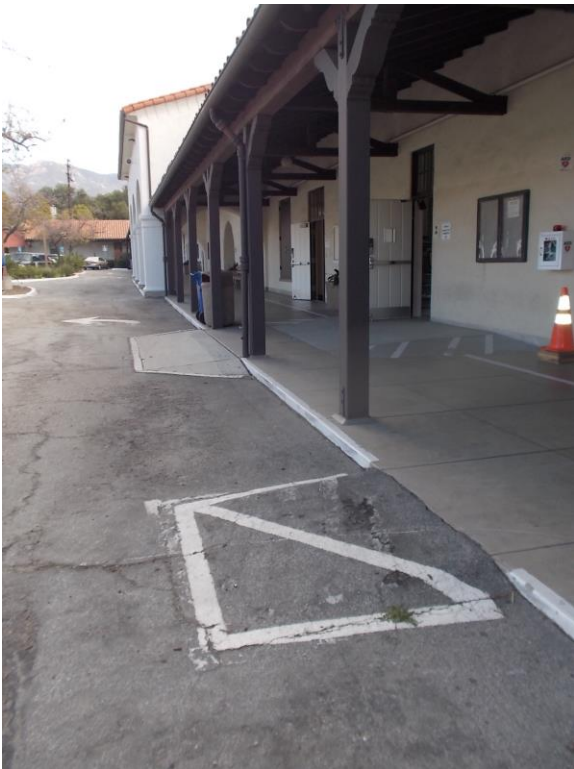
PT4. Curb ramps to parking lot; ramp cannot project into the path of cars, and are missing truncated domes. Asphalt surface is degraded.

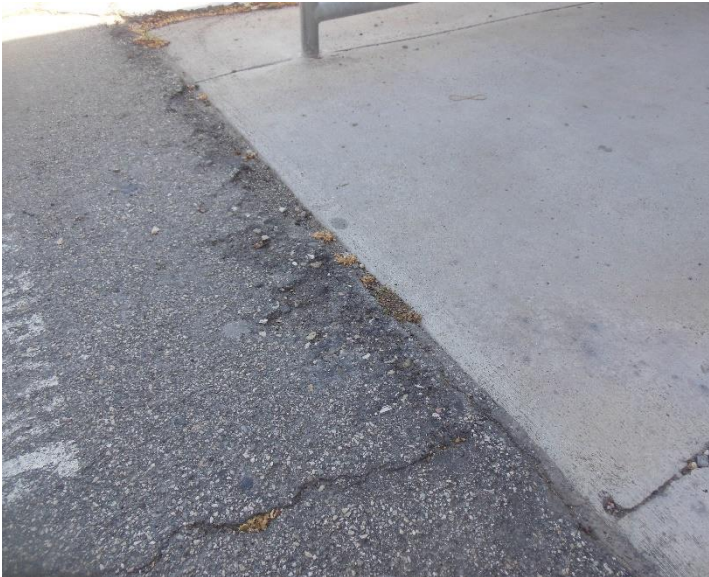
PT6. Landing at ramped walk to Men's restroom; abrupt change in level.

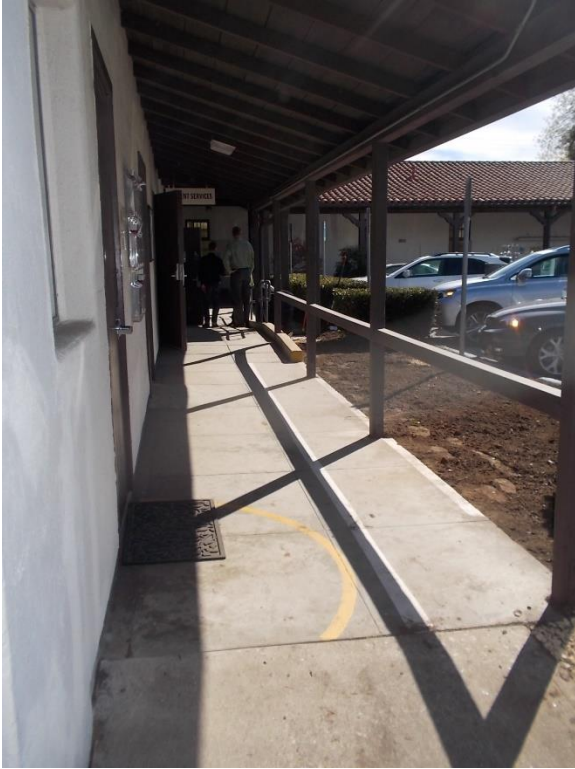
PT7. Exterior walkway; path of travel interrupted door swing, and curb edge not provided.

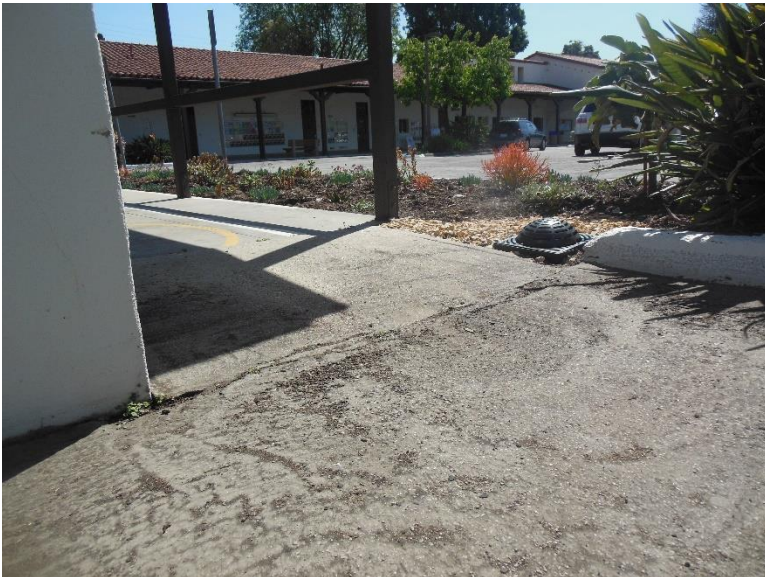
PT8. Exterior walkway; path of travel with hazardous surface feature and no level landing at bottom of ramp.

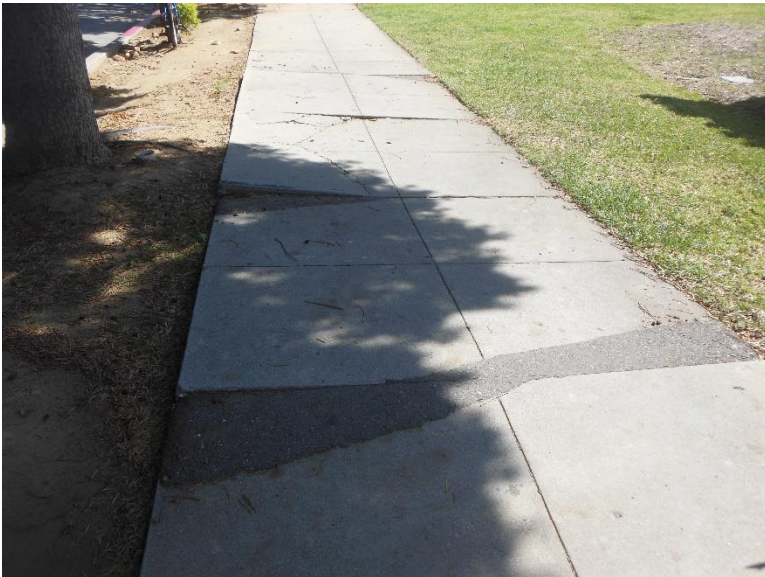
Although the public sidewalks surrounding three sides of the facility are beyond the property line, these sidewalks provide access to all entry points onto the campus, as well as to the public bus stop. These public walks have excessive cross and longitudinal slopes, abrupt changes in level, hazardous surface features, and non-compliant curb ramps.

PT10. Public sidewalk at east side of site, near bus stop; abrupt changes in level, and excessive cross slope.
