# SANTA BARBARA CITY COLLEGE

## ADA PATH OF TRAVEL ASSESSMENT

# Facility Condition Assessment Report ADMINISTRATION BUILDING

**Facility Condition Assessment Report**  
**Santa Barbara City College – Main Campus**  
**Administration Building**  
**721 Cliff Drive**  
**Santa Barbara, CA 93109**

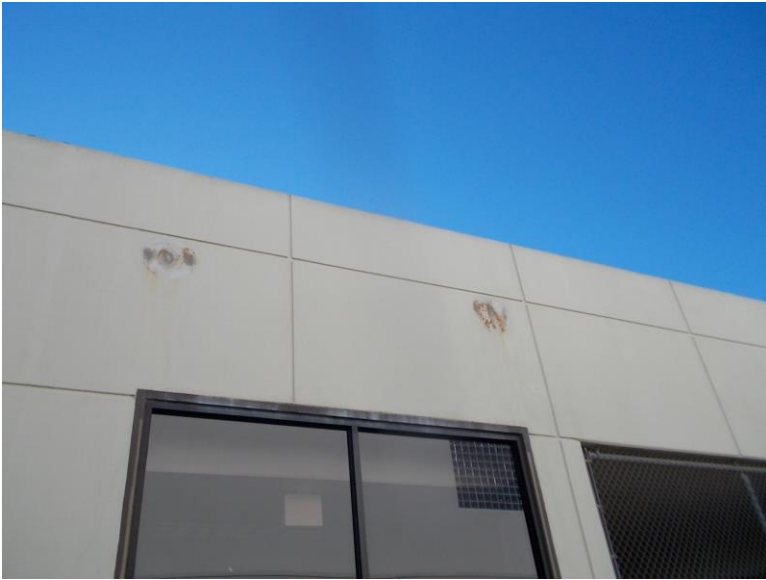
AE5. OE building, exterior wall facing Auto Quad.

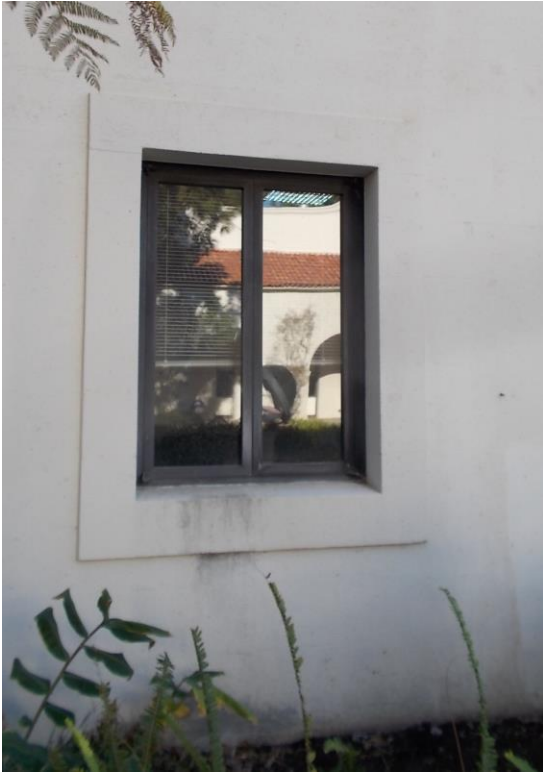
EW1. Northwest first floor.

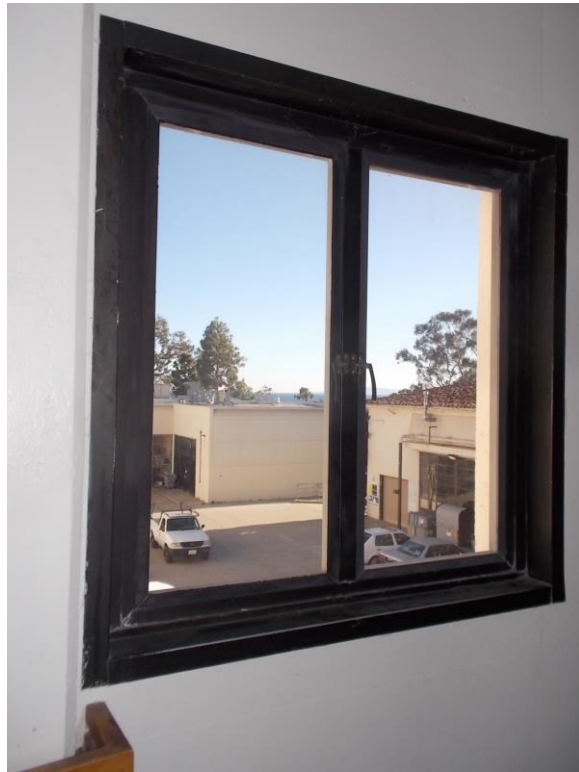
EW2. Southeast facing Auto Quad.

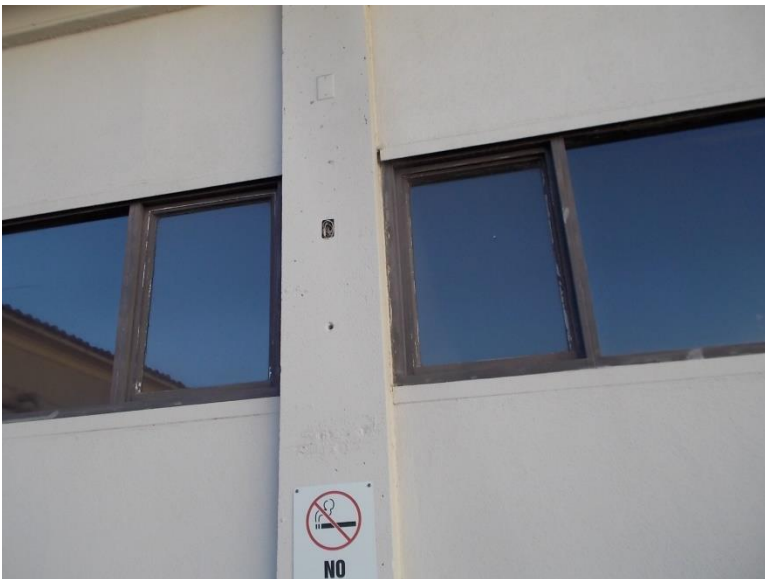
EW3. Southeast facing Auto Quad.

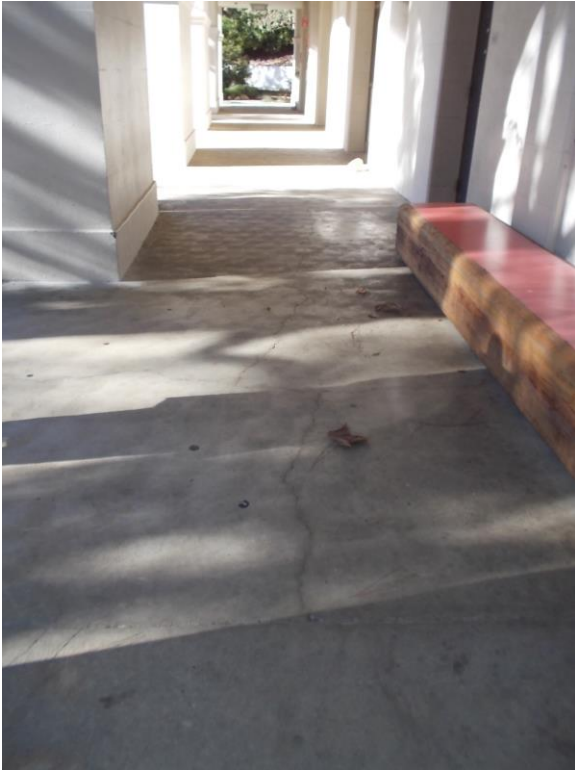
EF1. Northwest exterior corridor.

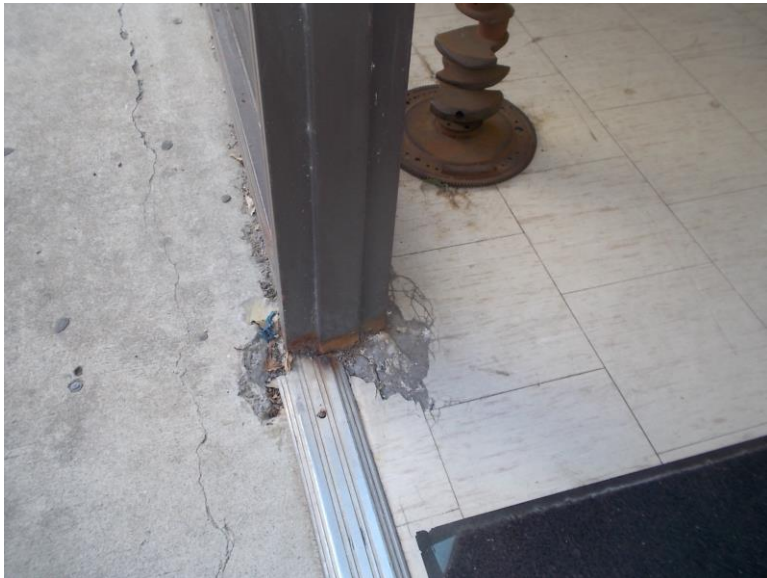
The South portion of the OE building has an outdoor stairway connecting the two levels, and its walls, ceiling, concrete stair and handrail finishes are badly damaged due to the outdoor elements. The upper landing storefront system is rusted, the flooring is badly pitted and the adjacent concrete is spalling.

EF4. Southeast OE upper exit to Auto Quad.

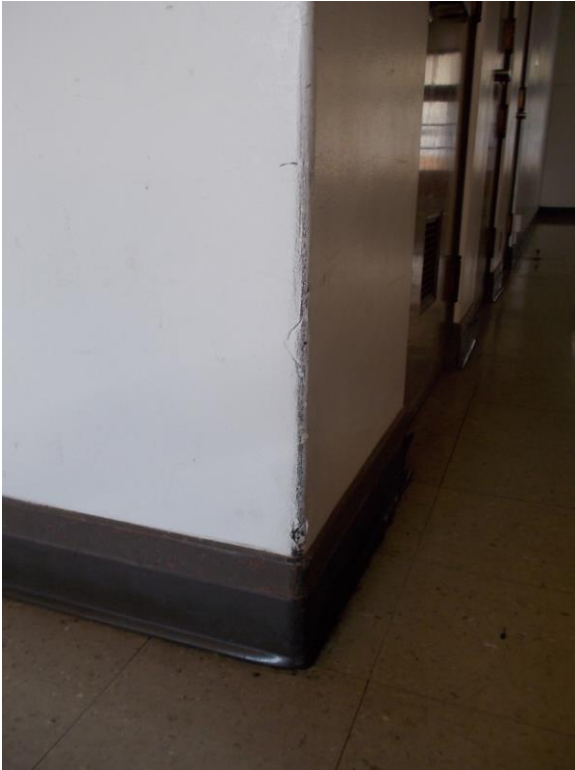
AI1. Interior corridor corner.

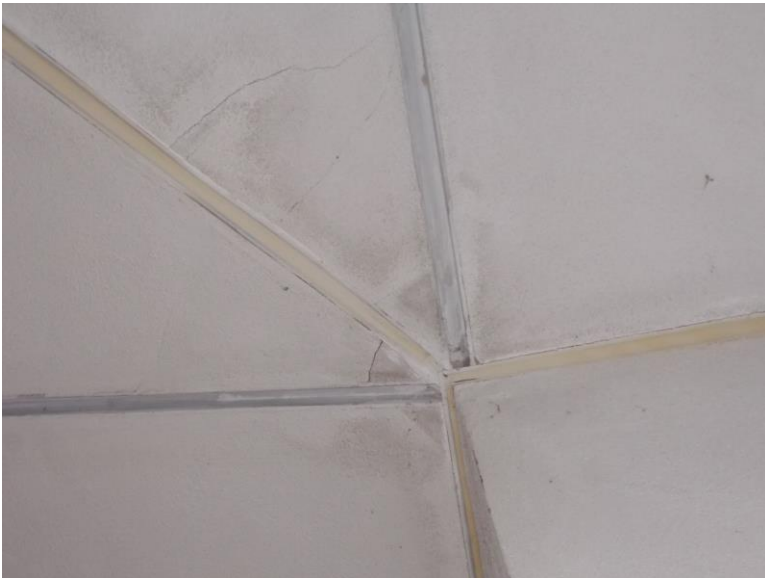
A14. Building joints.

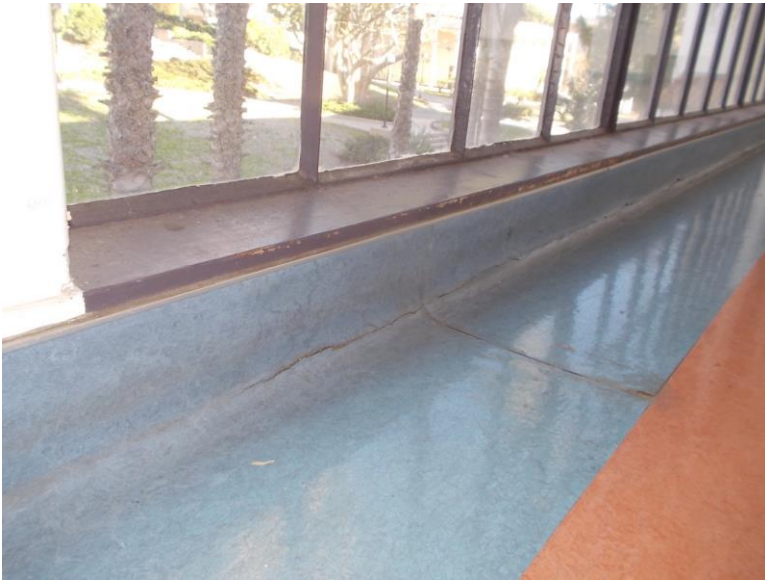
IF1. Southeast corridor.

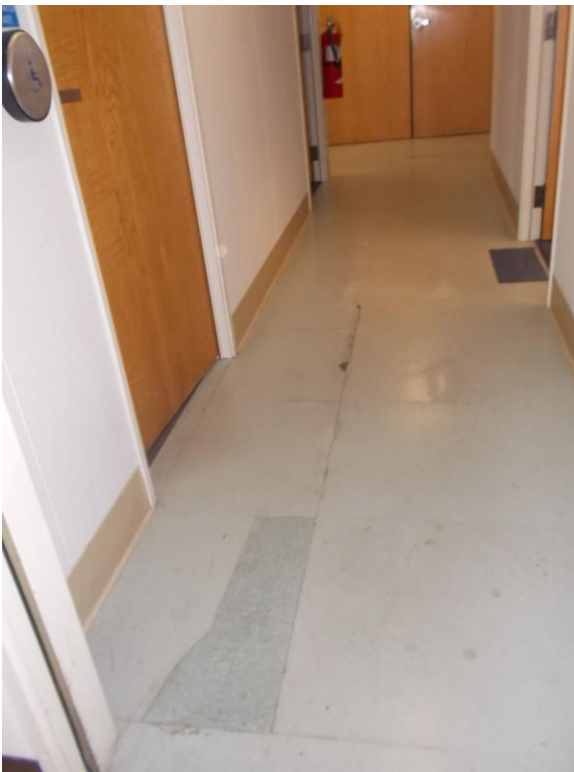
IF2. Southwest corridor 210.

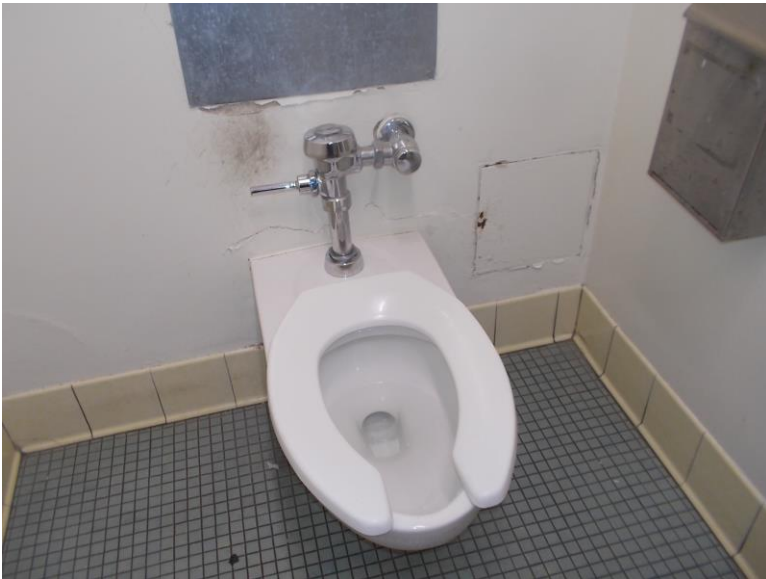
P4. Unisex –non-compliant toilet fixture, second floor northeast wing.

- Restrooms - There are student restrooms on both the first and second floors, and one unisex staff restroom on the second floor. All floor finishes, colors, fixtures and equipment of are in fair condition. ADA restroom door signs are non-compliant with current codes. Although the layouts and configurations are efficient, these restrooms were originally designed to meet earlier ADA standards, and should be re-evaluated for compliance to current ADA codes. The staff restroom on the second floor is non-compliant due to dimensional clearance deficiencies.

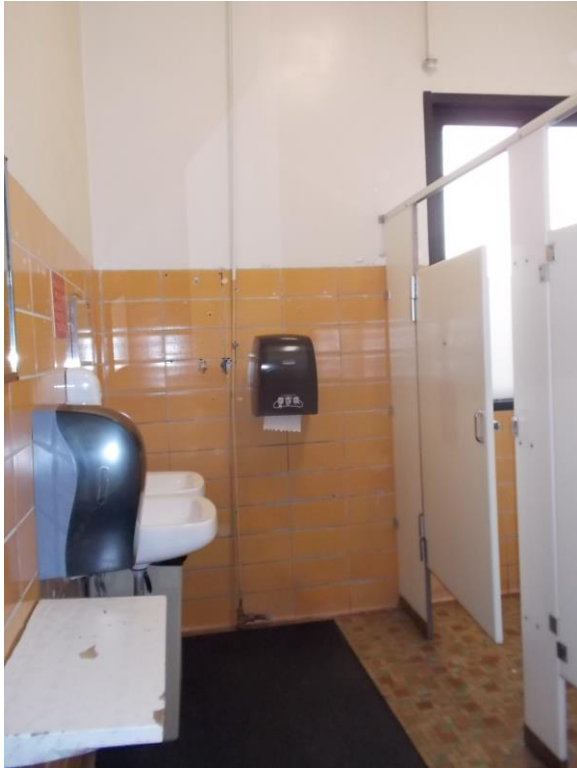
RR1. Womens non-compliant restroom, first floor northwest wing.

**RESTROOMS:** The finishes and fixtures are in fair condition, but the layouts require reconfiguration to meet current accessibility codes for dimensional clearances.

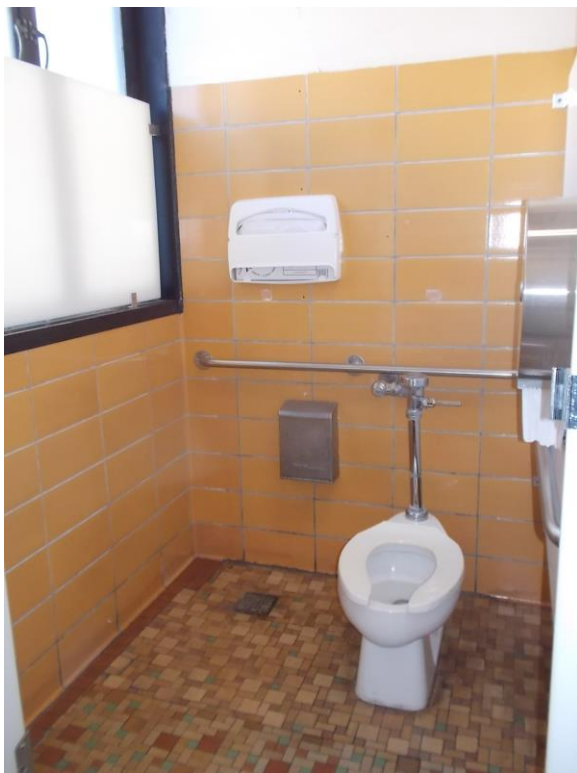
RR2. Womens non-compliant restroom, first floor northwest wing.

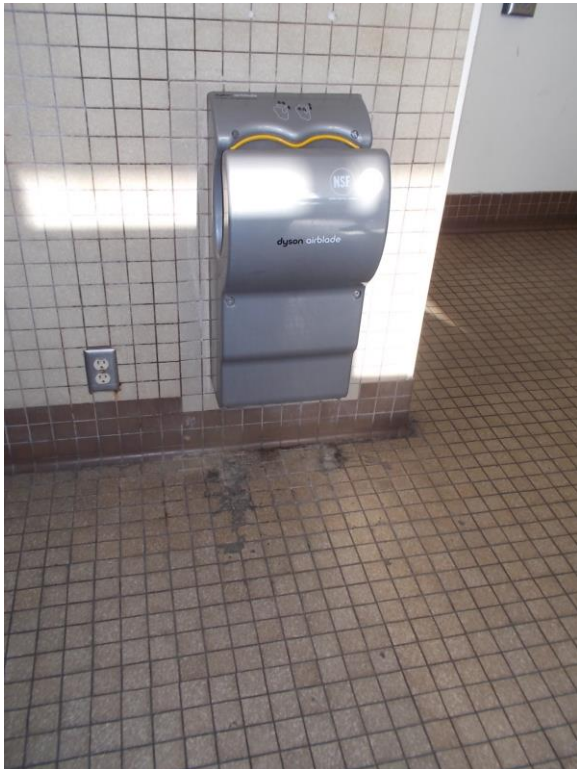
RR4. Womens restroom, second floor southwest wing.

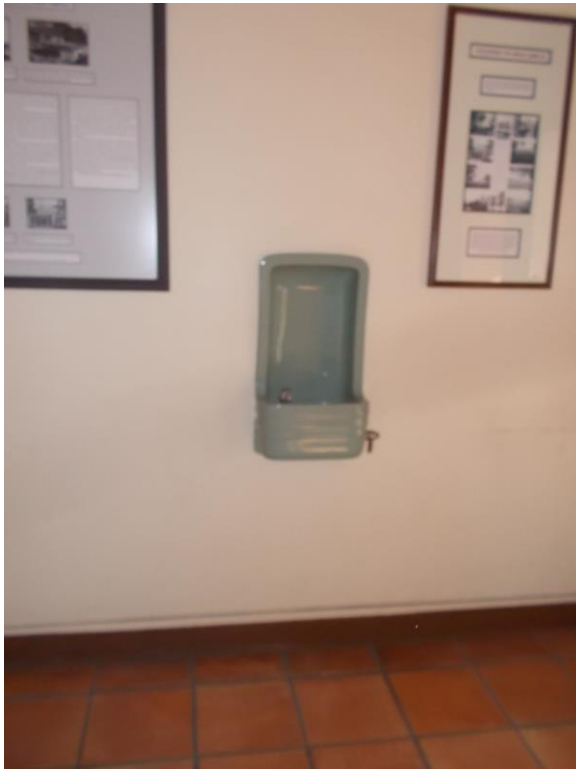
DF1. Charming era non-compliant drinking Fountain at first floor entry.

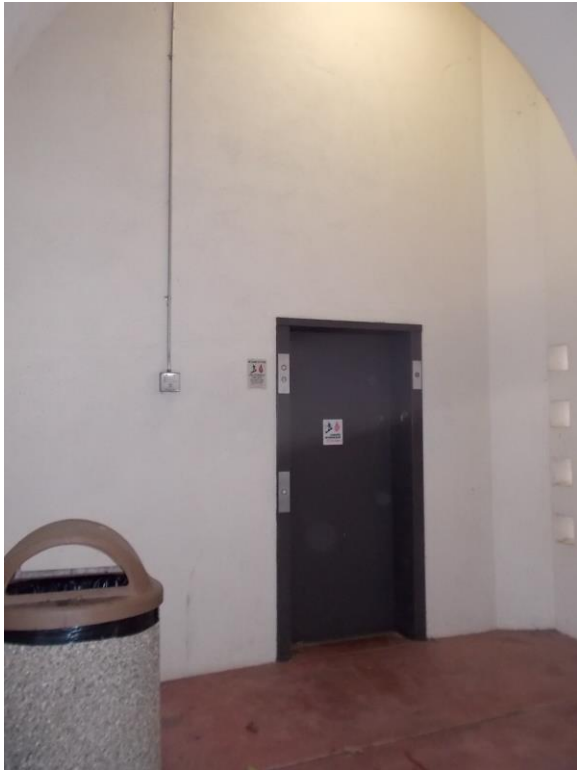
EV1. Elevator as central ADA access.

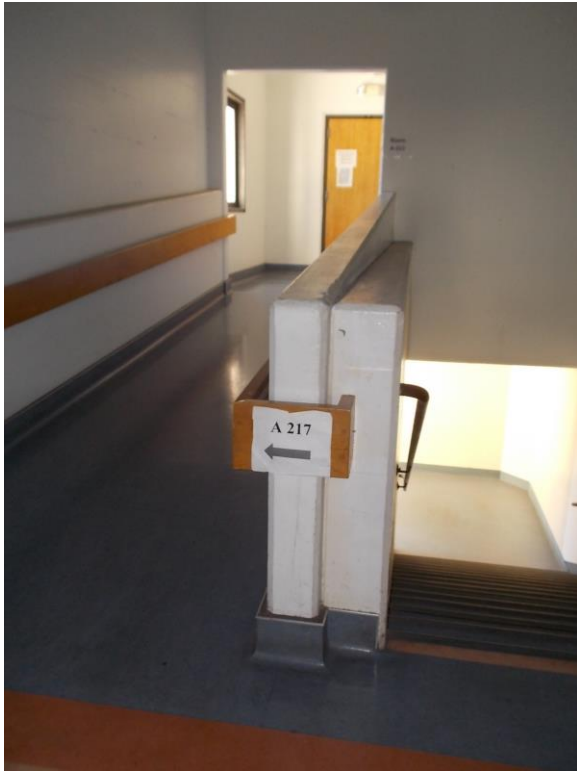
S3. Room ID signage – second floor.

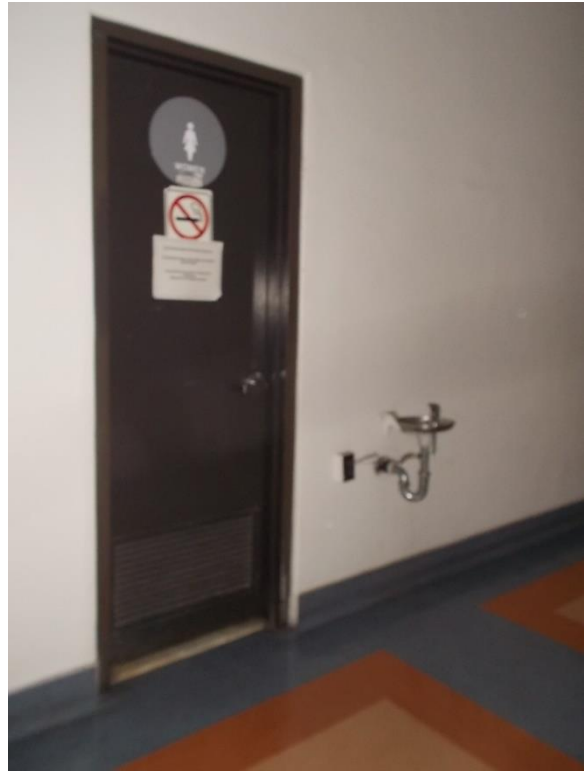
S4. Non-compliant RR signage – 2nd floor.

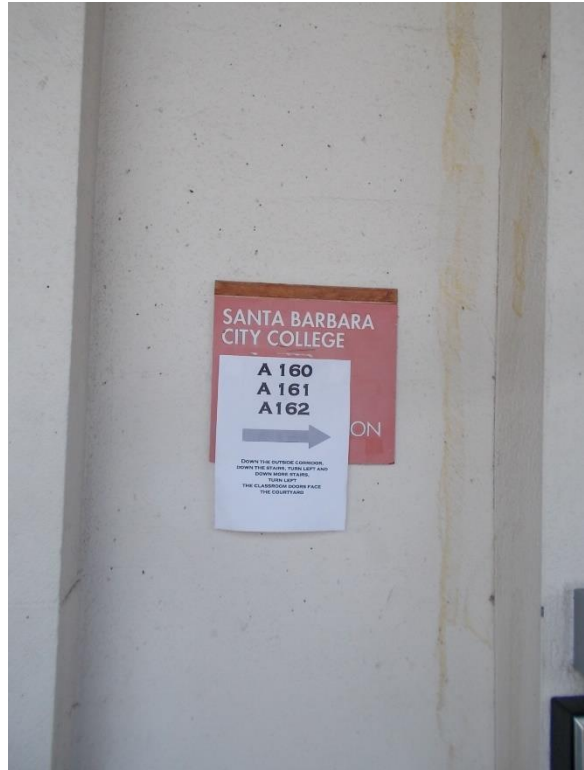
S6. Exterior wayfinding signage.

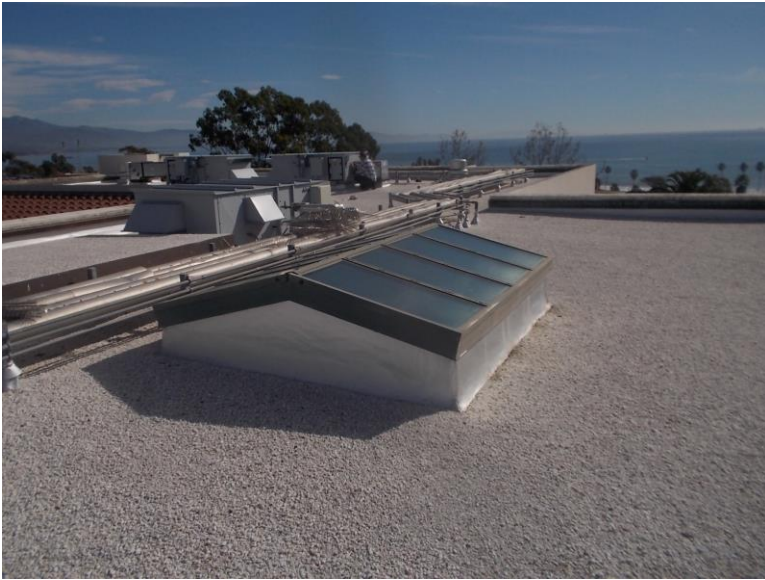
R1. Skylight at built-up roof system, in good to excellent condition.

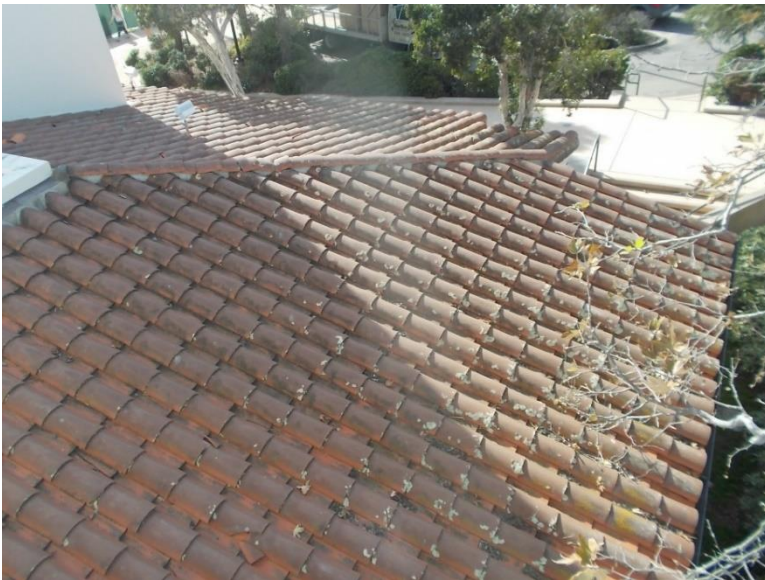
- Roofing - The built-up roofing is in good condition. The Mission clay roof tile is in overall good condition, but it is unknown if the roof tile tie-down system meets current Department of the State Architect (DSA) requirements.

R2. Mission clay original roof tile.

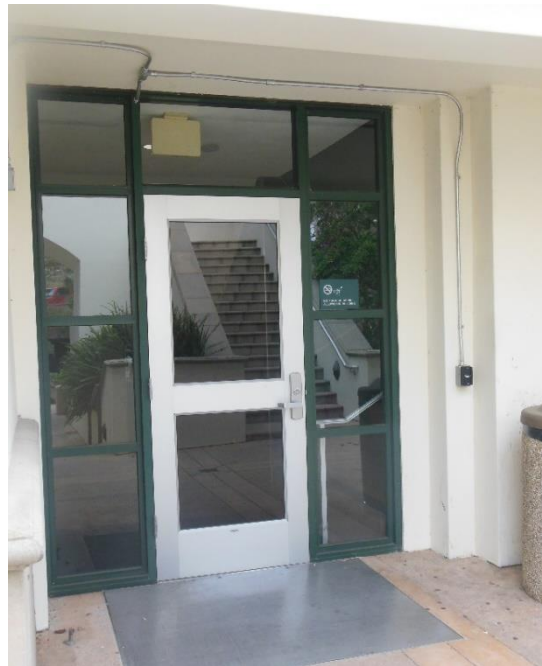
D2. Second floor entry, door lacking wall mounted room ID signage.

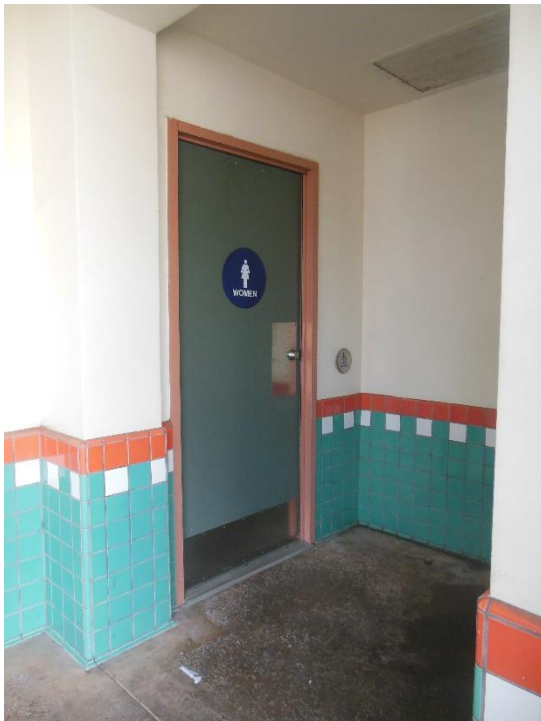
D5. Café restroom doors are missing wall mounted room ID signage. Low level access button for electronic door operator is required by code.

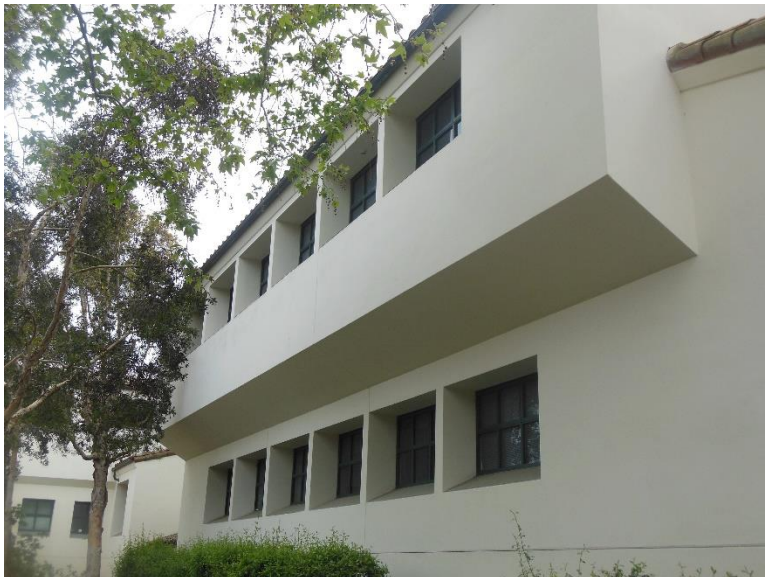
EW2. Aluminum framed lower and upper floor windows in good condition.

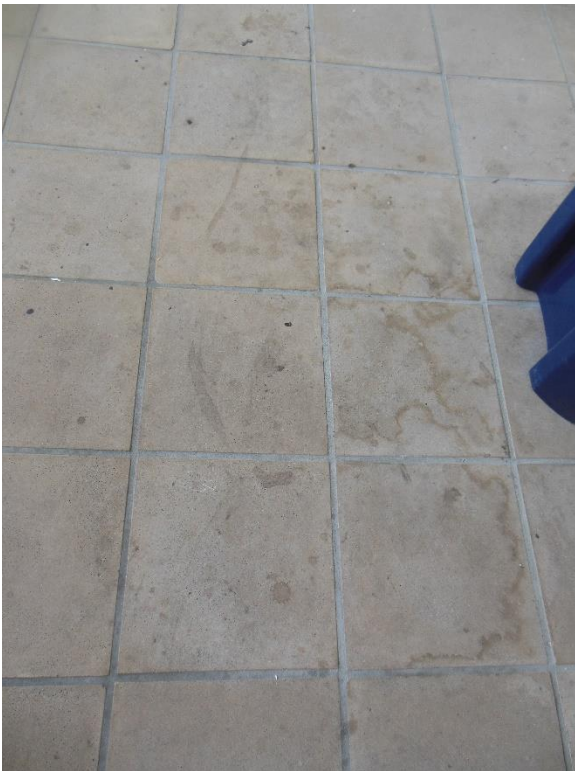
EF4. Third floor exterior walkway; concrete pavers stained.

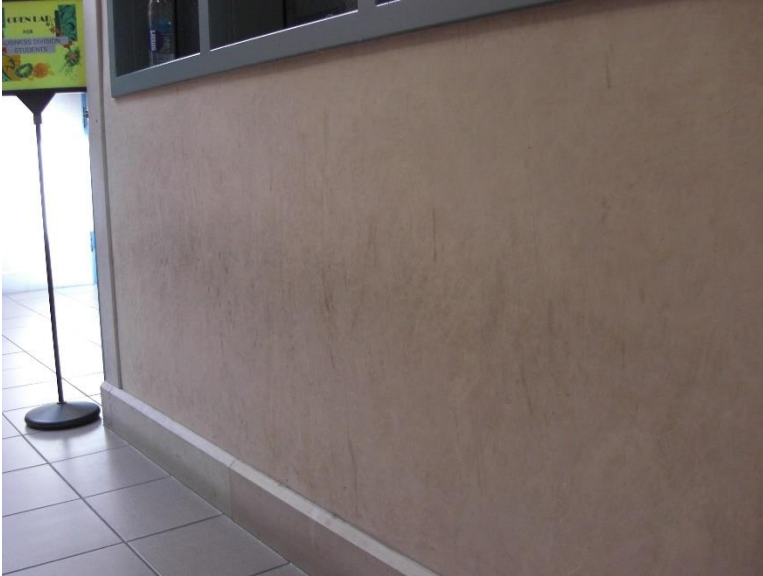
A1. Second floor corridor; veneer plaster wall stained and damaged.

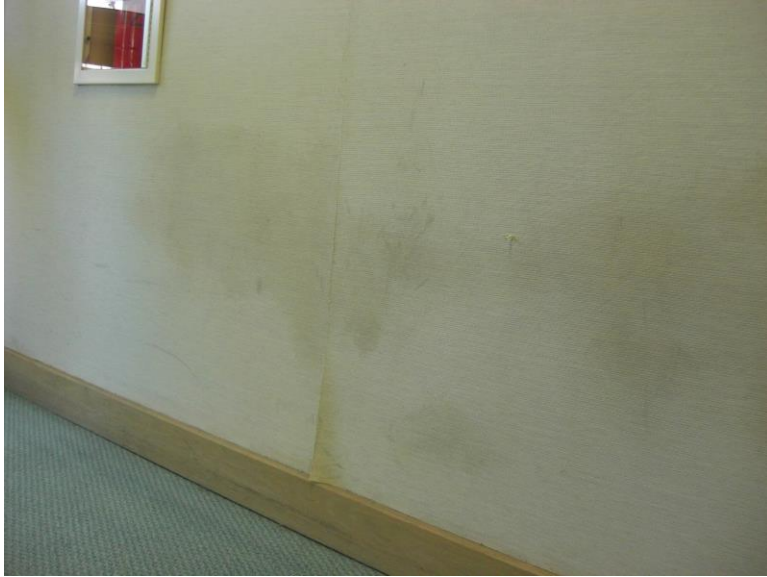
A3. Second floor Corridor 205; fabric covered wainscot stained and damaged.

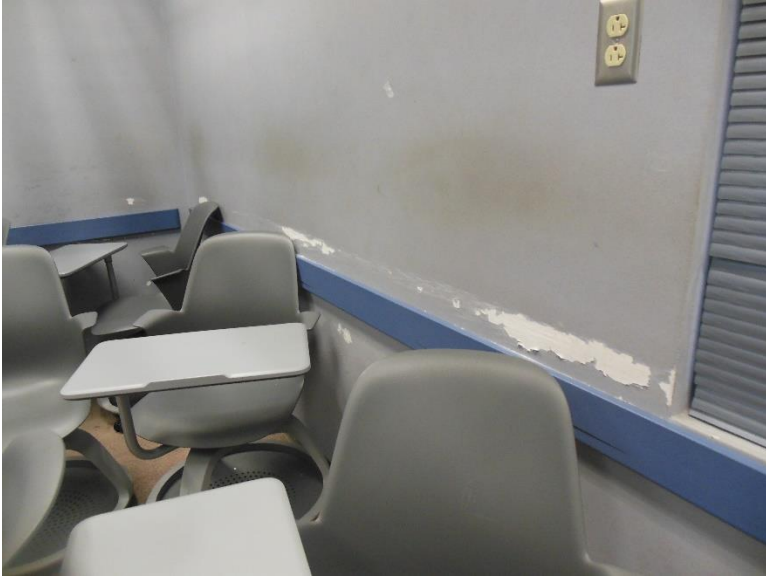
A6. Second floor classroom; paint finish damage from chair backs.

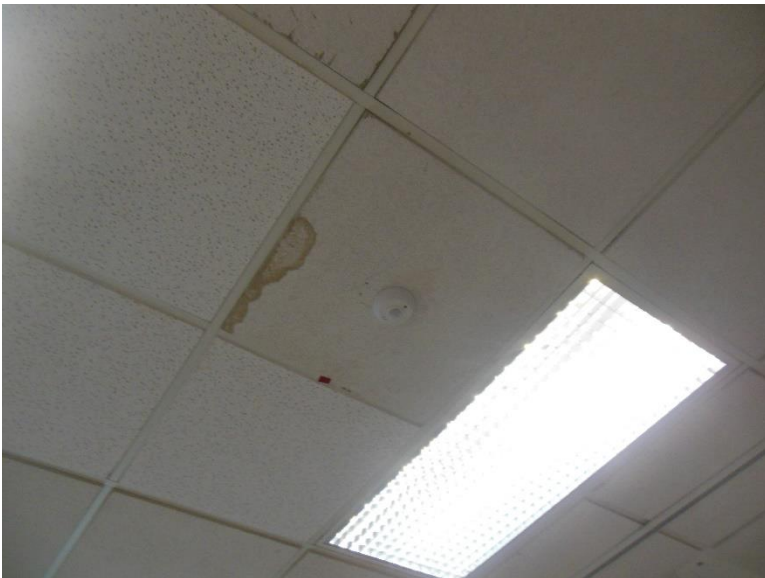
C2. Second floor classroom, stained and damaged ceiling tiles.

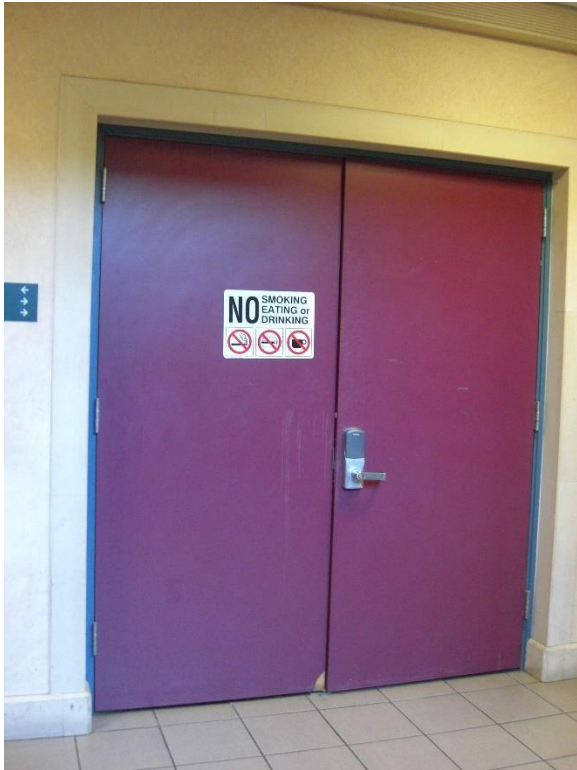
- Doors - The color of the plastic laminate finish on the doors vary throughout the building; many show wear, are stained, and the edges of the laminate are damaged and chipped. Reskinning these doors would benefit the overall life span of the space.

D1. Second floor; damaged and stained plastic laminate faced classroom doors.

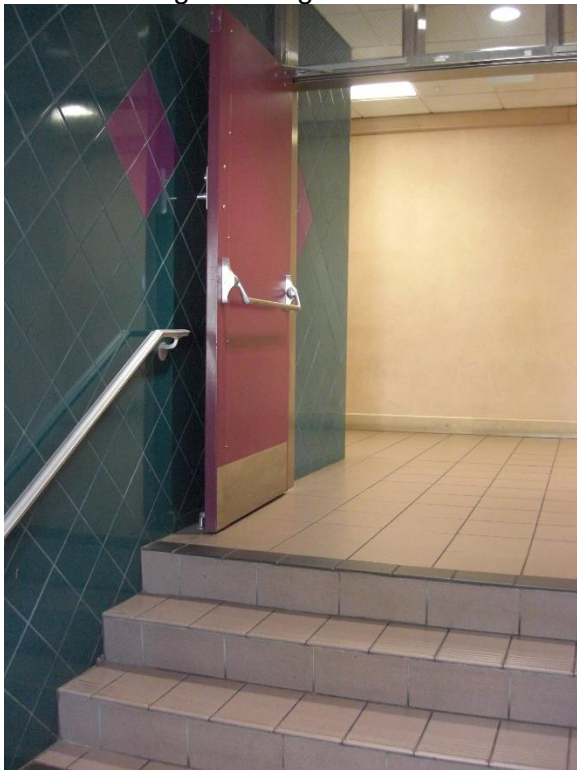
D6. Third floor, doors impede upper landing clearance.

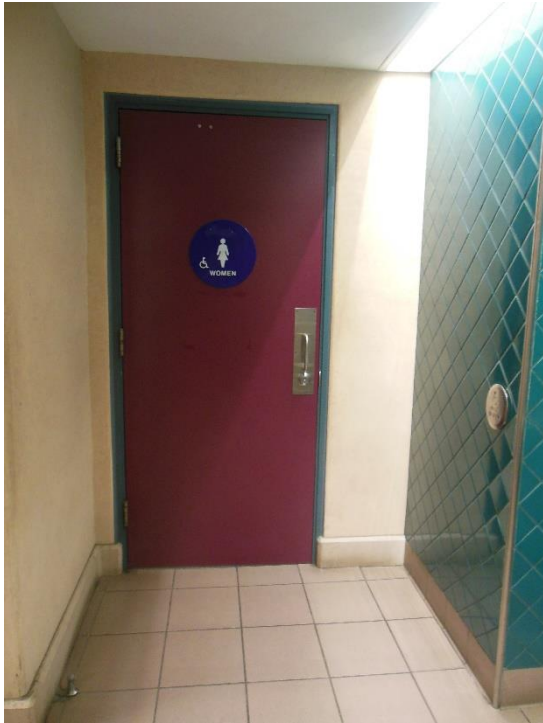
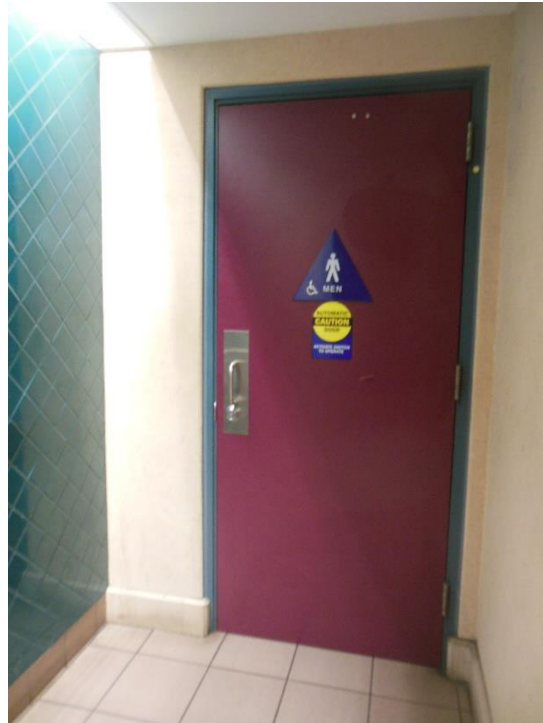
D7. Second floor restroom doors are missing wall mounted room ID signage. Low level access button for electronic door operator is required by code.

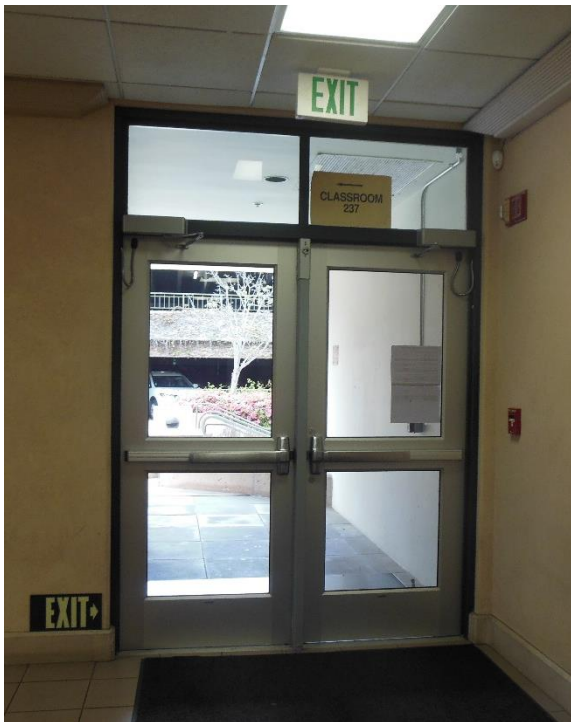
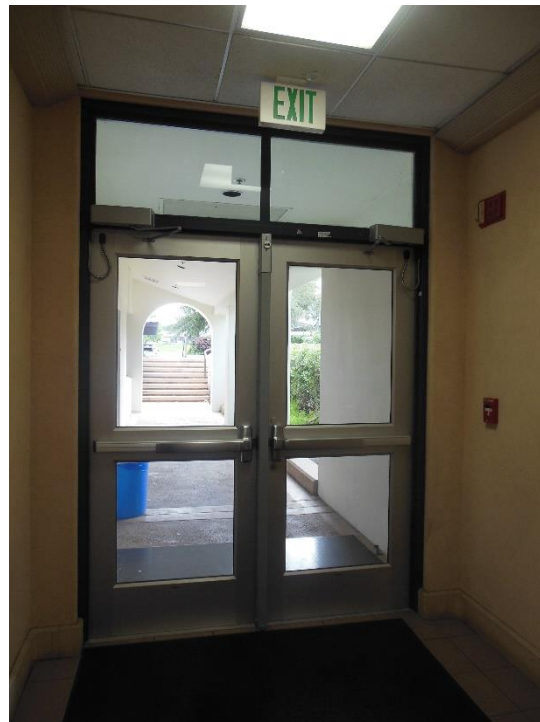
D8. Second floor corridor exit doors; missing wall mounted ADA exit signage and overhead exit signs are not illuminated.

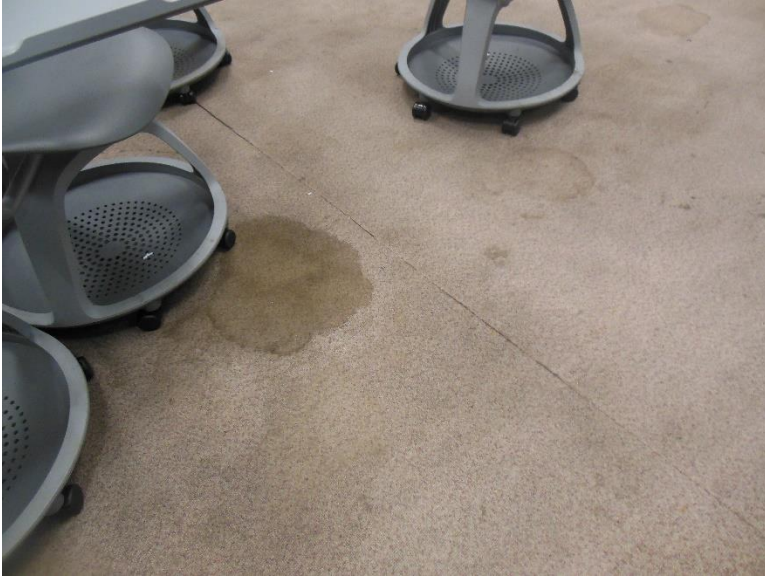
IF4. Second floor classroom, worn and stained carpet, typical.

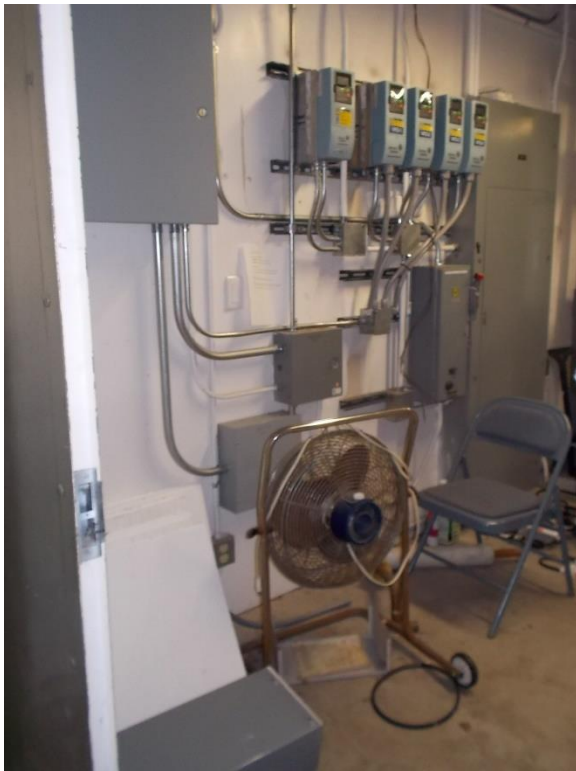
E2. Electrical equipment lacking clear floor space required by code.

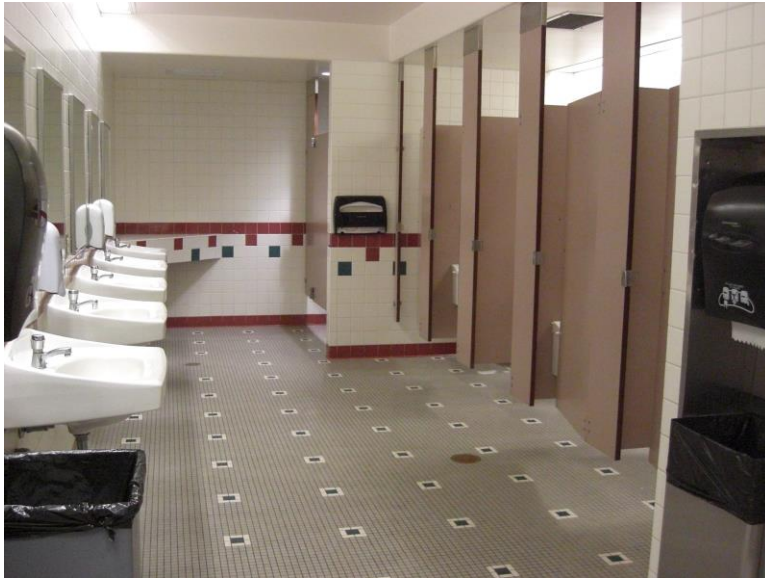
RR1. Second floor restrooms; improper placement of seat cover dispenser.

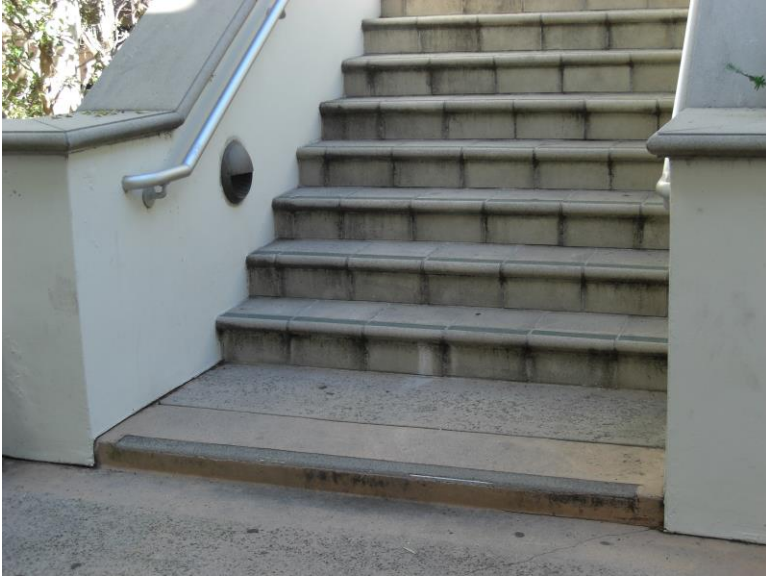
ST5. East exterior stairs with non-compliant landing length.

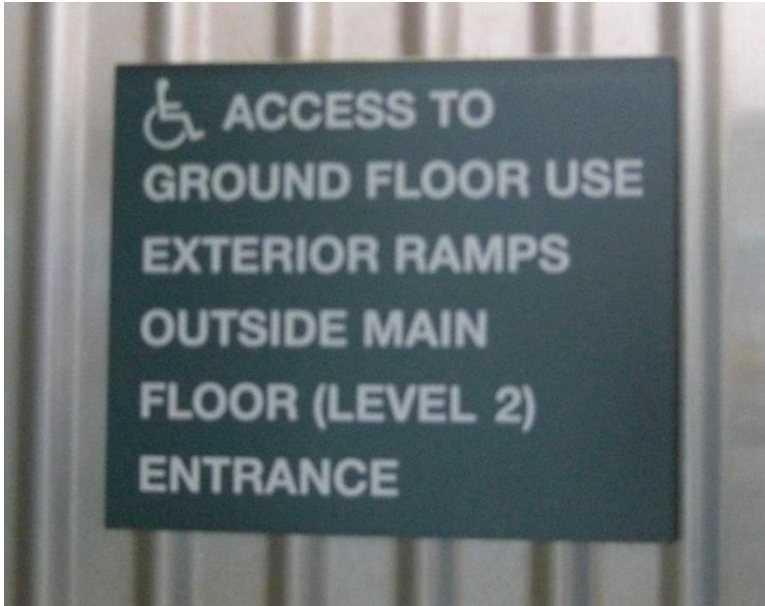
S1. Second floor; wayfinding signage at elevator.

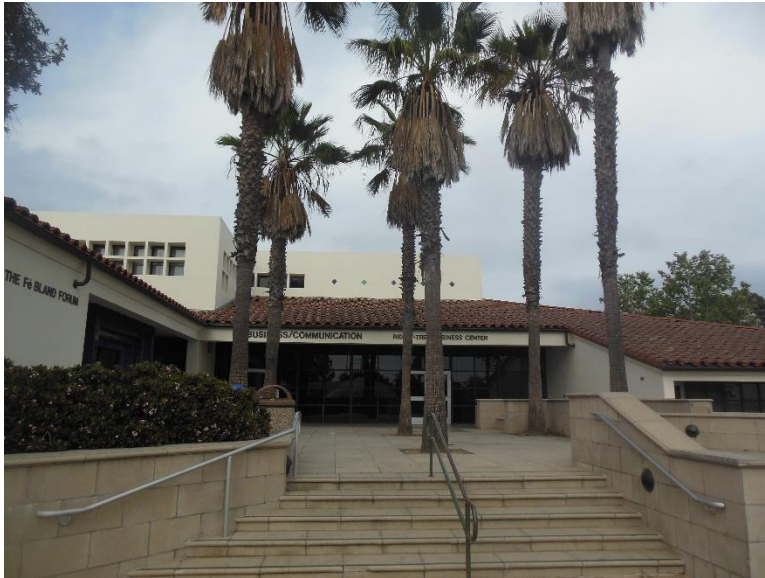
PT1. West side; main entrance plaza.

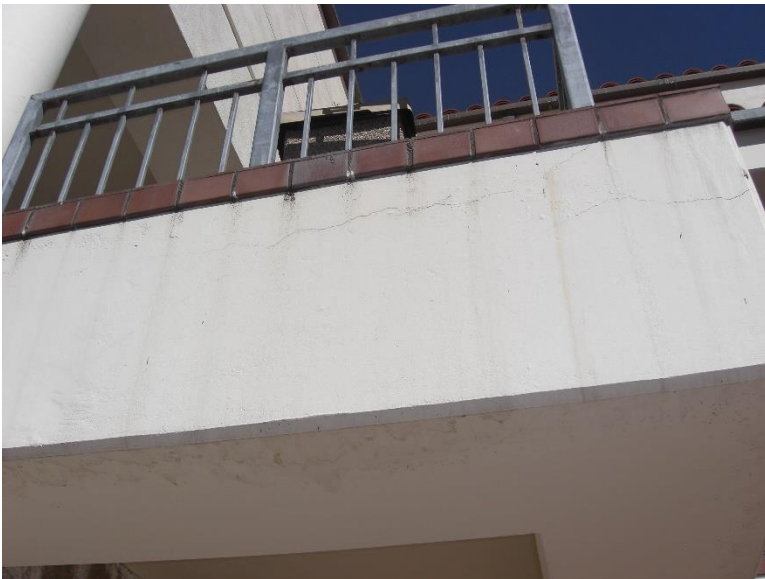
AE2. West facing entrance overhang cracked plaster finish with water damage.

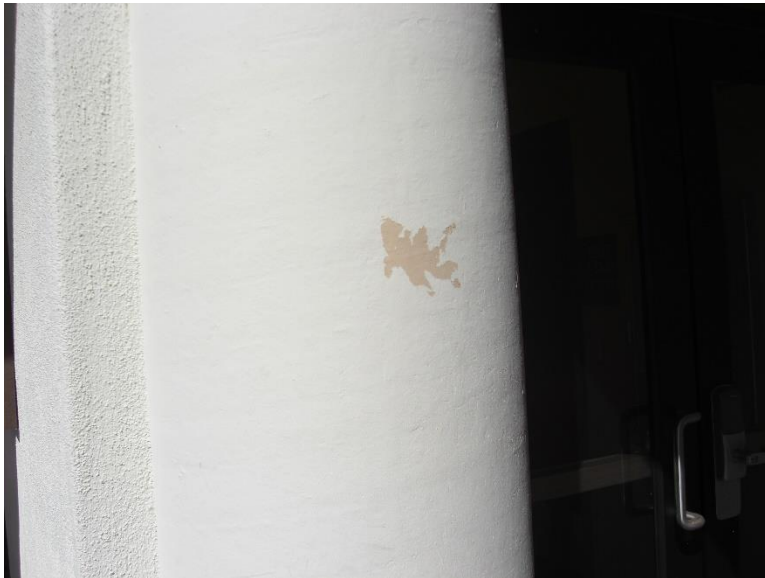
AE4. First floor CMU column under overhang with paint finish damage.

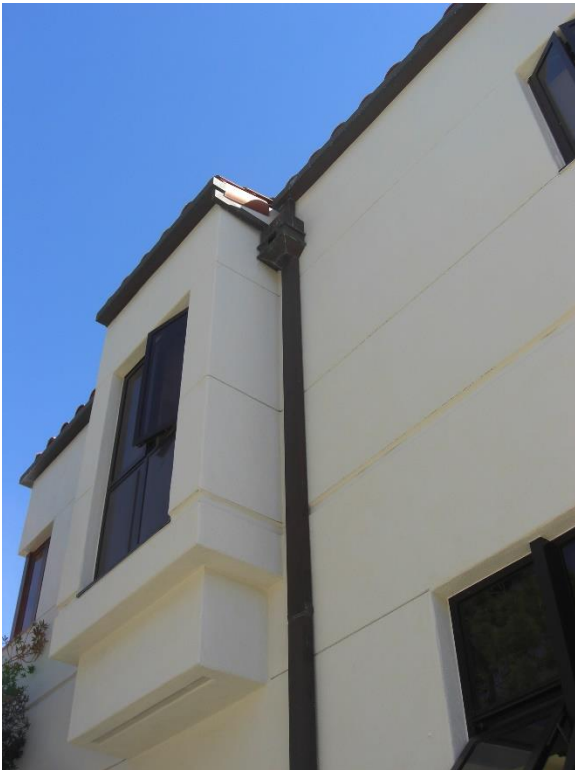
R4. Clay tile roof system with metal downspouts, in good condition.

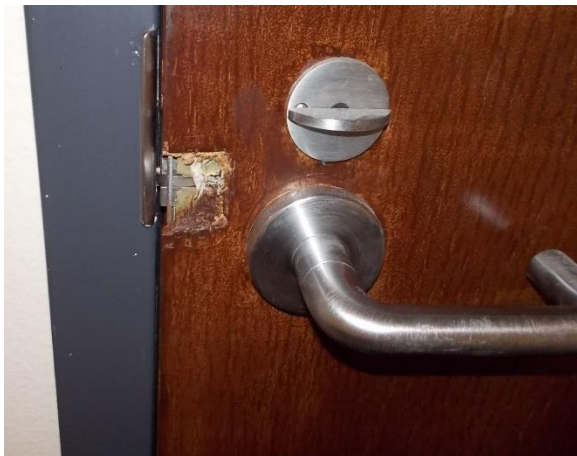
D5. Third floor office door with damage edge at latch.

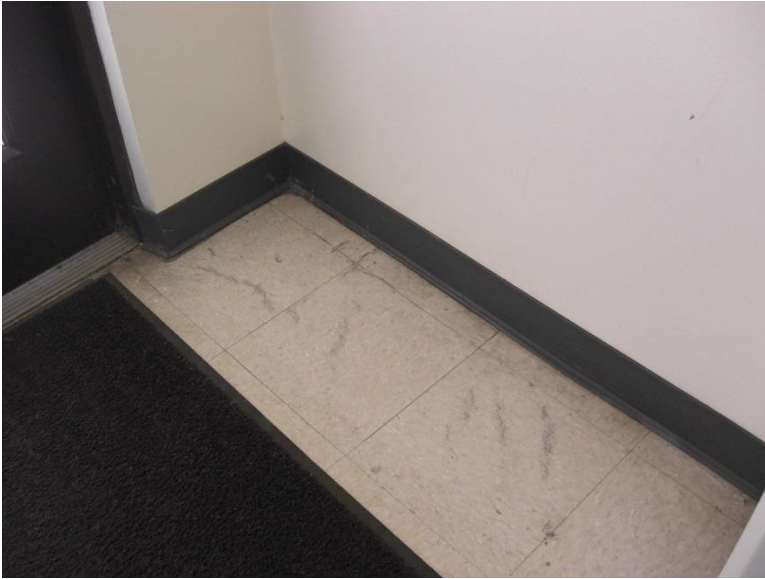
**FLOORING:** The corridor flooring on the first and second floors was not upgraded during the refurbishment projects, and is the original 12"x12" vinyl composition tile (VCT). It requires regular maintenance to keep it in fair to good condition, and has a few scratches and minor holes. These flooring surfaces would benefit from a modernization to match the lifespan of the other new materials throughout the building.

IF1. Second floor entry corridor; cracked and damaged VCT flooring.

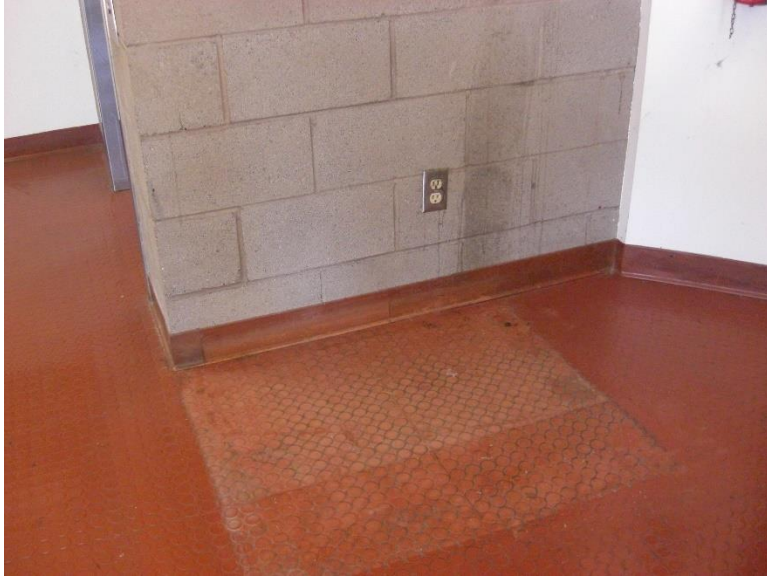
IF3. First floor exit passageway at stairwell enclosure by elevator. Damaged rubber flooring and resilient base.

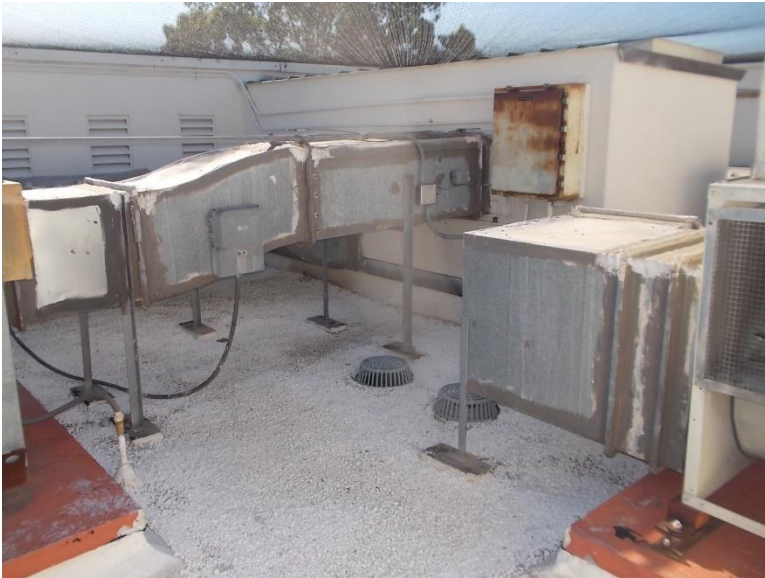
M1. Rooftop mechanical equipment at end of useful life.

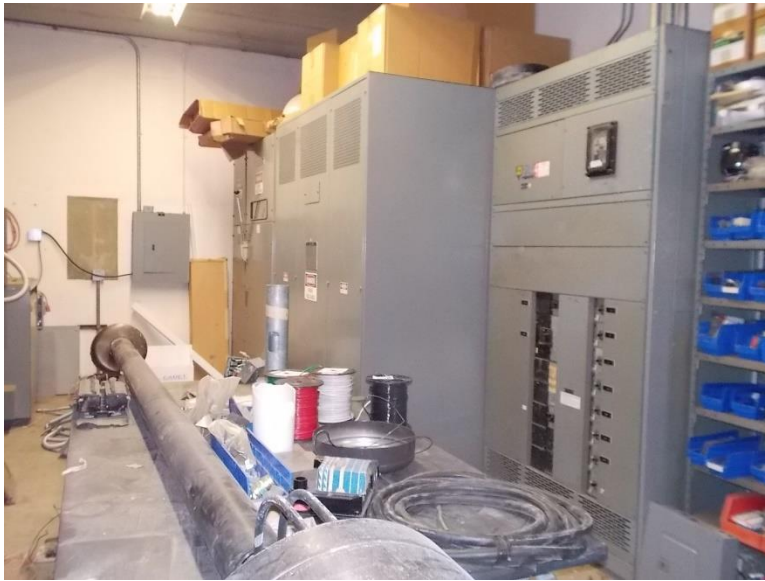
E1. Electrical equipment lacking clear floor space required by code.

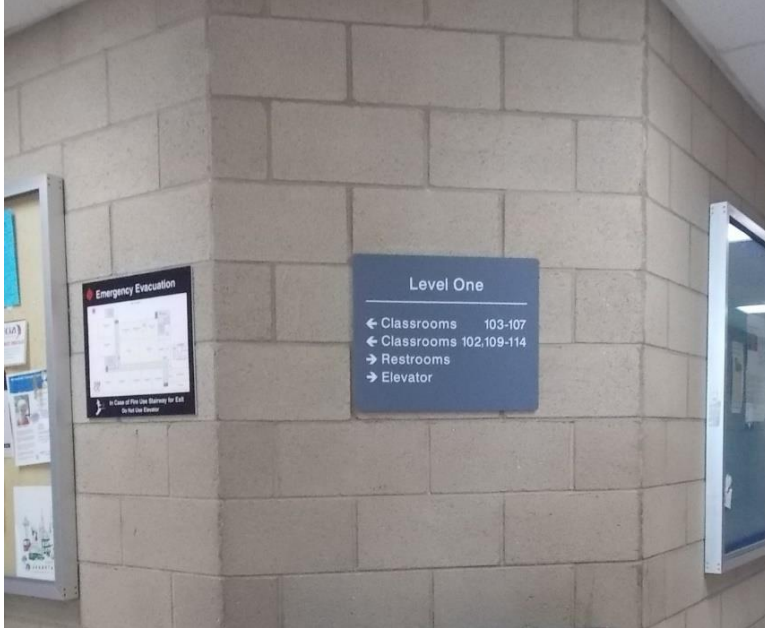
S1. Directory and Evacuation Signage; first floor.
