# SANTA BARBARA CITY COLLEGE

## ADA PATH OF TRAVEL ASSESSMENT

# Facility Condition Assessment Report ADMINISTRATION BUILDING

**Facility Condition Assessment Report**  
**Santa Barbara City College – Main Campus**  
**Administration Building**  
**721 Cliff Drive**  
**Santa Barbara, CA 93109**

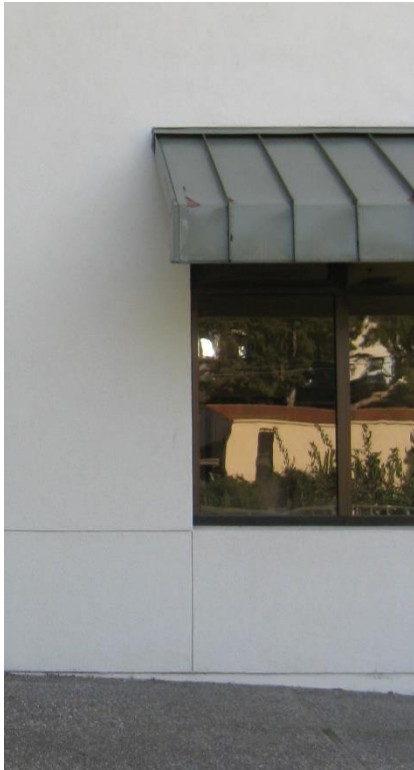
**ROOF:** Multiple standing seam metal awnings are rusted, damaged, and are in need of repair. There is damaged mortar at the roof tile ridge on the northeast side of the roof. The built-up roof system is in good to excellent condition.

R1. Metal awning damage, northeast side of building.

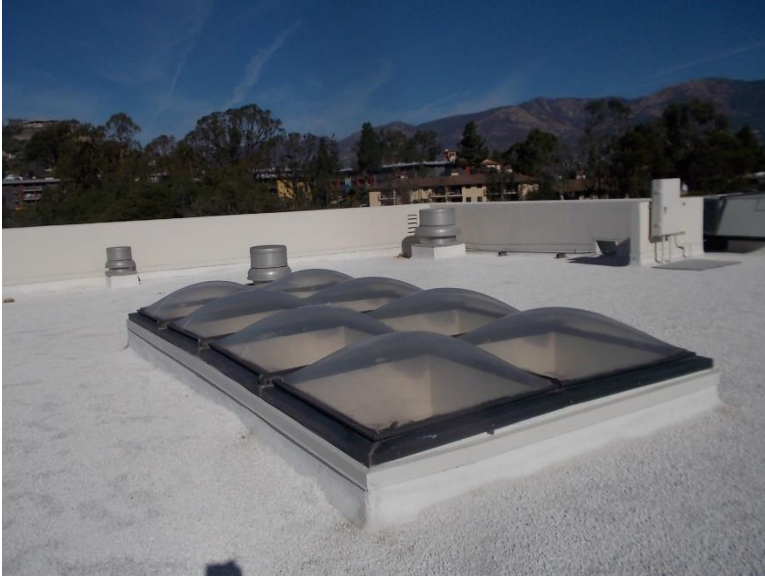
R3. Skylights over Library east side.

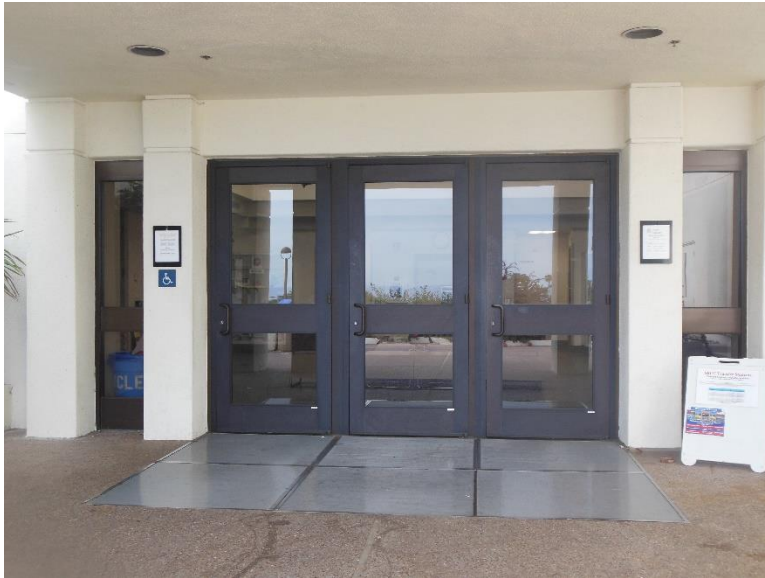
D1. Main Entrance; doors do not provide code required pull-side clearances, and wall mounted door identification signage.

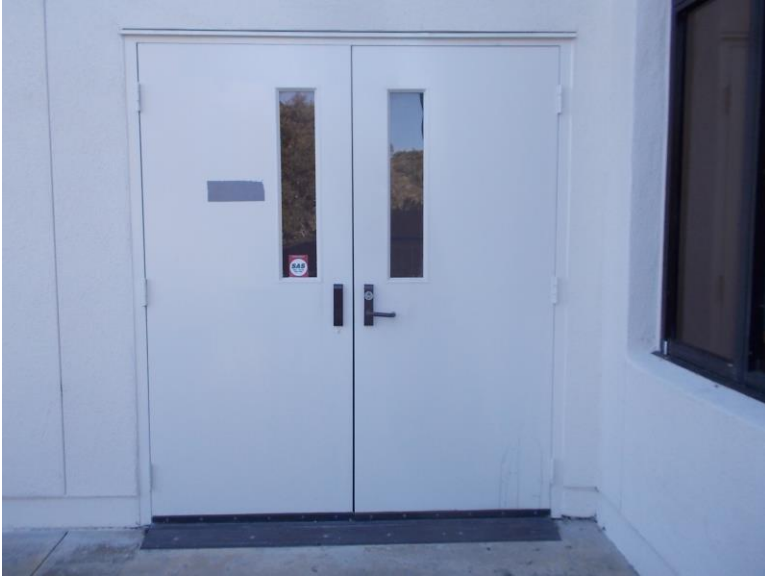
D3. Doors to stairs, at lower level; lacking code required wall mounted door identification signage.

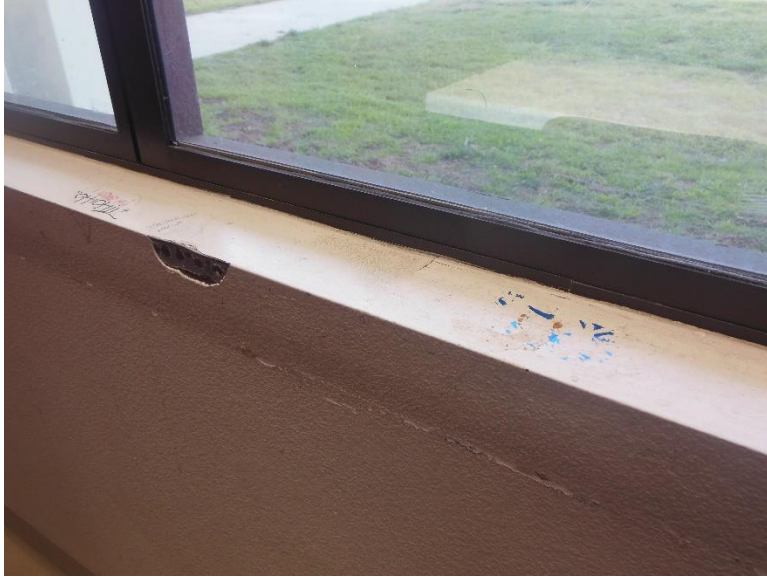
A6. Library south side; lower level window sill vandalism and damage.

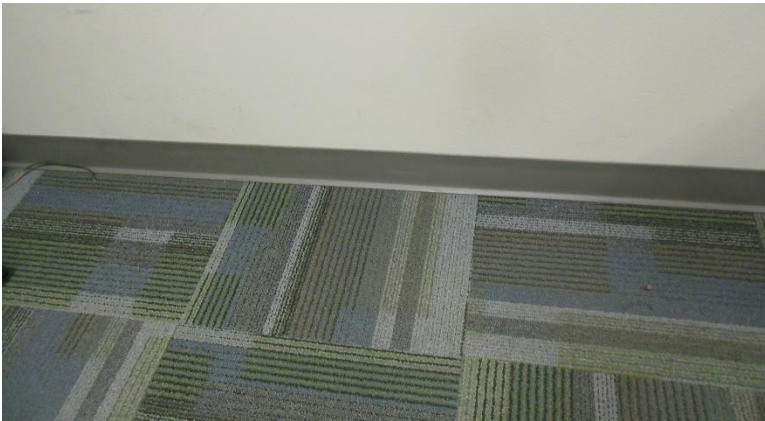
IF2. Learning Center carpet tile and rubber base in excellent condition.

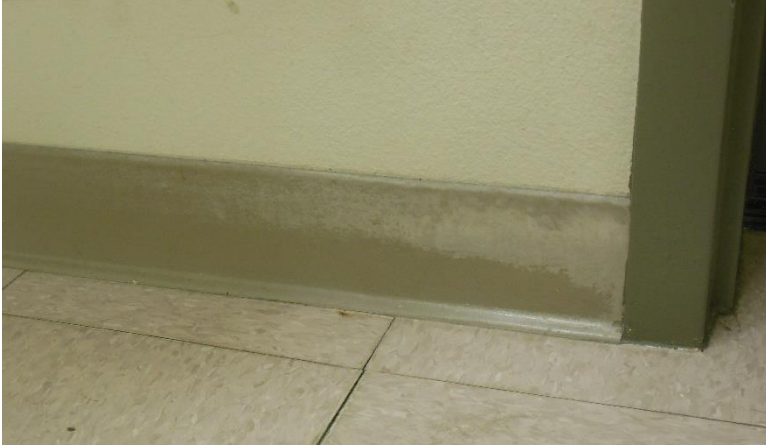
IF4. Corridor 112; original VCT and rubber base in poor condition.

- Flooring - Areas which received new carpet tile and base remain in good condition. The resilient flooring green colors are dated and the finish conditions are stained, worn, and should be replaced. The basement area has the original 9x9 VAT which is badly damaged and exposed. Remediation and abatement at this damaged material is recommend now, as well as during any future renovation.

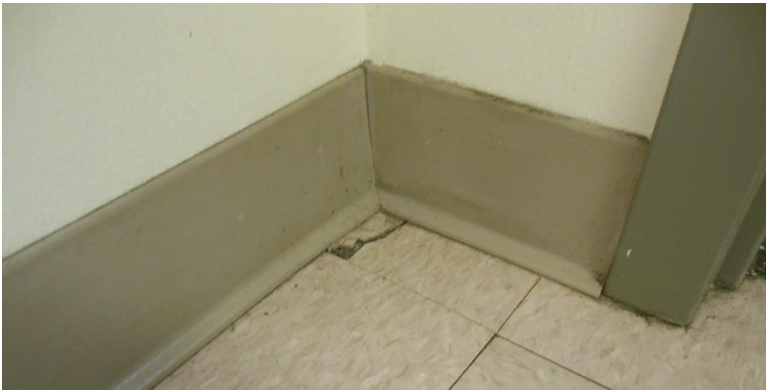
IF5. Corridor 112; original VCT and rubber base in poor condition.

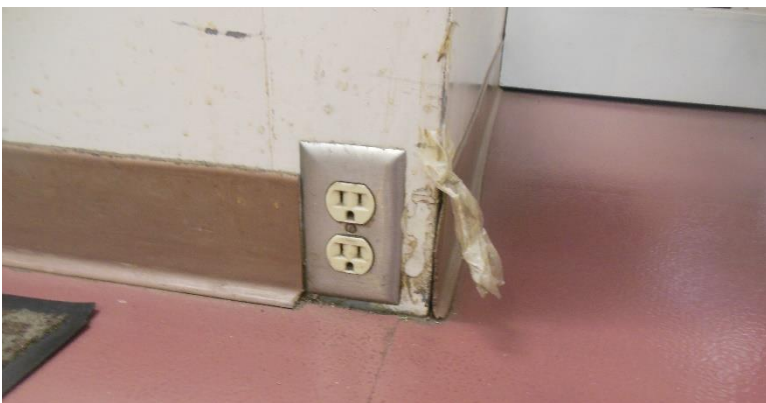
IF6. Library vestibule; resilient base in very poor condition.

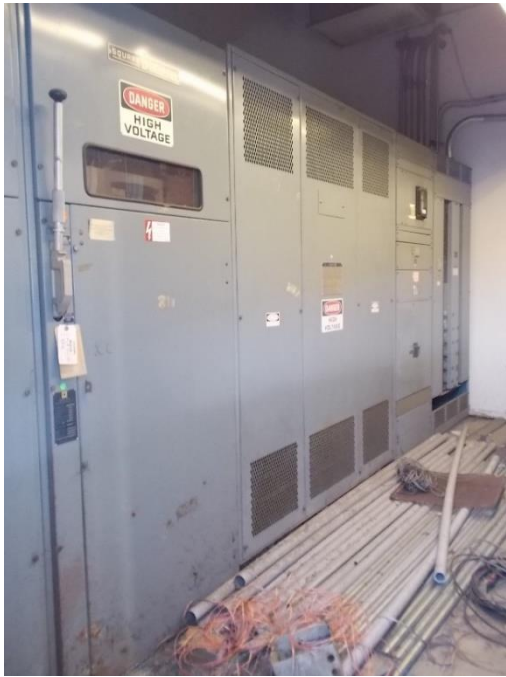
E1. Electrical equipment lacking clear floor space required by code.

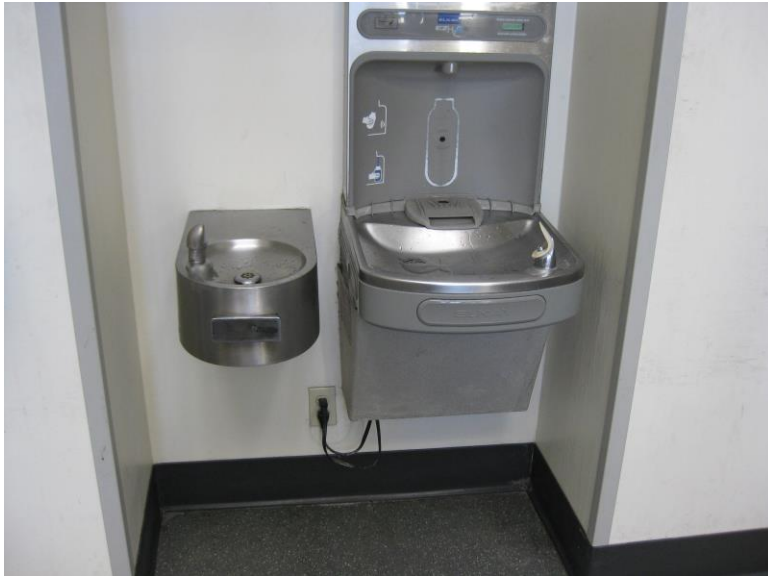
DF1. Lobby; water bottle filling station and drinking fountain.

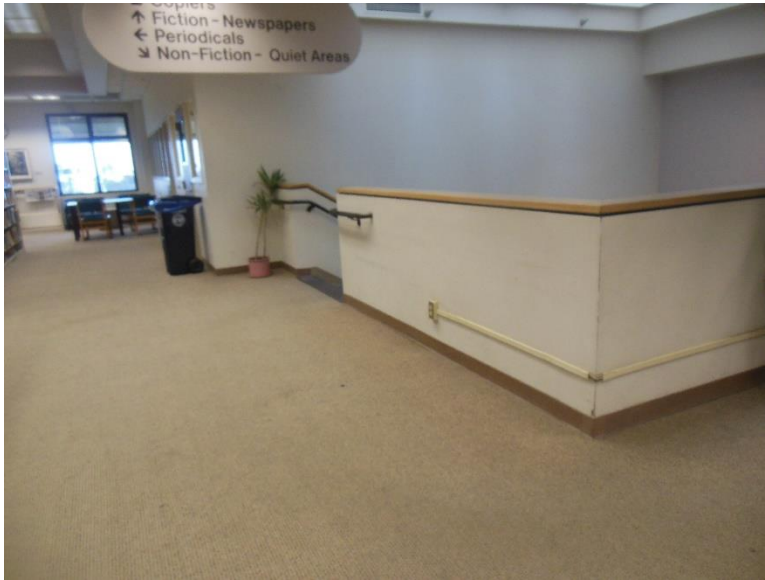
ST1. Library main interior staircase; ADA signage missing.

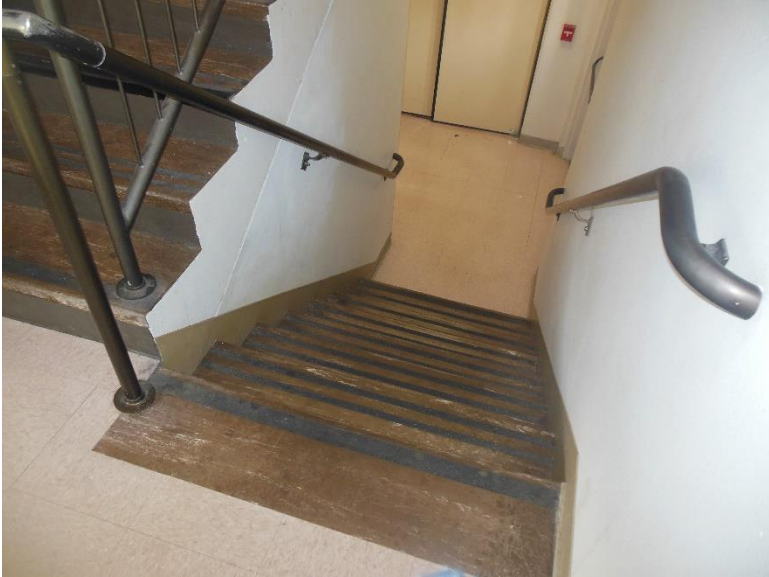
ST4. Stairwell 136; minimum stairwell width of 44" is not provided.

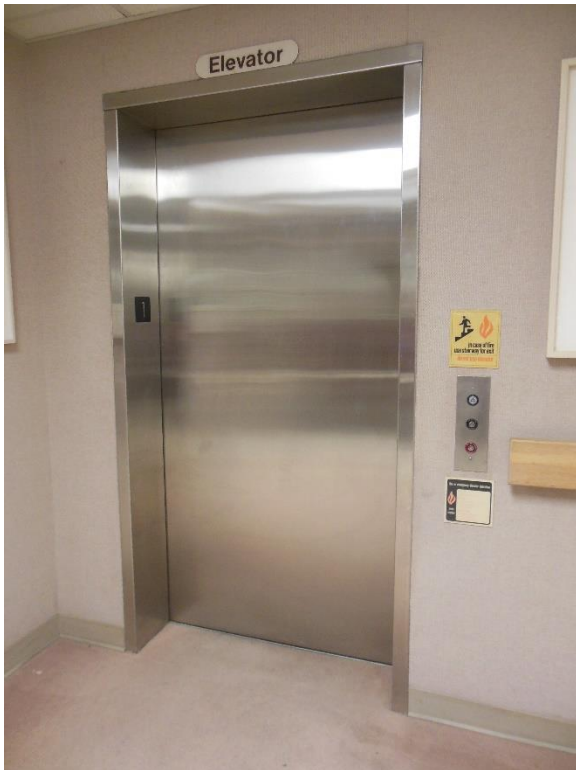
EV1. Library; first floor elevator entrance.

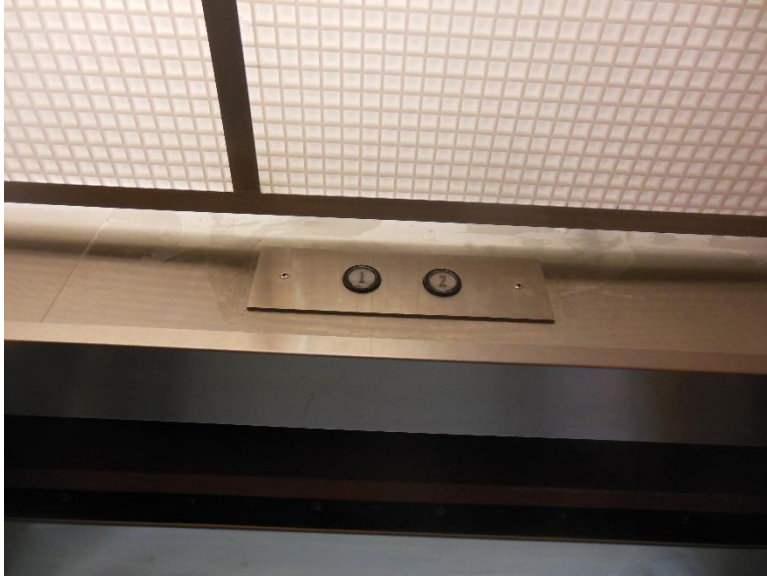
EV3. Inside elevator cab; floor indicator lights not operating.

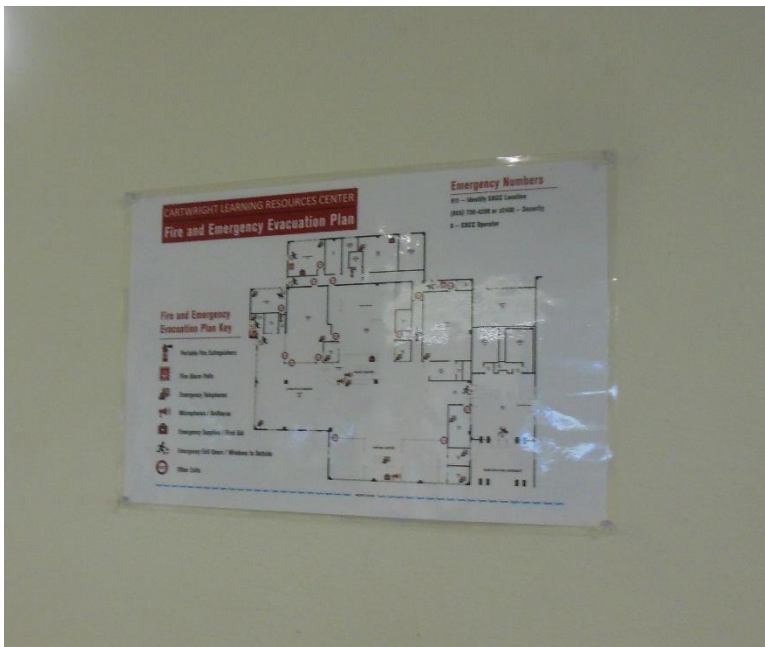
S2. Evacuation maps provided at west side of building, not east.

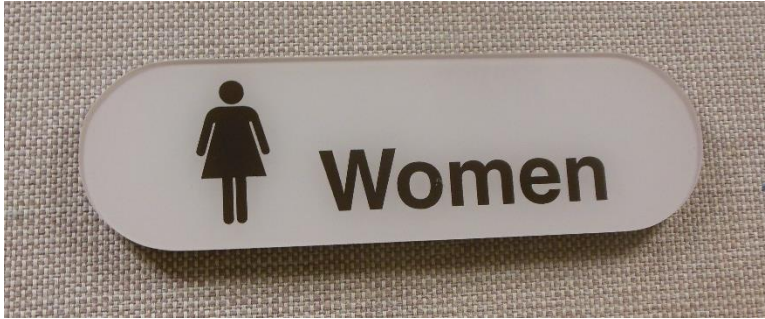
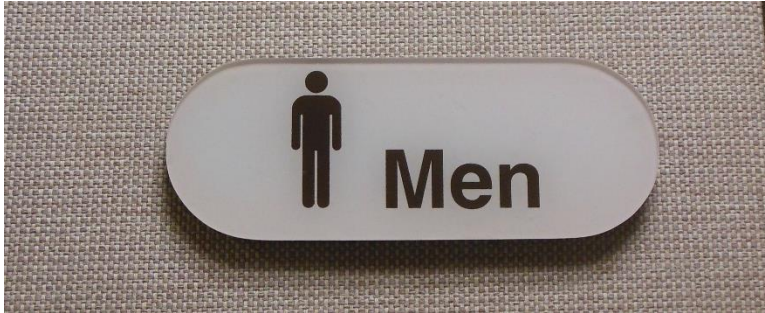
S3. Library restrooms, second floor.  
Women's and Men's non-compliant wall signage.

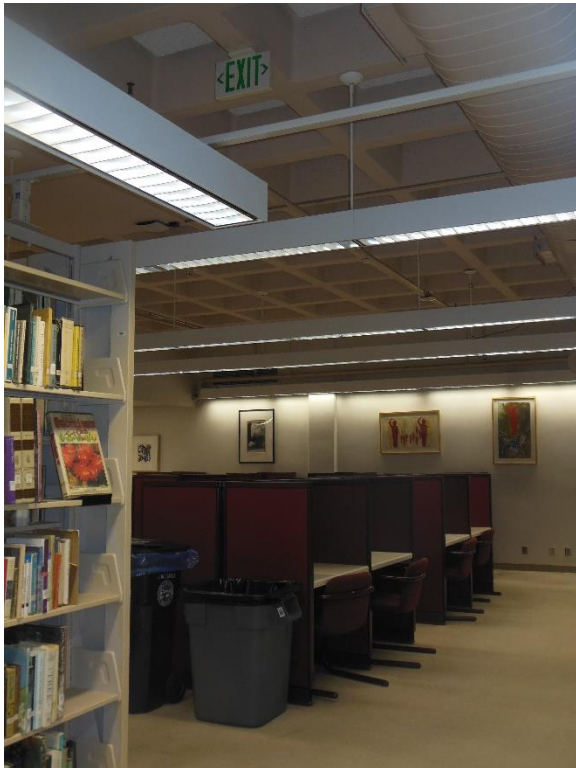
S4. Library, lower level; exit sign not illuminated,  
and excessively high for visibility.

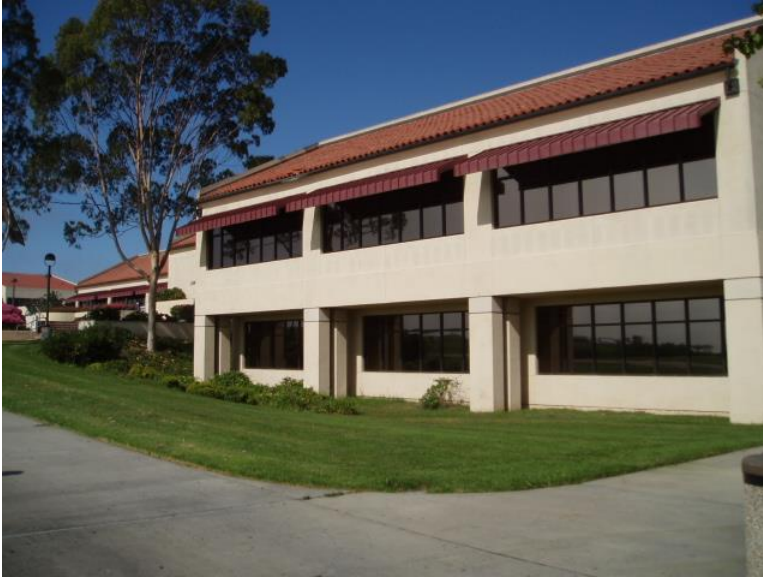
PT1. Non-compliant path at southeast side of building.

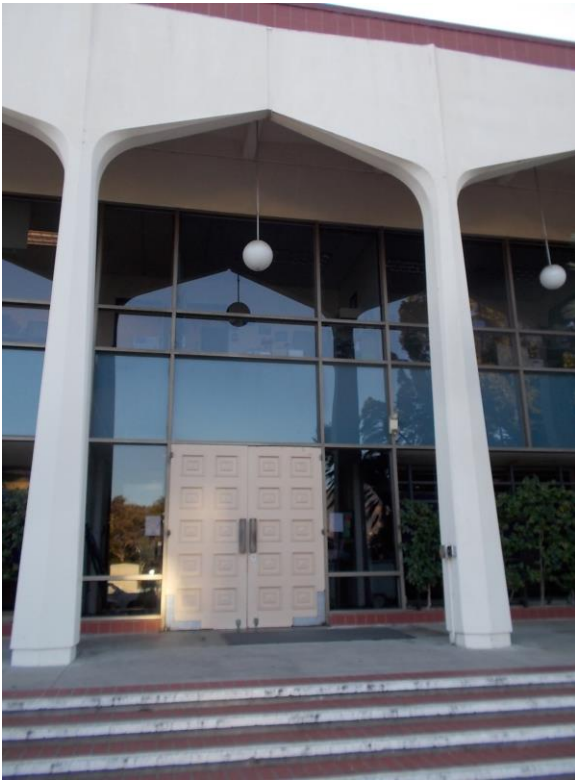
D1. East side entrance; doors require excessive force to open, electronic door opener lower-level push plate not provided and ISA sign not installed.

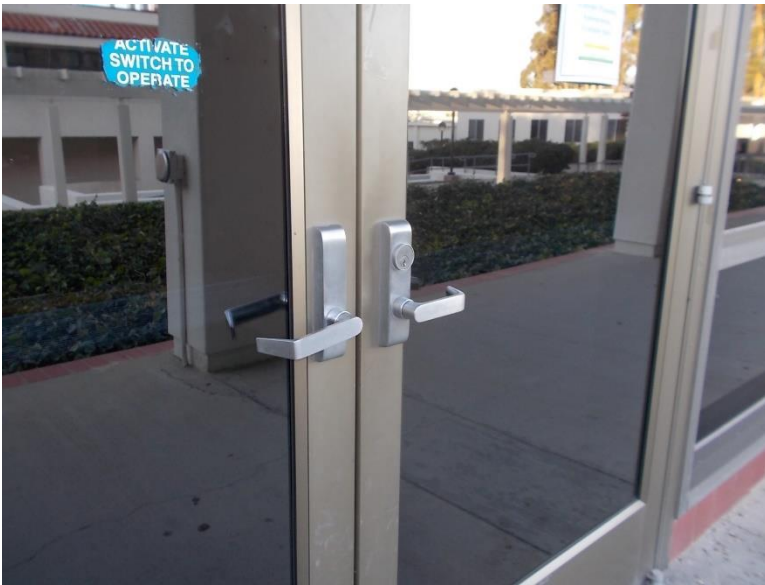
D4. South side entrance; doors require excessive force to open, electronic door opener lower-level push plate not provided and ISA sign not installed.

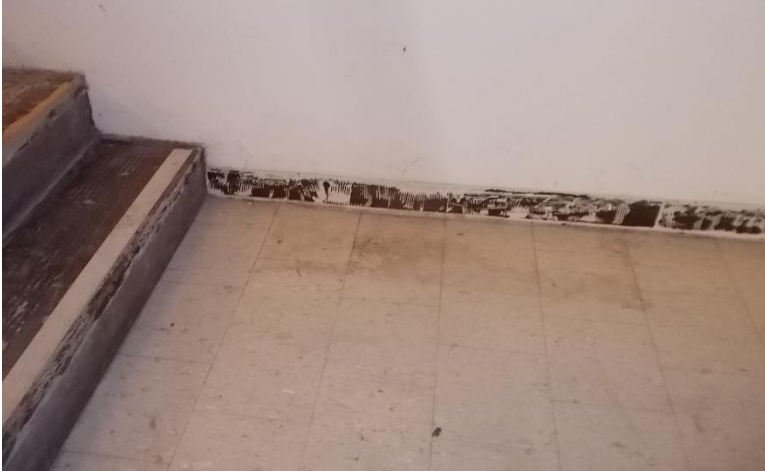
IF3. Basement; base damage at wall and stair riser.

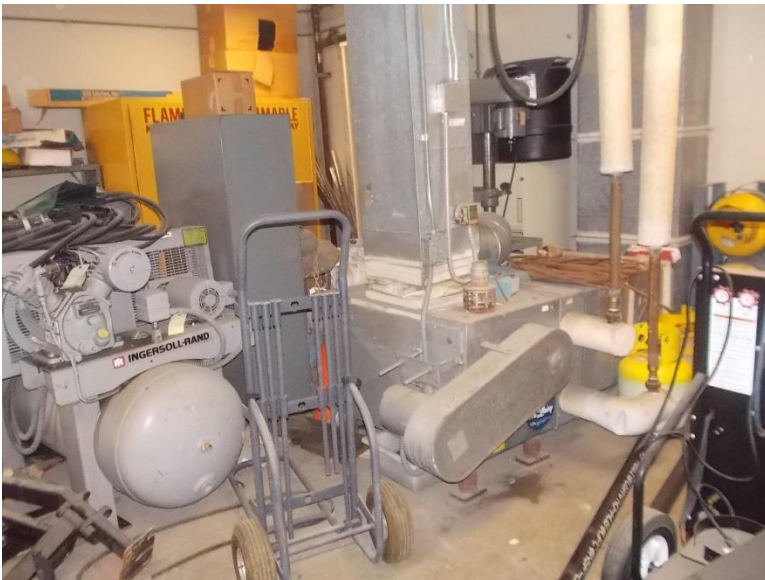
M2. Mechanical equipment lacking clear floor space required by code.

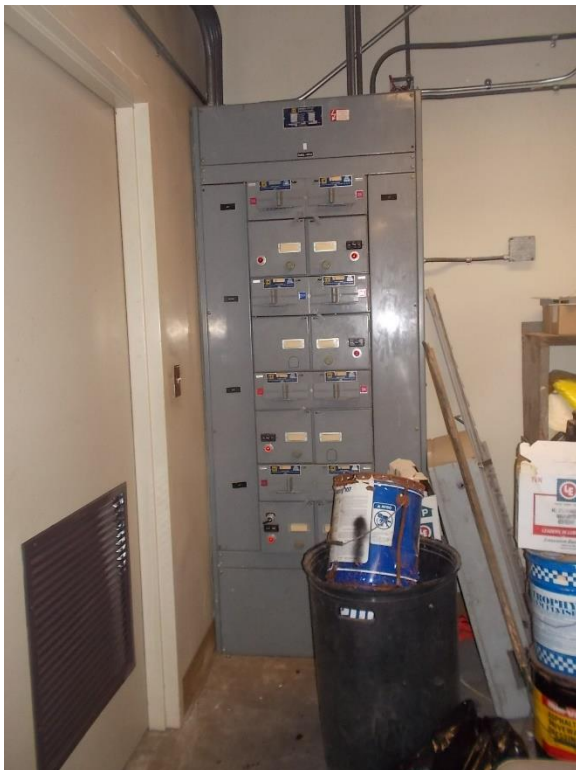
E2. Electrical equipment lacking clear floor space required by code.

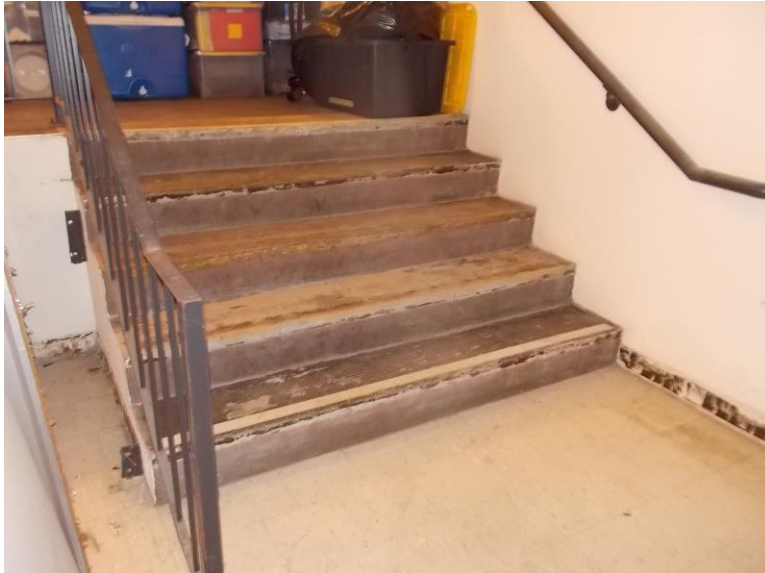
S1. Basement stairs; severely damaged materials, and non-compliant handrails.

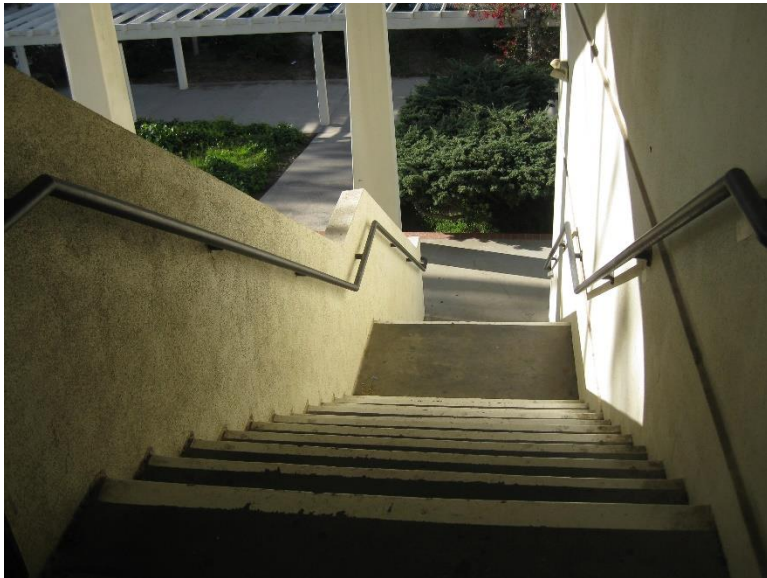
S4. Exterior northwest stair; stair nosing stripping faded, handrail heights and returns non-compliant.

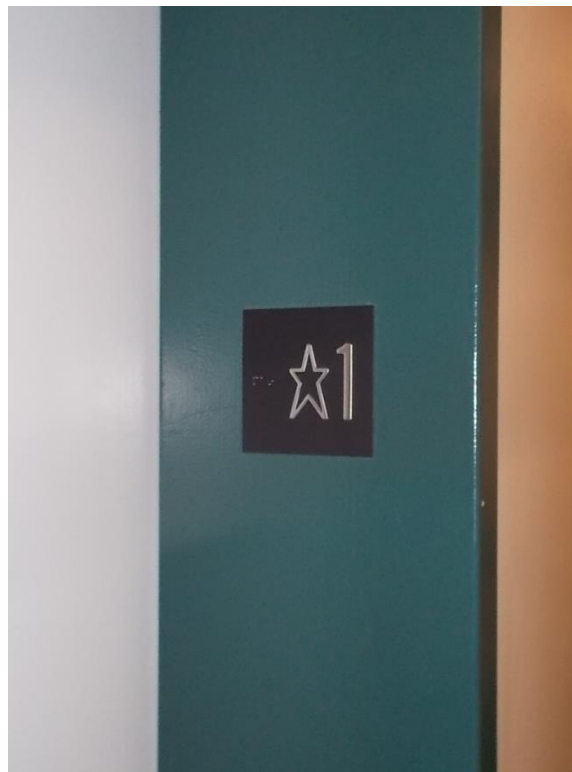
EV3. Braille floor level sign.

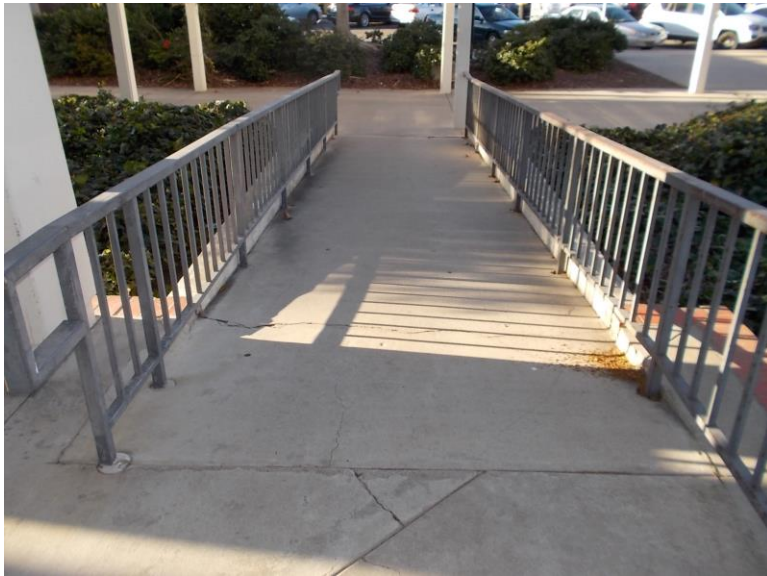
PT1. Exterior north ramp; non-compliant ramp. Handrails heights are too short, gripping surface is too wide, and ramp has excessive running slope. ADA directional signage is not provided.

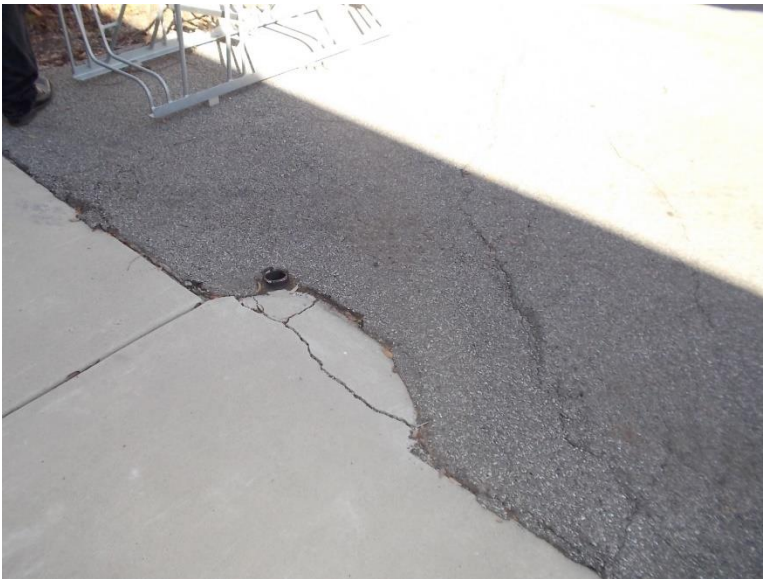
EF2. Exterior sidewalk transition; abrupt change in level.

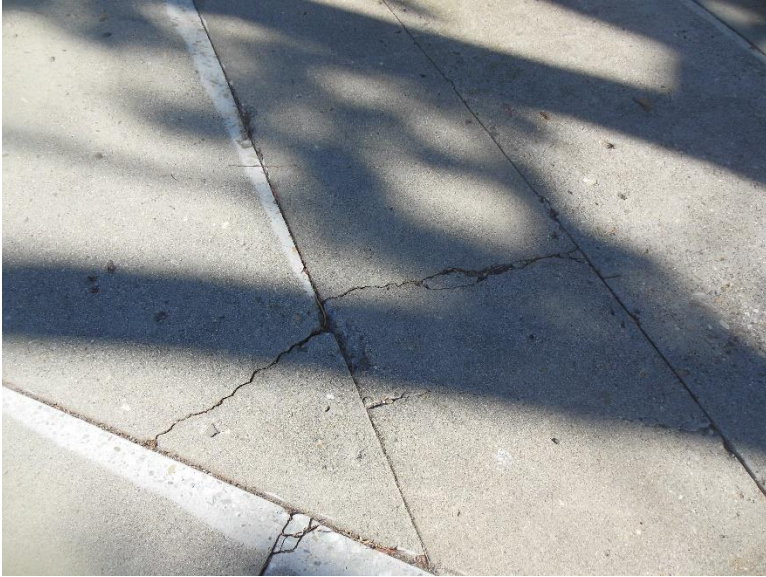
EF3. Exterior corridor walkway; cracked and degraded concrete.

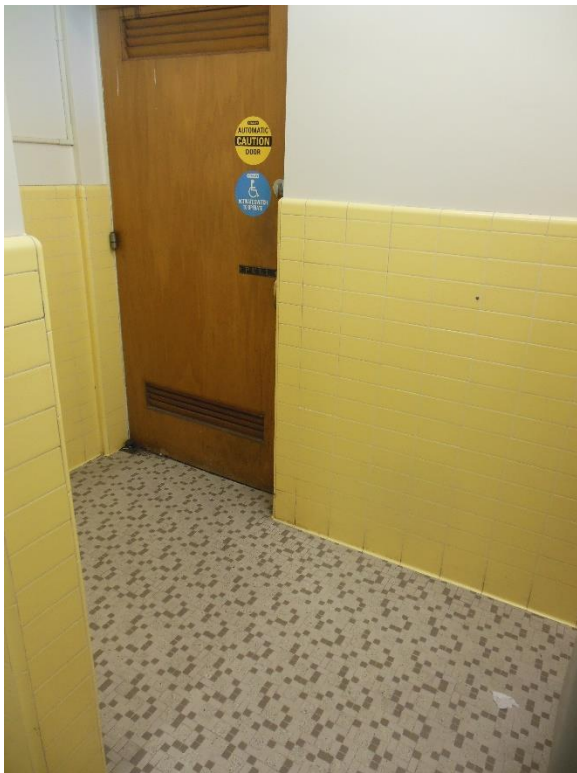
AI4. Restroom foyer, original ceramic tile wainscot.

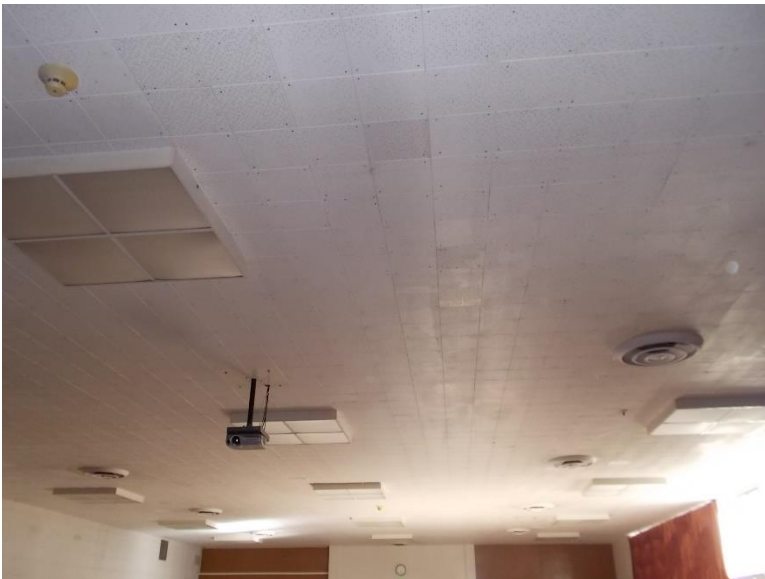
C2. Auditorium; glue on ceiling tiles, screwed into sub-structure.

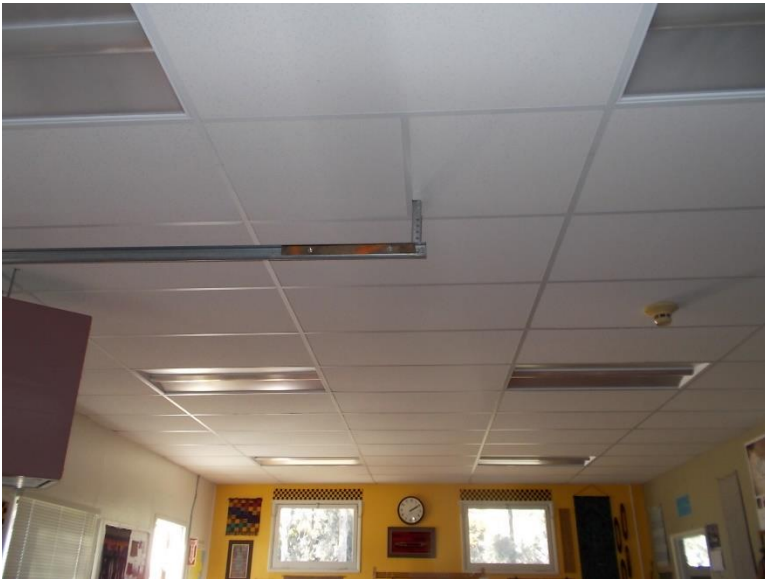
C4. Classroom 32; suspended ceiling system, with recessed lights, typical.

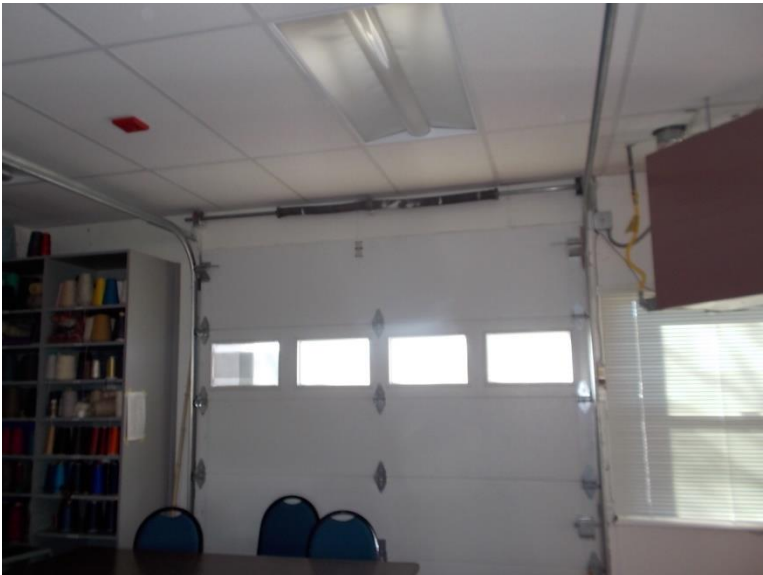
D2. Classroom 32; interior roll-up door.

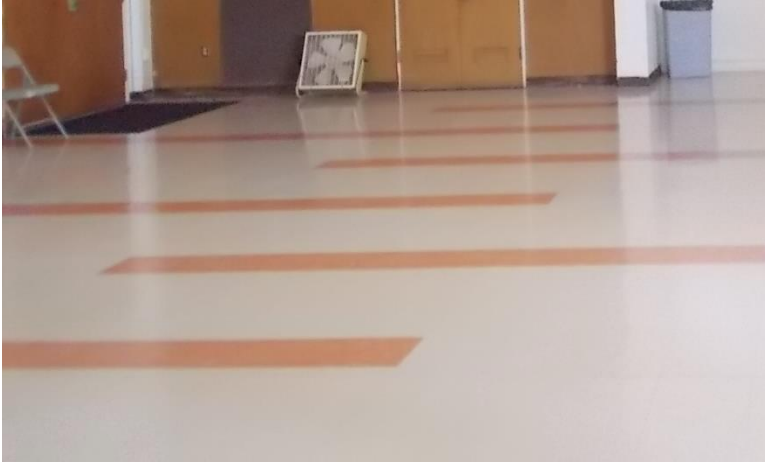
IF1. Auditorium; VCT.

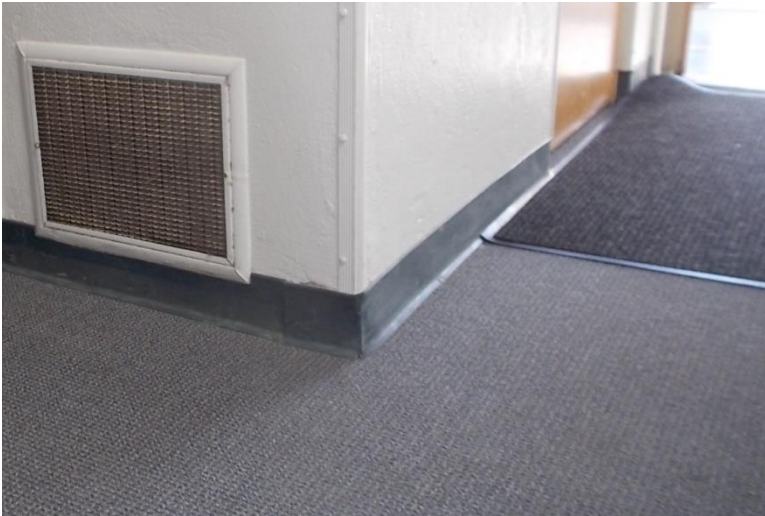
IF2. Office 02; 4; broadloom carpet and rubber base.

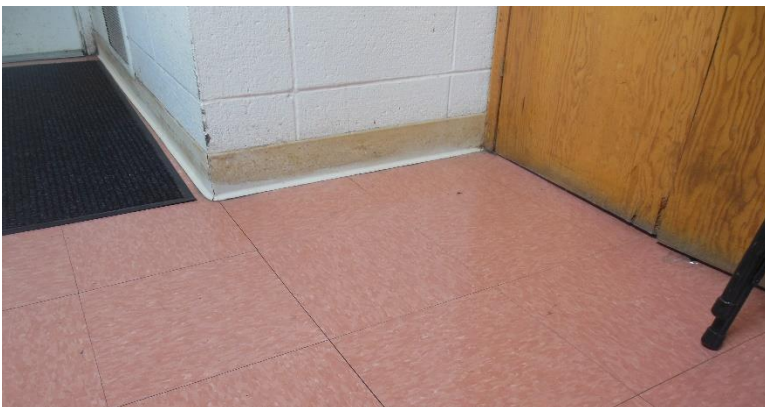
IF3. Classroom; VCT.

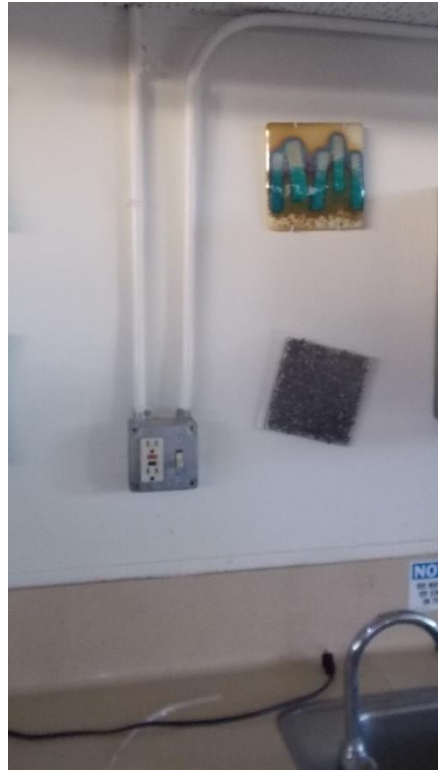
E2. Classroom; exposed conduit and wall mounted duplex outlet.

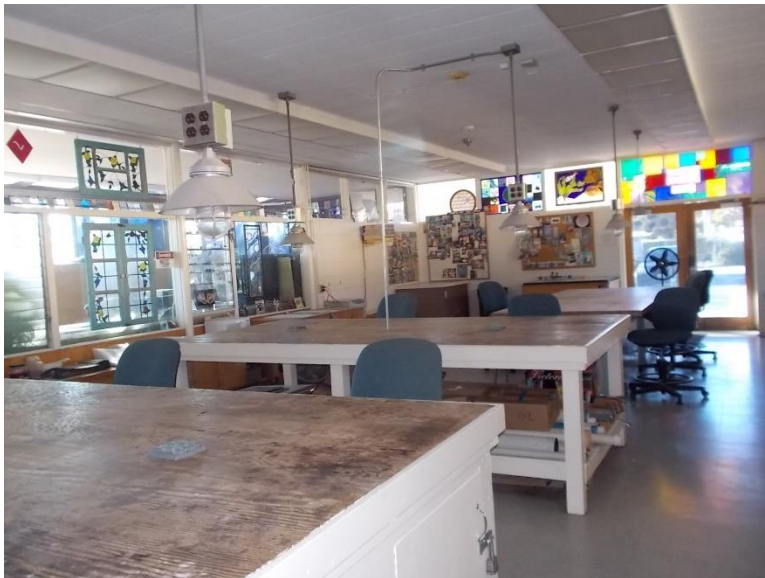
E3. Glass fusing classroom; power supply hanging from above.

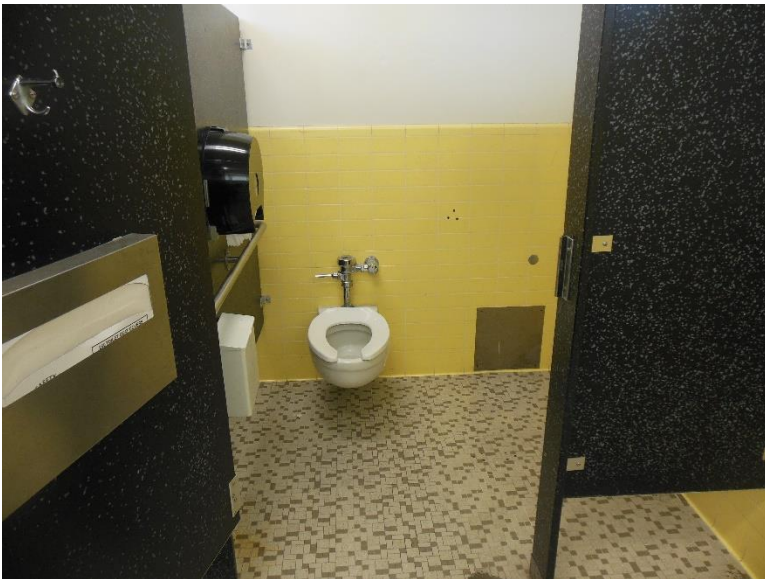
RR2. Women's Restroom; accessible stall, missing back handrail and stall size too small.

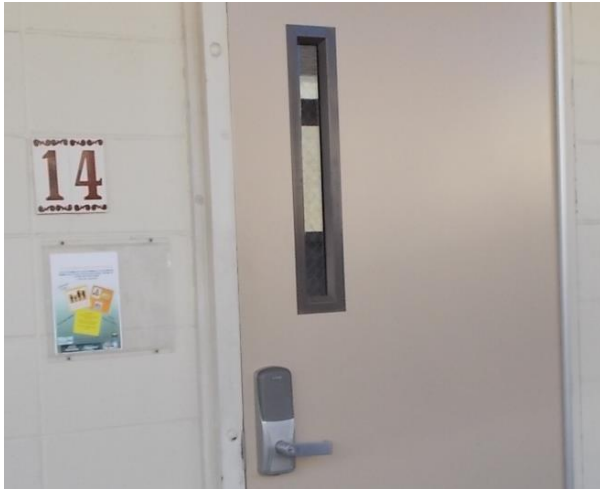
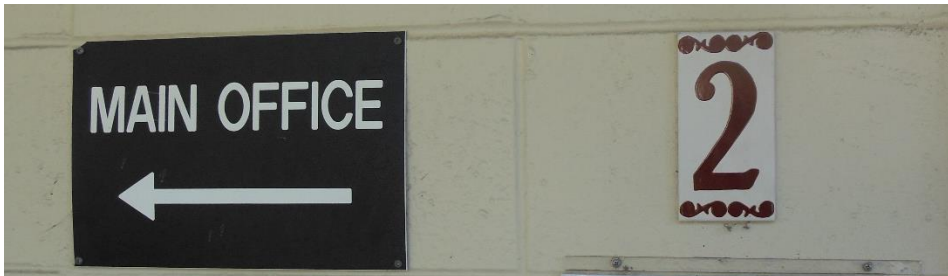
S1. Exterior room identification and wayfinding signs; non-compliant.

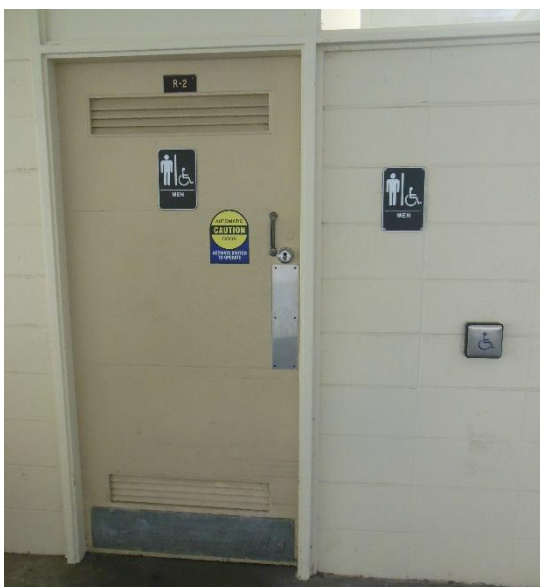
S2. Restroom room identification signs; non-compliant mounting locations.

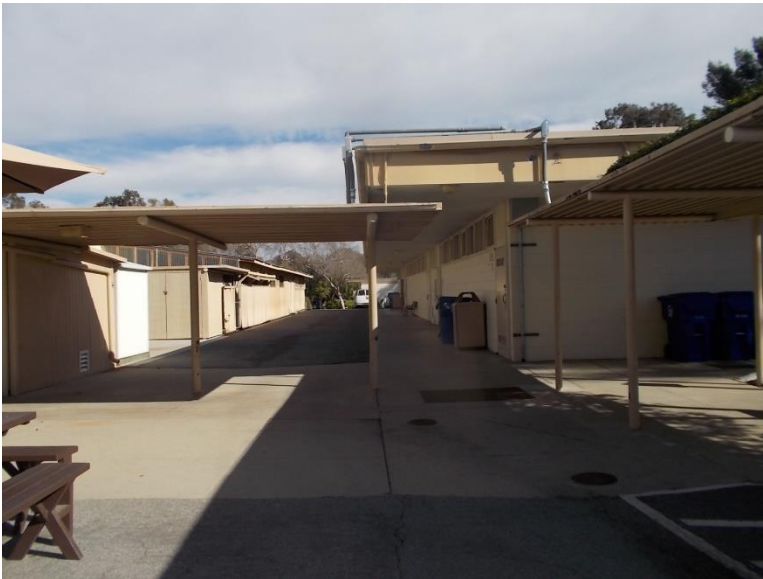
PT2. Exterior walkway; uneven, excessive slopes at path of travel.

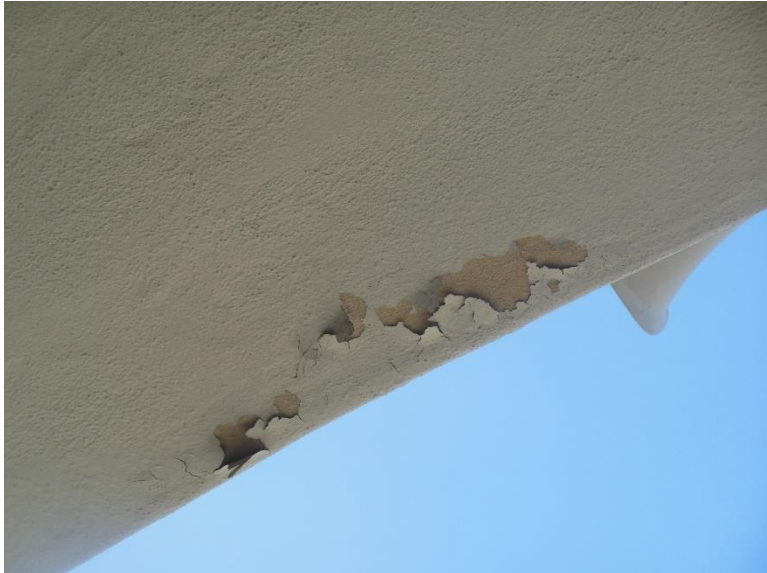
AE1. Permanent building exterior arch; peeling painted plaster.

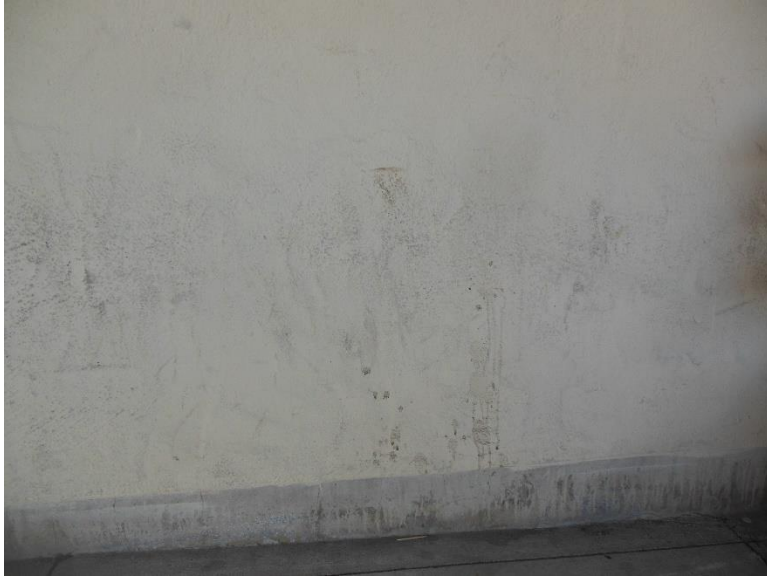
AE3. Permanent building exterior corridor wall; painted plaster damaged.

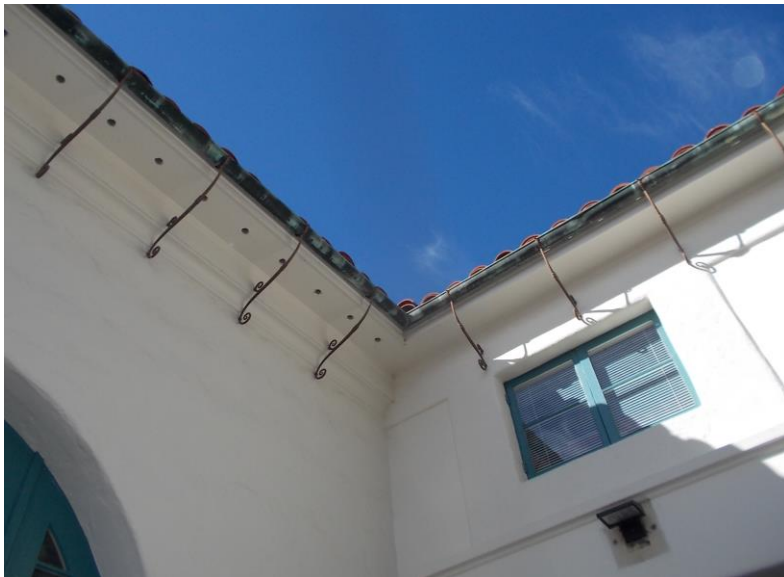
R2. Permanent buildings, copper gutters, downspouts and supports in good condition.

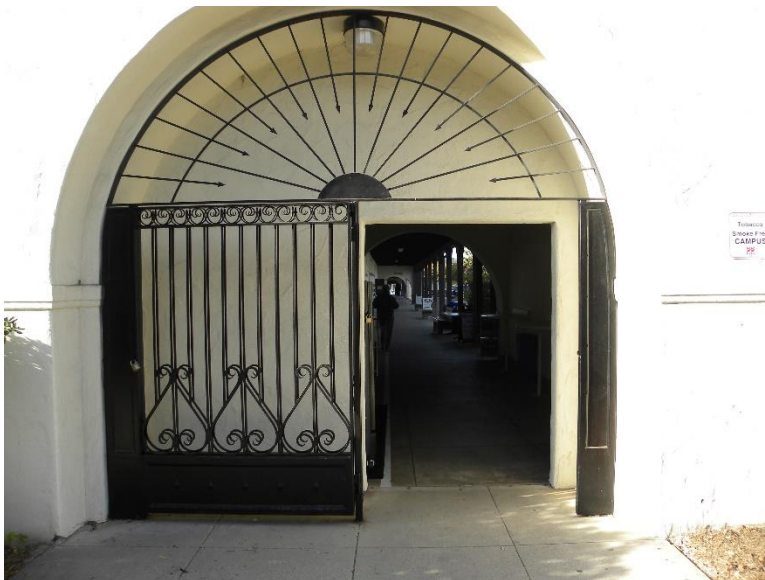
D2. Entrance from east side of site; missing ISA signage.

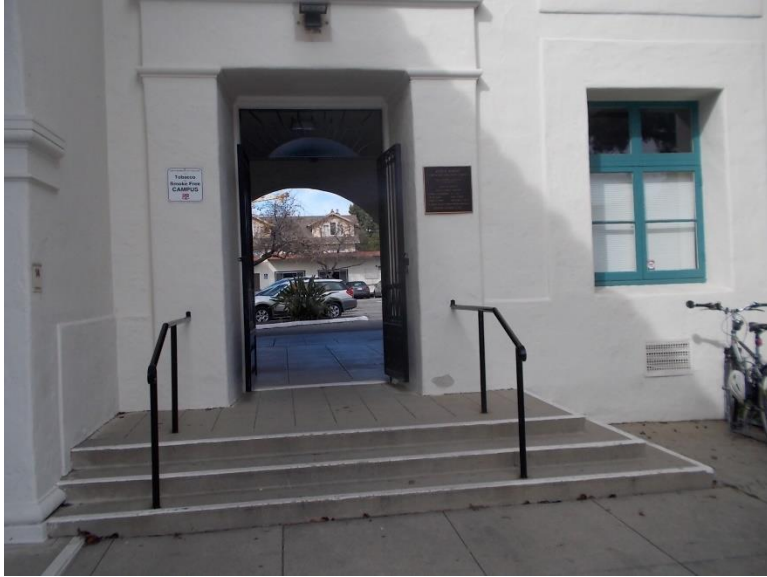
D3. Entrance from south side of site; non-compliant handrail returns.

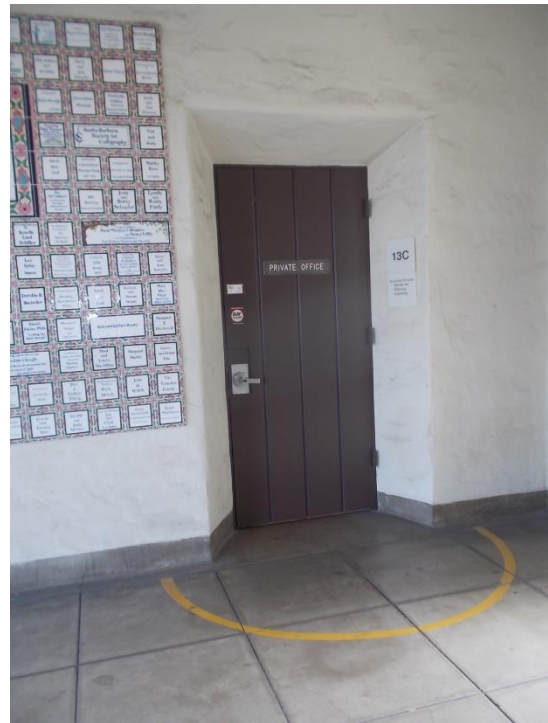
D5. Office 13D door; pull-side clearances not met.

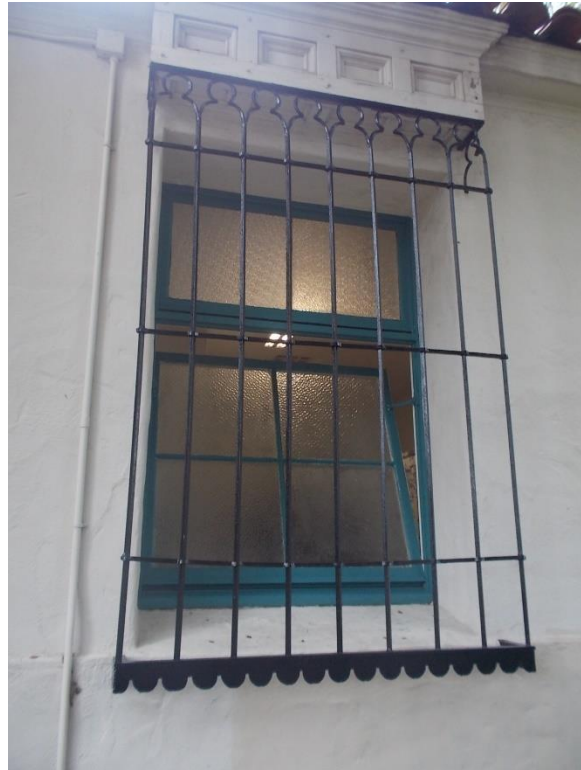
EW2. Women's restroom operable wood window with bars, and newly painted frame.

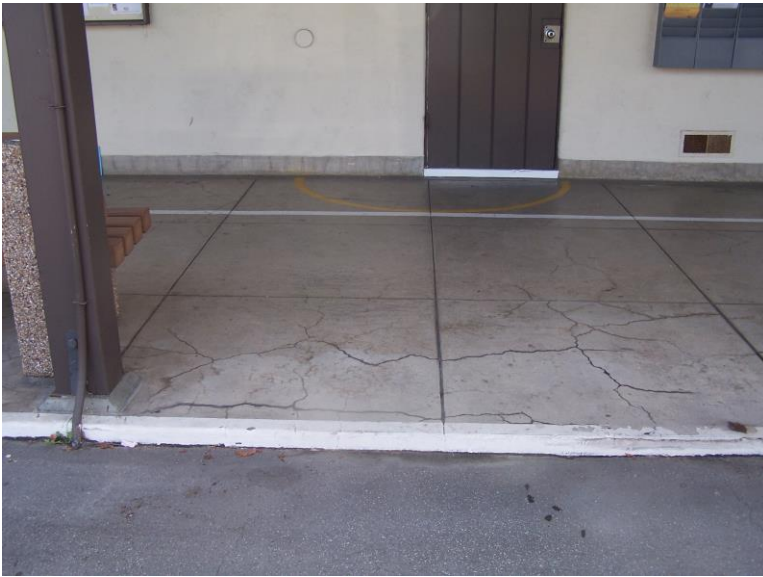
**FLOORING:** The exterior concrete walkways are in poor condition with deep cracks and uneven surfaces and deteriorated materials. The interior flooring varies throughout the facility and includes broadloom carpet, carpet tile, VCT, wood, and exposed concrete. Although the carpet tile is in good condition, all other finish materials are dated and worn, and should be replaced. During any renovation, abatement may be required in some areas with 9"x9" resilient tile flooring.

EF1. Exterior corridor walkway; cracked and degraded concrete.

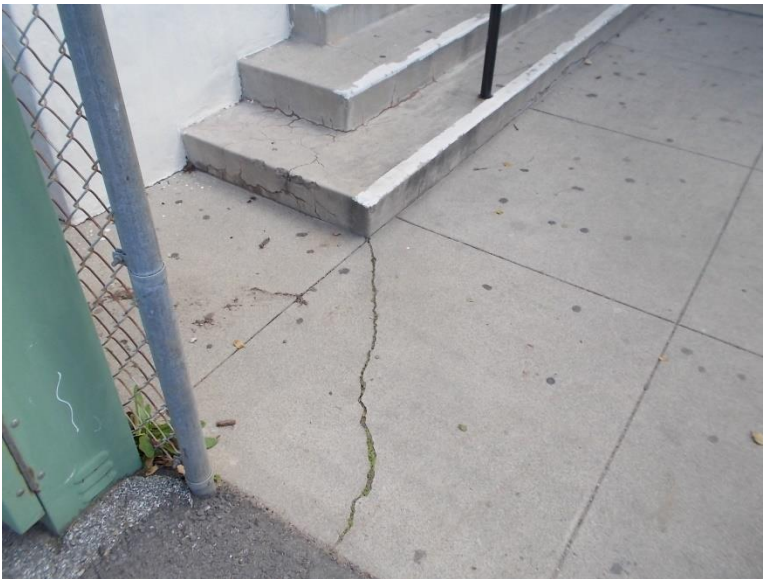
EF2. Exterior sidewalk, west side; cracked and degraded concrete.
