# SANTA BARBARA CITY COLLEGE

## ADA PATH OF TRAVEL ASSESSMENT

# Facility Condition Assessment Report ADMINISTRATION BUILDING

**Facility Condition Assessment Report**  
**Santa Barbara City College – Main Campus**  
**Administration Building**  
**721 Cliff Drive**  
**Santa Barbara, CA 93109**

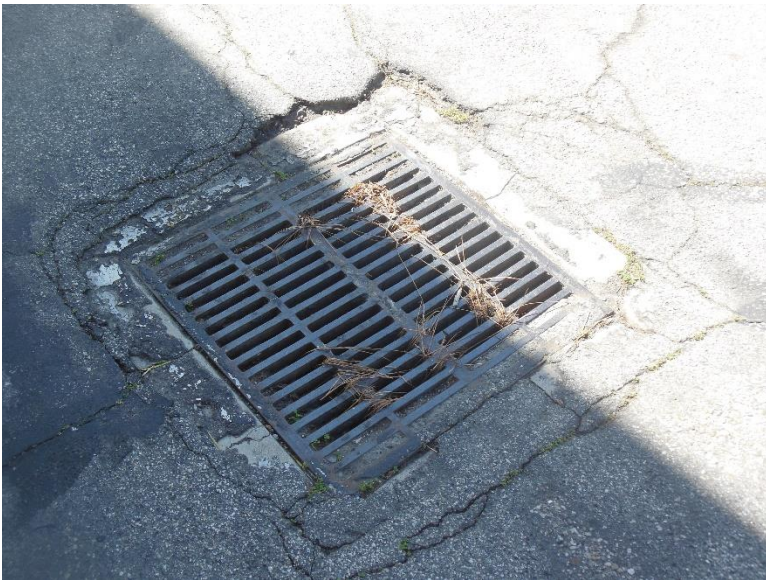
EF4. Drainage catch basin on parking lot with degraded surrounding asphalt materials.

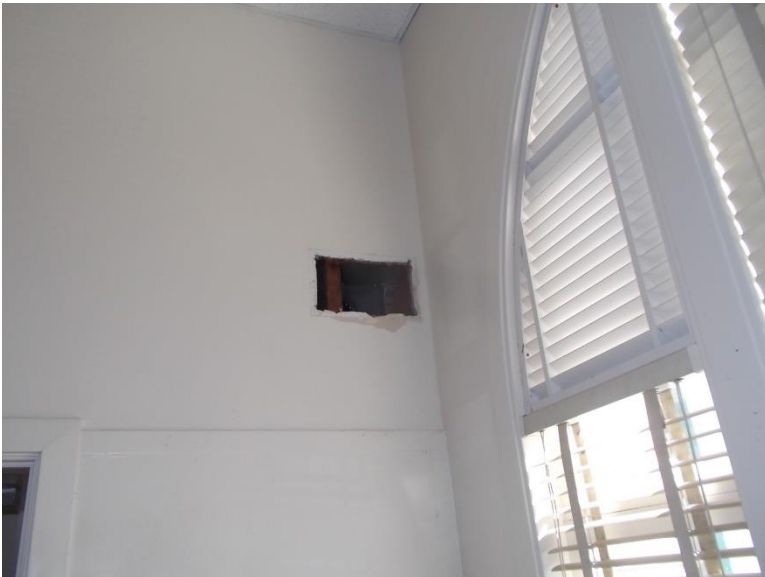
AI2. Office; hole in wall.

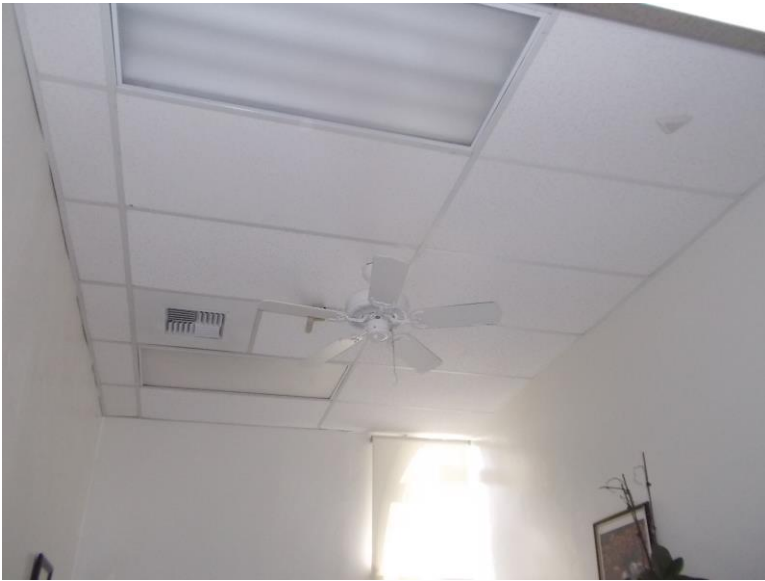
C1. Office; suspended acoustical ceiling system.

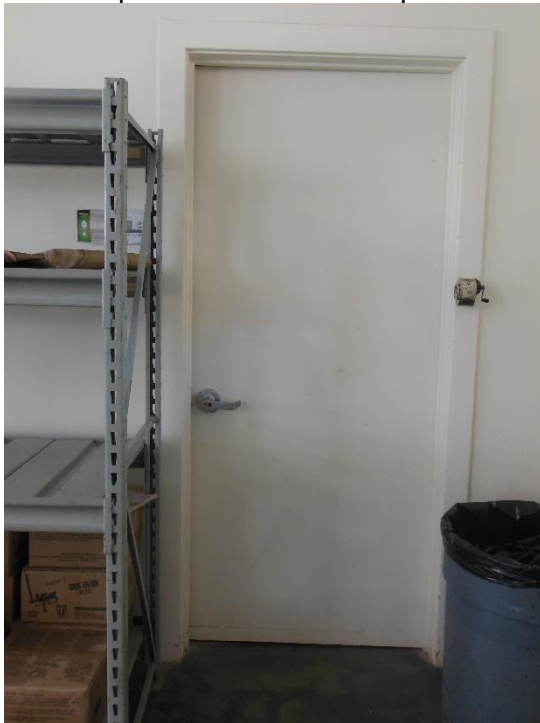
D2. Classroom 22; interior painted wood door, push-side clearance not provided.

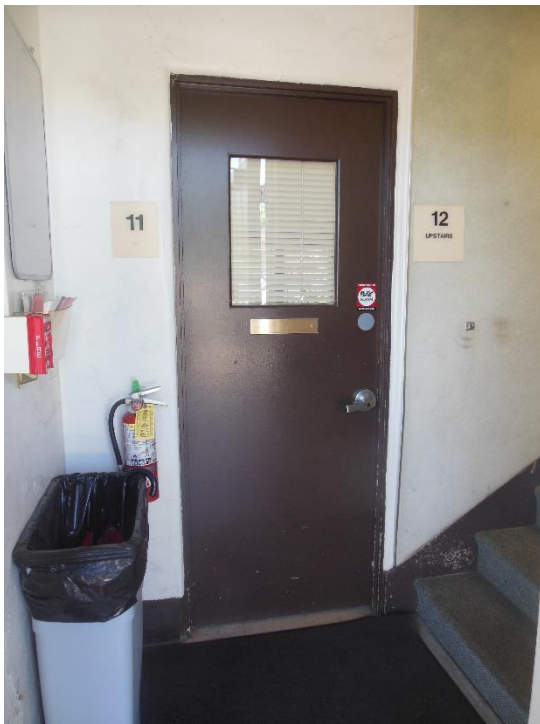
D4. Office 11; interior painted wood door; pull-side clearance not provided.

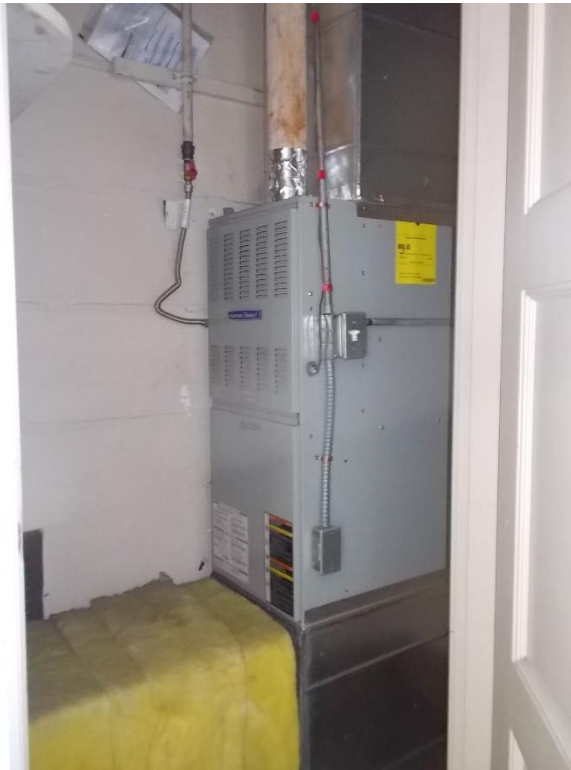
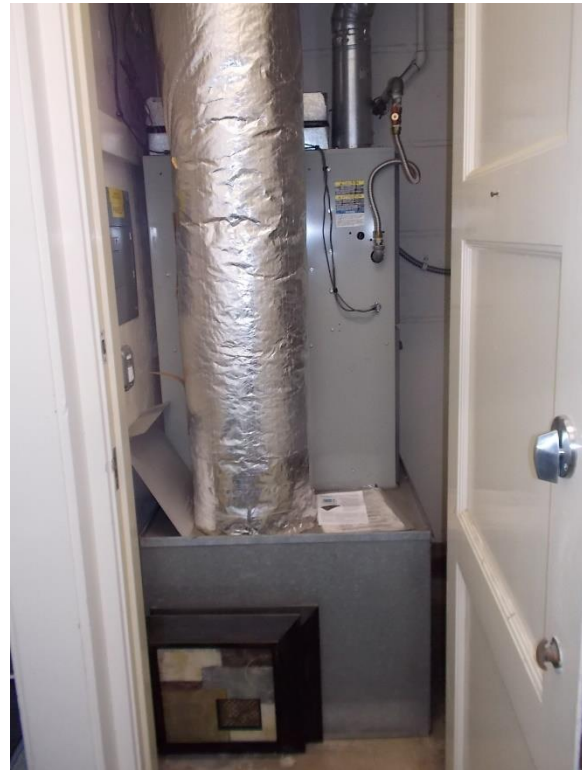
M3. Gas fired forced air heating units in mechanical closet adjacent space served, typical.

The forced air units are at the end of their useful life and should be replaced with high efficiency units with cooling coils and high efficiency condensers.

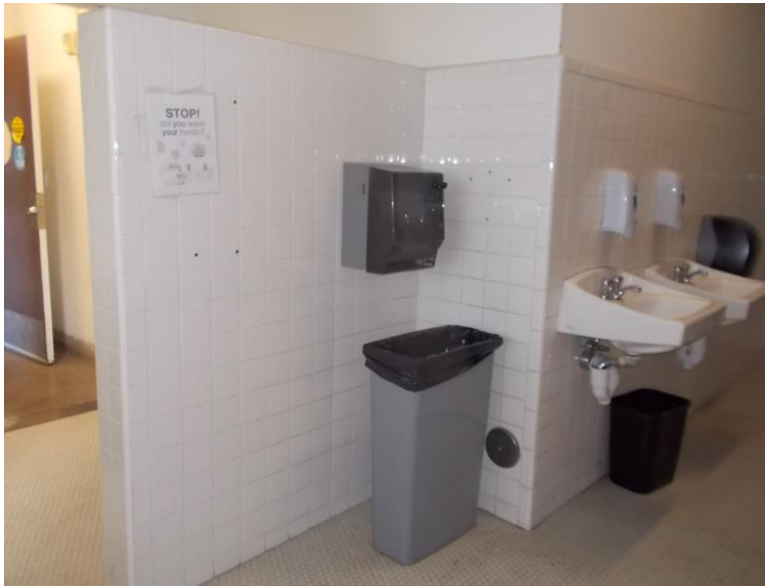
RR1. Women's Restroom; lavatories and fixtures.

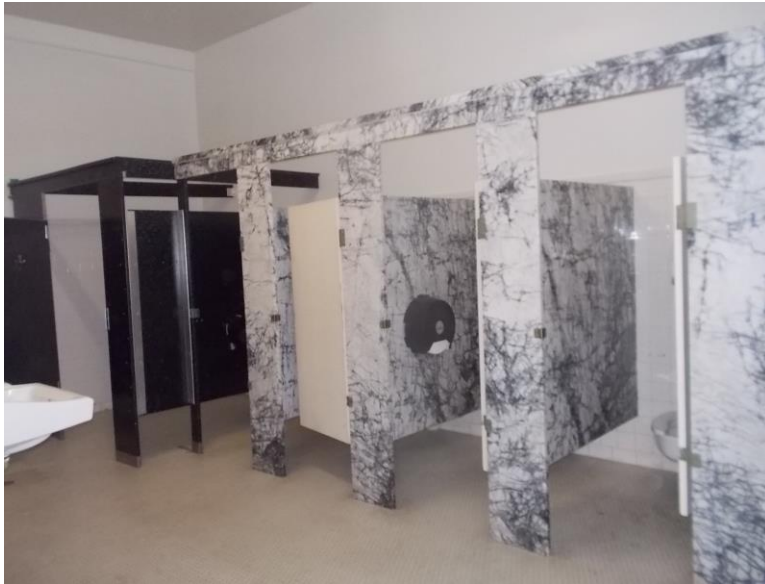
RR3. Women's Restroom; toilet compartments.

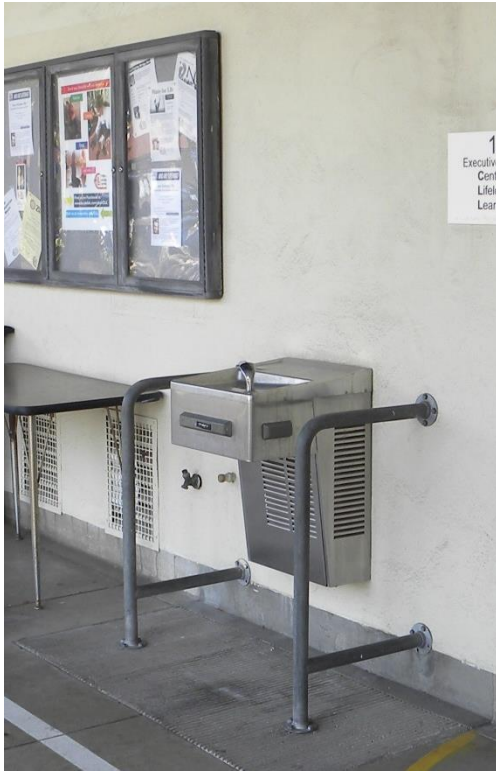
DF1. Drinking fountain in exterior walkway; hi-low fountains not provided.

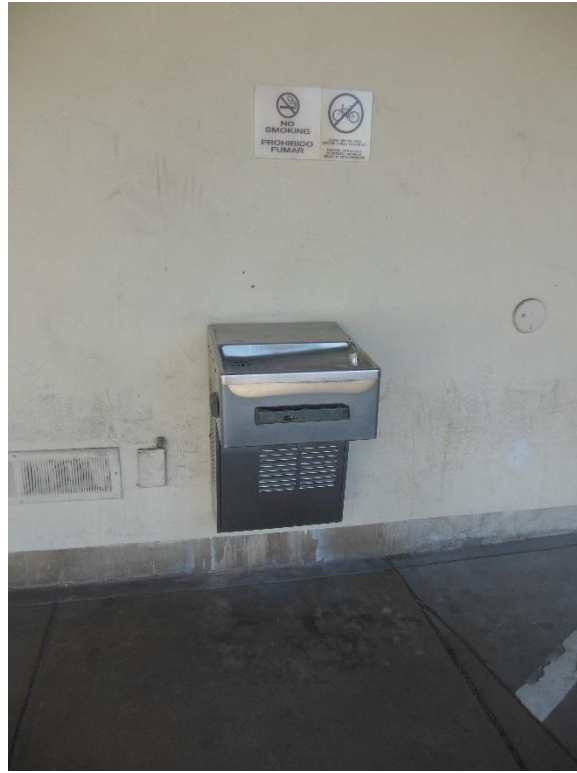
DF2. Drinking fountain in exterior walkway; Handrails not provided.

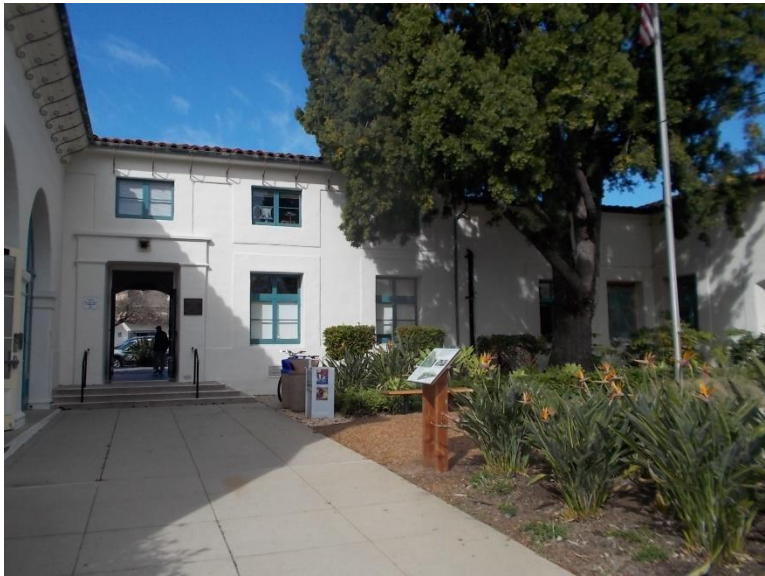
PT1. Exterior walkway to south entry; path of travel with excessive slopes, hazardous surface features, and no wayfinding signage.

The south and west sidewalks lead up to staircase entries with cracked concrete, faded nosing stripping and non-compliant handrails. There are no wayfinding signs directing the user to the accessible east entrance. These staircases would benefit from the addition of signage, and a ramp or sloped walkway.

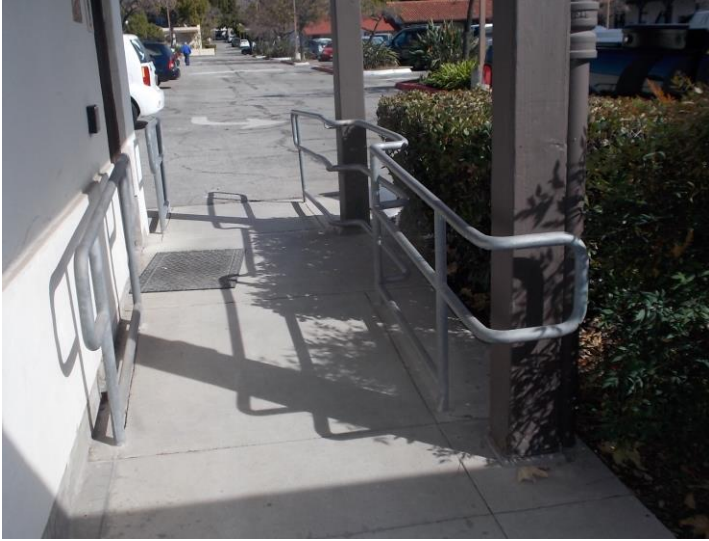
PT5. Ramped walk to Men's restroom; non-compliant handrails.

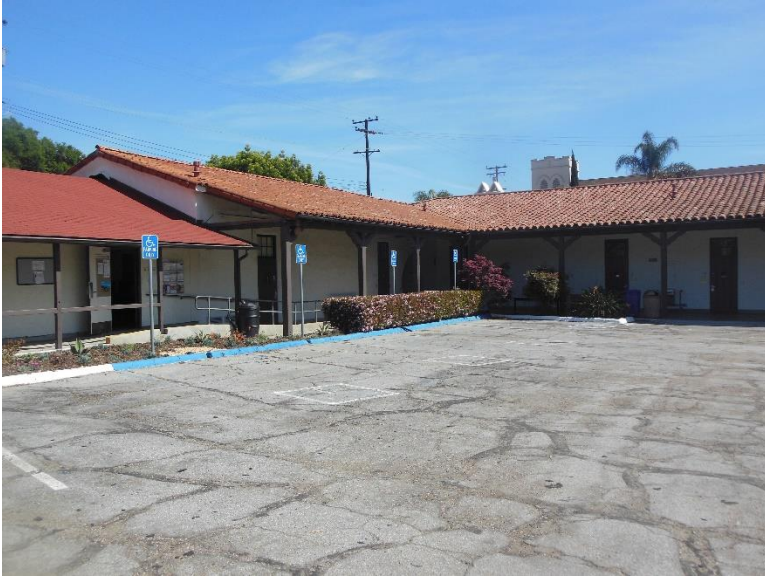
The asphalt surface at both parking lots is in very poor condition, and the stripping is faded. The asphalt surface has raveling, alligator cracks, upheaval, and depressions. Cracks have been filled with slurry, but the surfaces would benefit from a full restoration and restriping. Additionally, the main lot slopes toward a poor draining catch basin in the southwest corner by Rooms 17 and 20. During periods of heavy rain, this area floods up to the doors, due to excessive storm water retention.

PT9. Accessible stall stripping degraded, layout not-compliant and no safe path from stalls to covered walkway.
